Coiled Tubing String Failures – Past and Present

ICoTA Canada Breakfast Technical Session

May 30th 2018

Tomas Padron – Coiled Tubing Research & Engineering

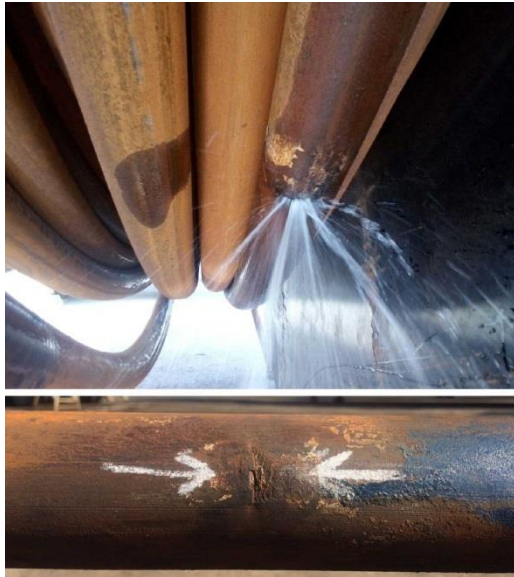
Pinhole

POOH – PLT run

2-3/8" OD – CT90

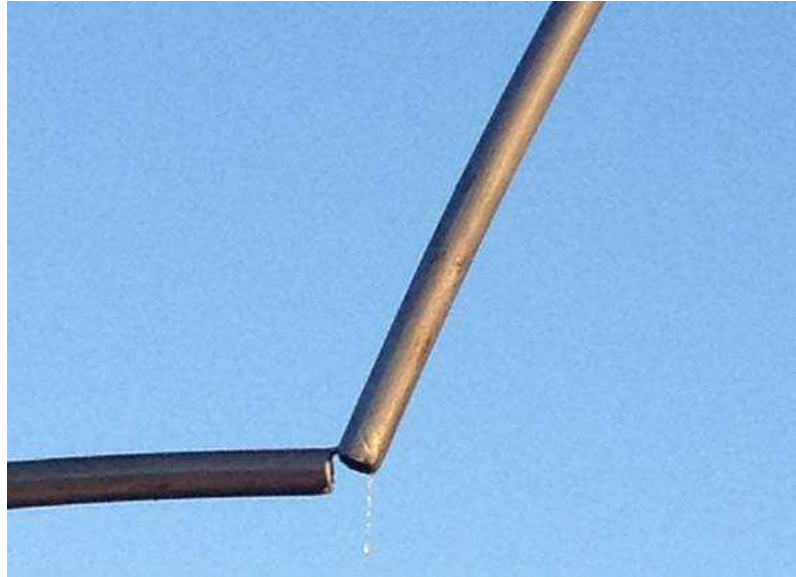
Partial Fracture

RIH – Milling

2-3/8" OD – CT100

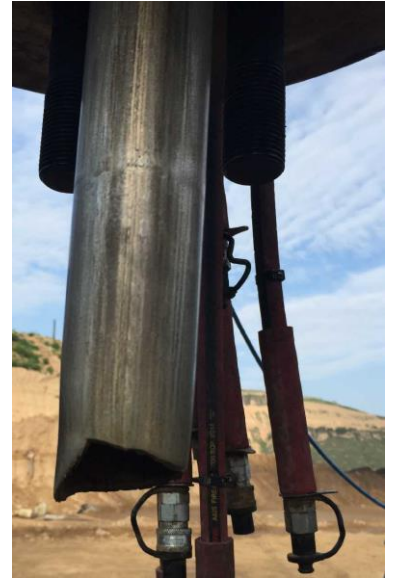
Total Fracture

Pulling to free string
Cleanout

2" OD – CT90

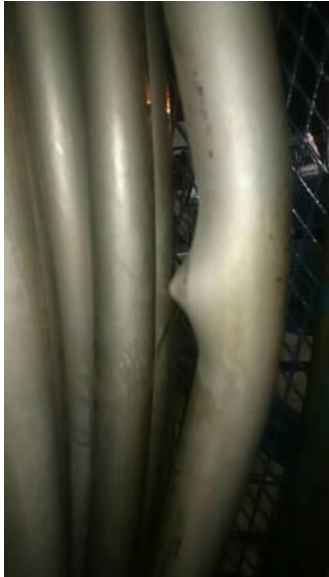
Burst

Pressure testing

1-3/4" OD – CT90

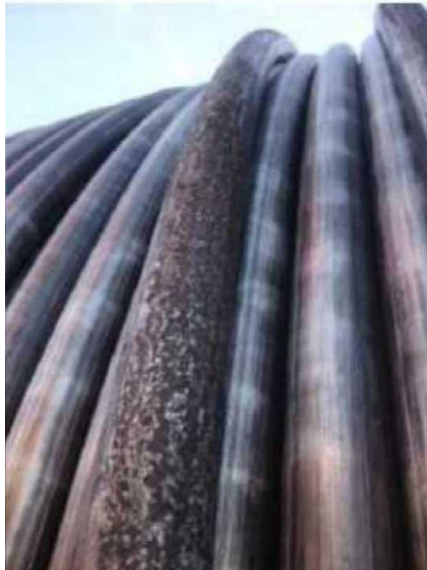
Extensive Damage

POOH Logging job

1-3/4" OD – CT90

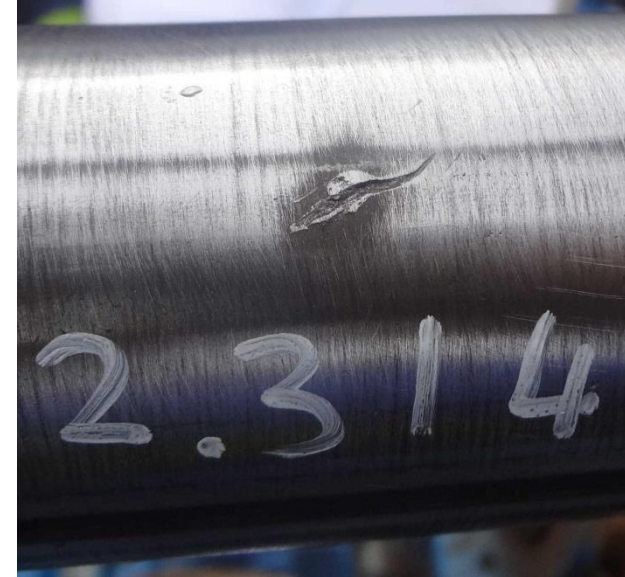
???

New string - Inspection

2-3/8" OD – CT80

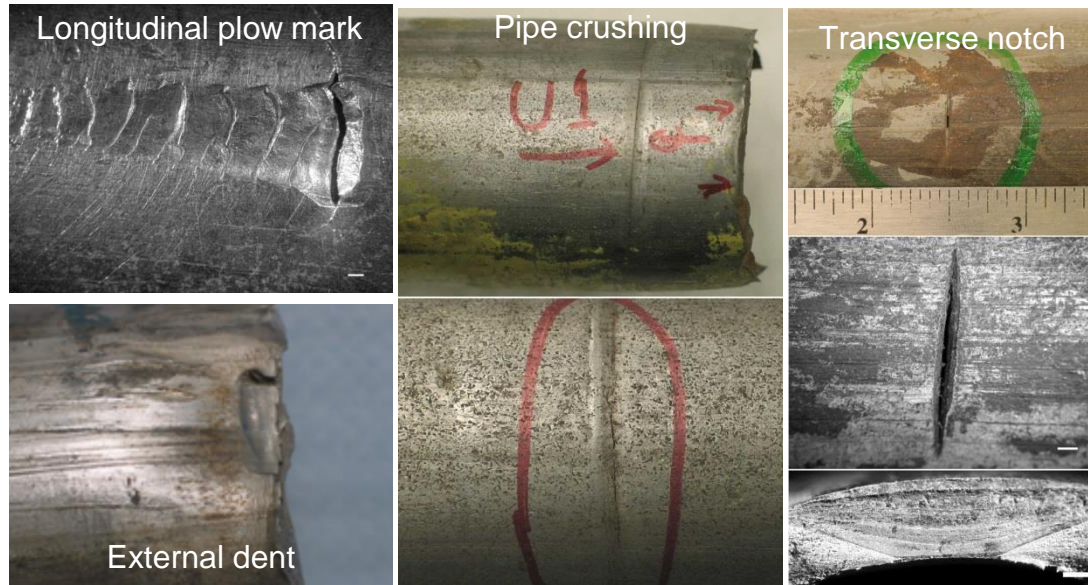
Mechanical damage

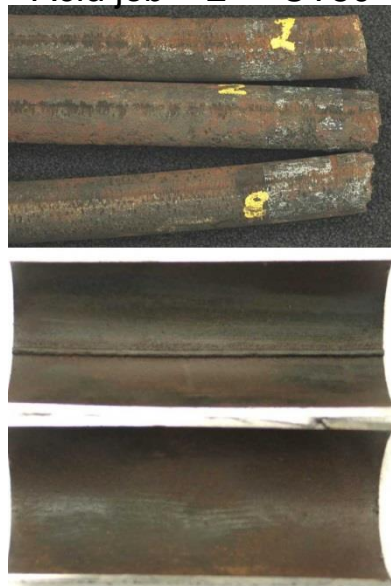
External Corrosion

Acid job – 2" – CT80

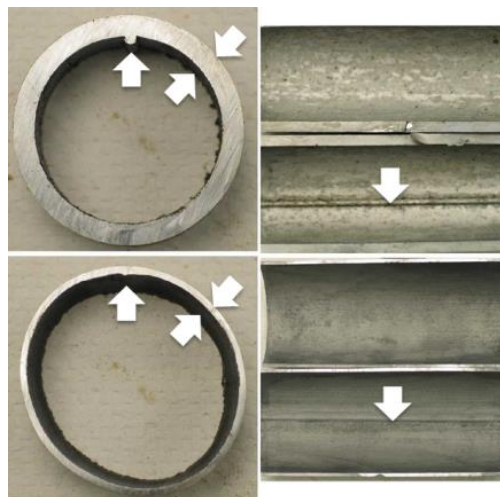
Internal Corrosion

Acid job – 1-1/2" – CT80

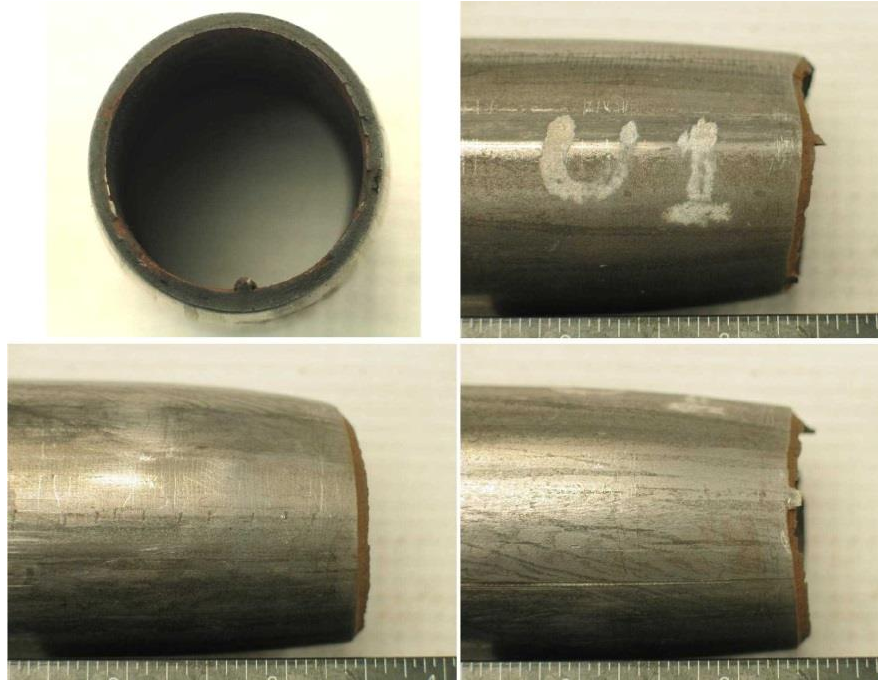
Necking and 45° fracture propagation

Fishing – 2" – CT90

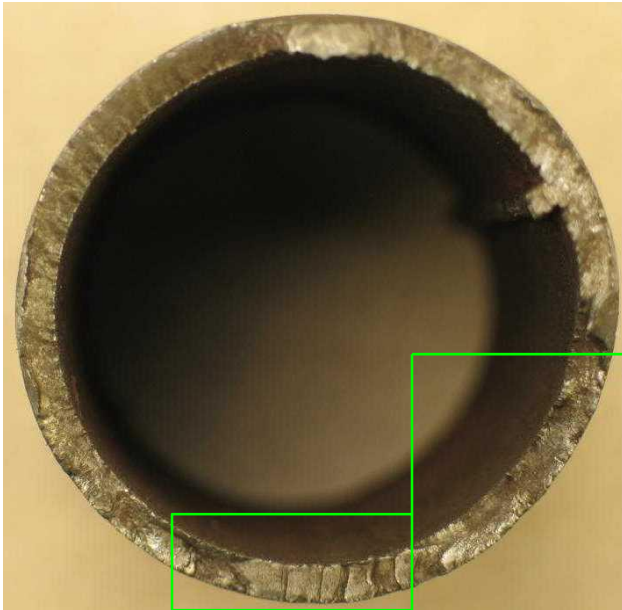
Fracture origin

Fishing – 1-3/4" – CT90

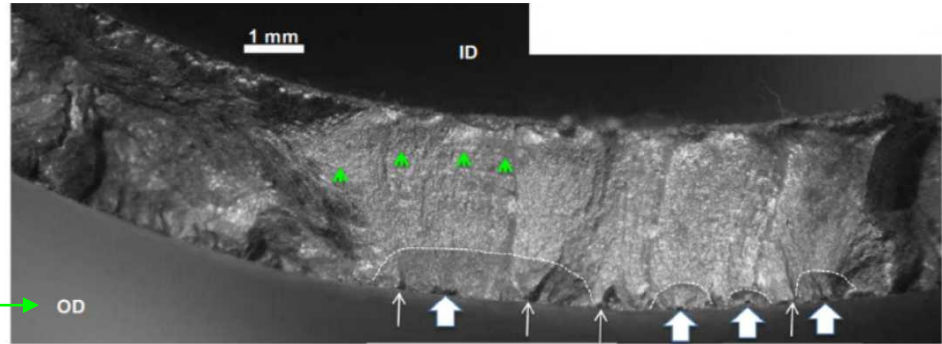
Figure 4. Detailed view of the “flat” portion of the fracture shown in Figure 3b. The following features can be observed:

- Ratchet marks at the outside diameter (small white arrows), indicative of multiple fatigue cracks starting at the outside diameter.
- Thumb nail cracks starting from external pits (darker areas enclosed by dotted lines and block arrows).
- Some light marks concentric towards the OD can be observed (small green arrows), indicating propagation by fatigue from the OD.

All these features indicate that the fracture started at this location (fracture origin) from multiple fatigue cracks that propagated from the outside diameter at external pits.

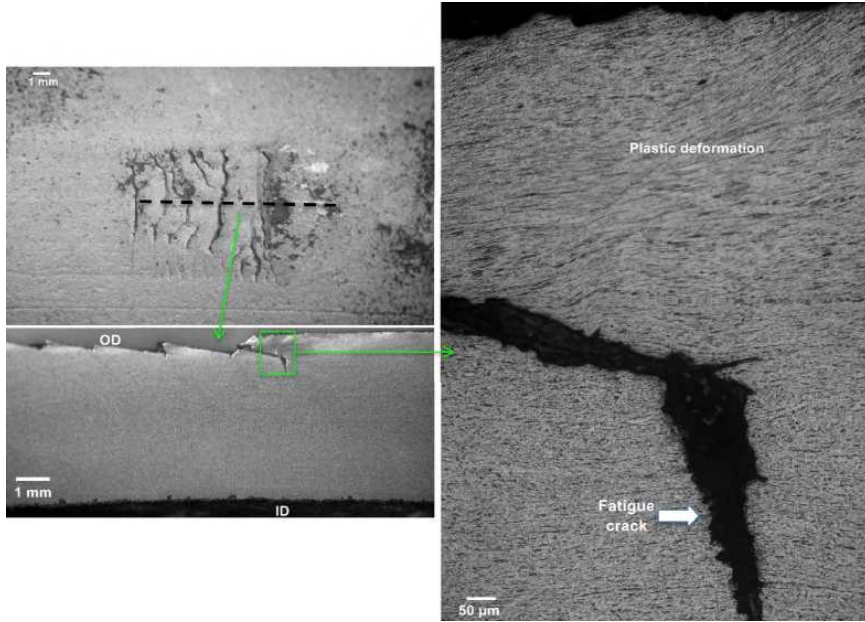
- Mechanical damage: confirm plastic deformation at damage:

Longitudinal plow mark

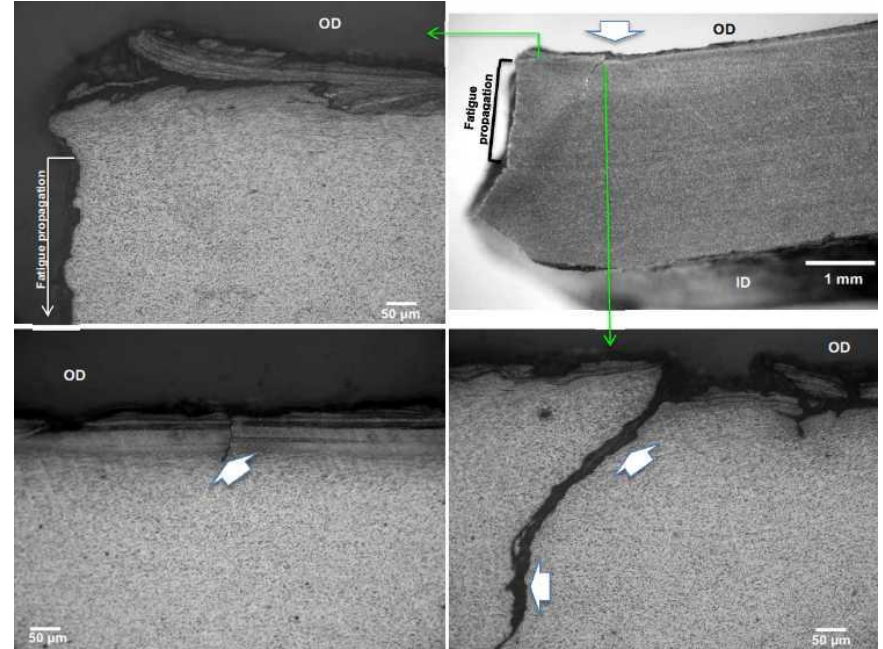
Pipe crushing

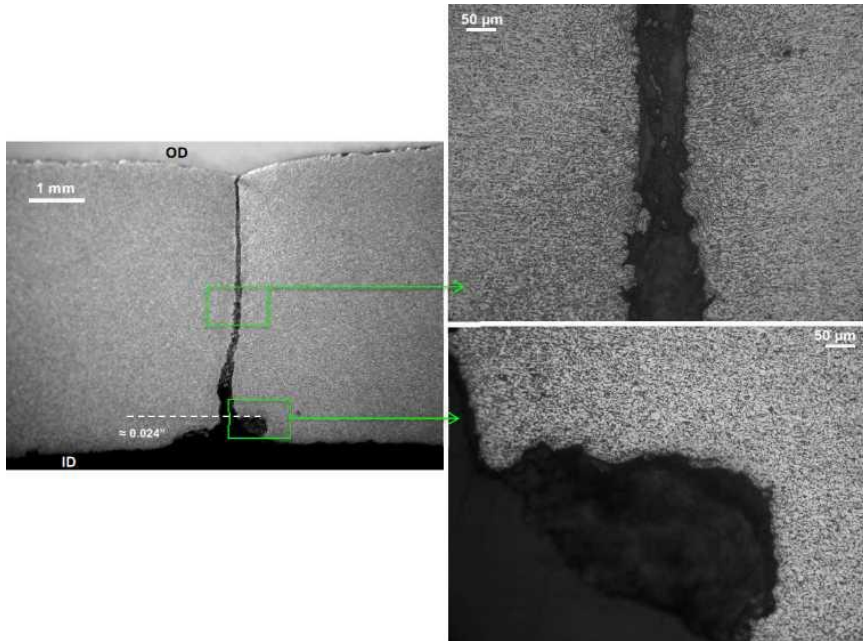
- Corrosion: corrosion depth / metallurgy at corrosion:

Internal pit

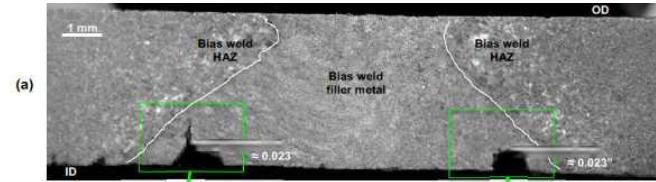
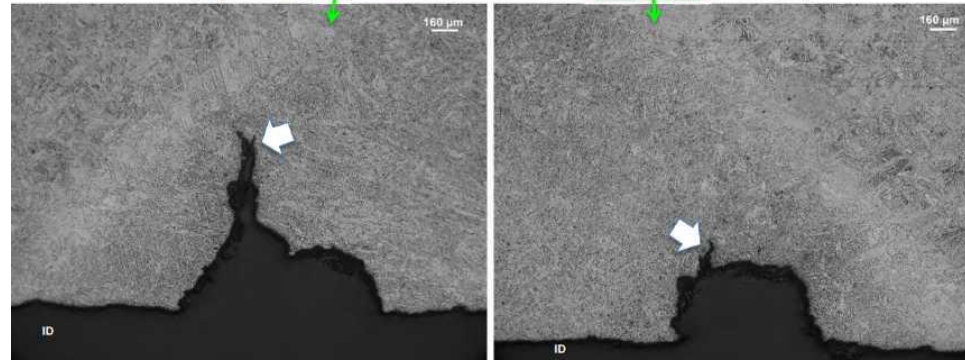
Internal pitting at bias weld

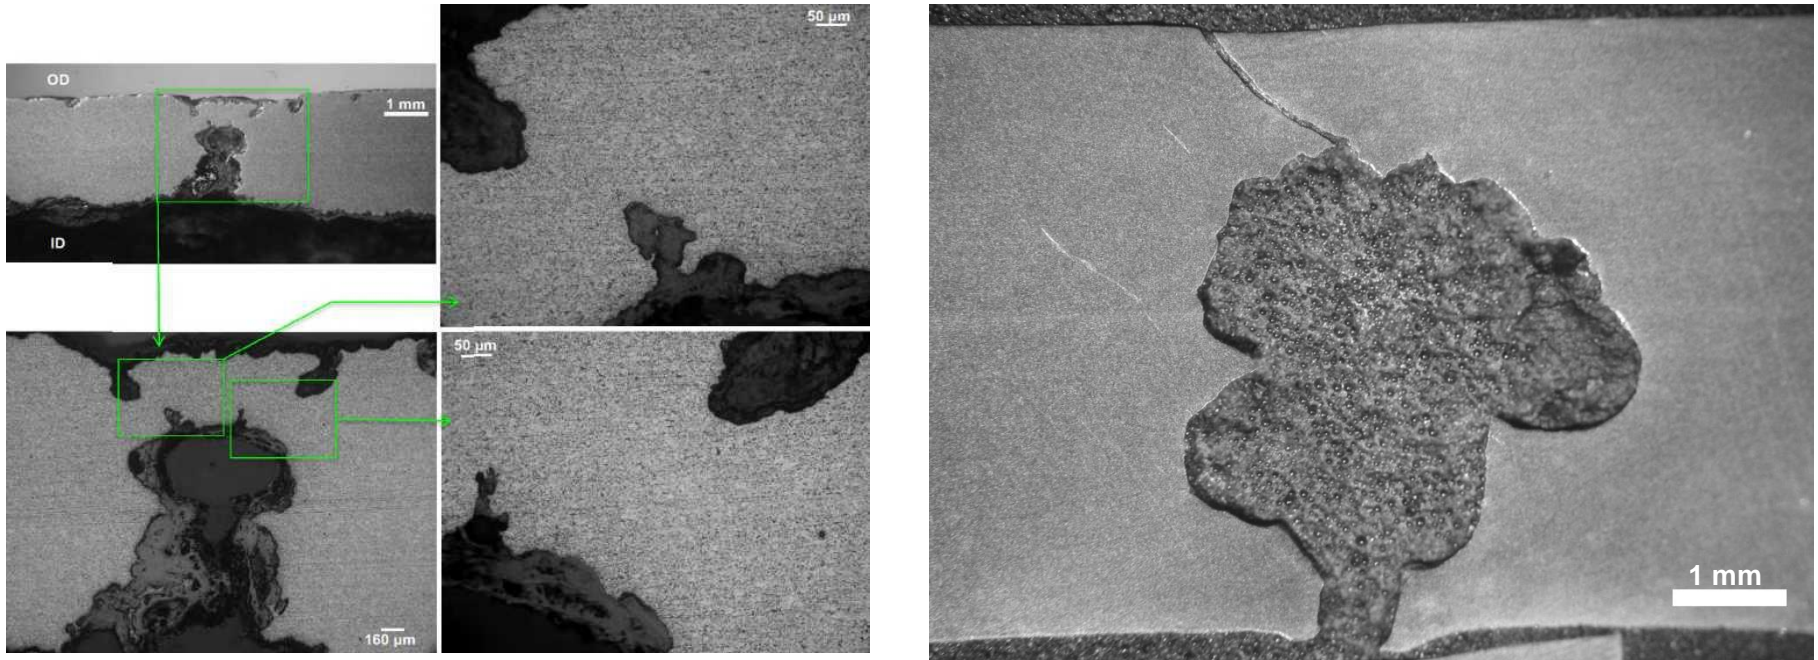
- MIC: pitting shape: normally “cavernous”, deep, and very aggressive:

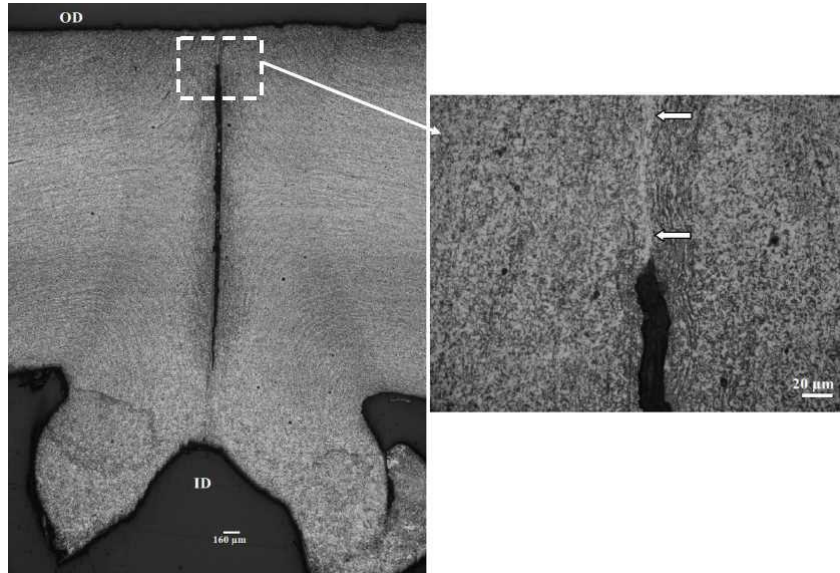
- Manufacturing flaw:

“Cold weld”

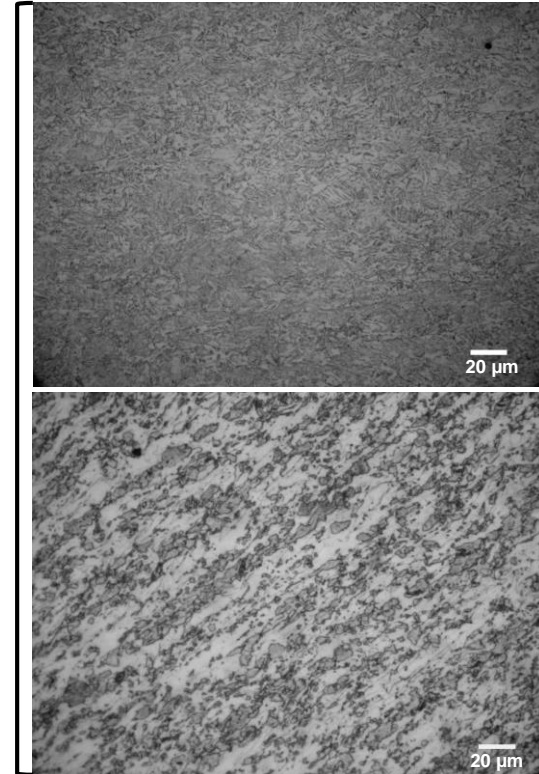
Abnormal microstructures

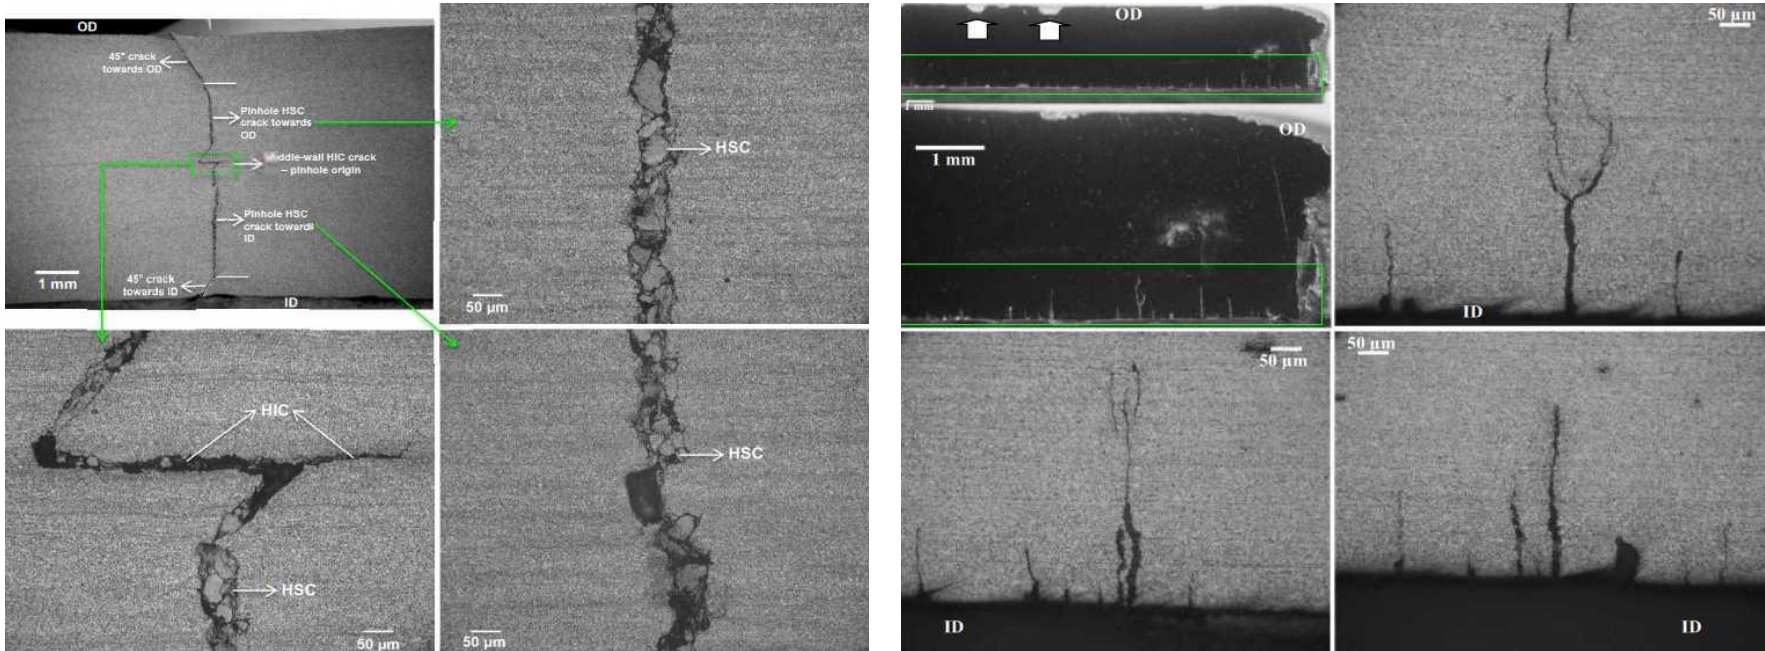
- Environmental cracking:

H2S cracking

Caustic cracking

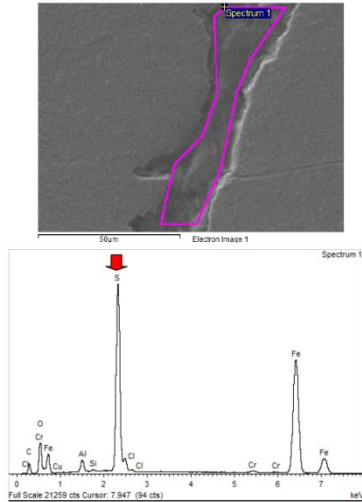
EDS within a crack – (S)

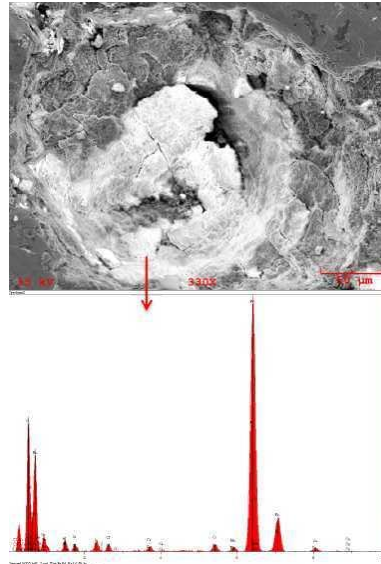
EDS within external pit – (Fe, O)

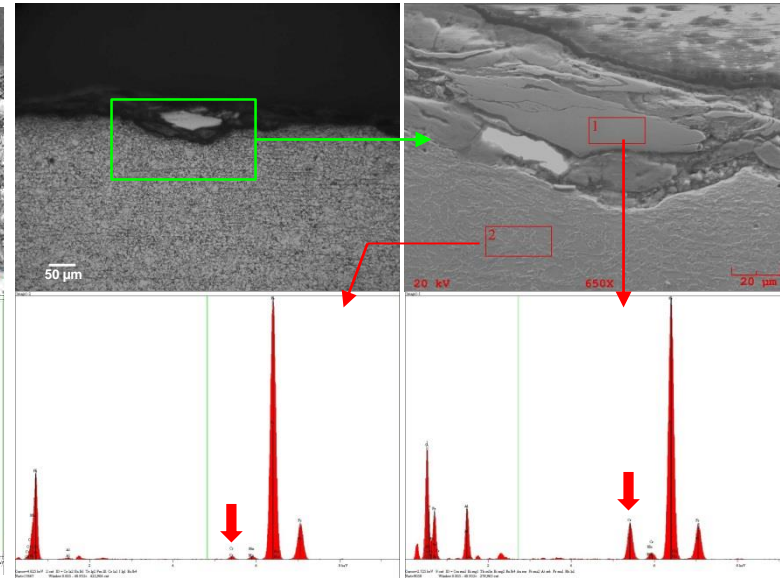
EDS on particle – Higher Cr than base metal

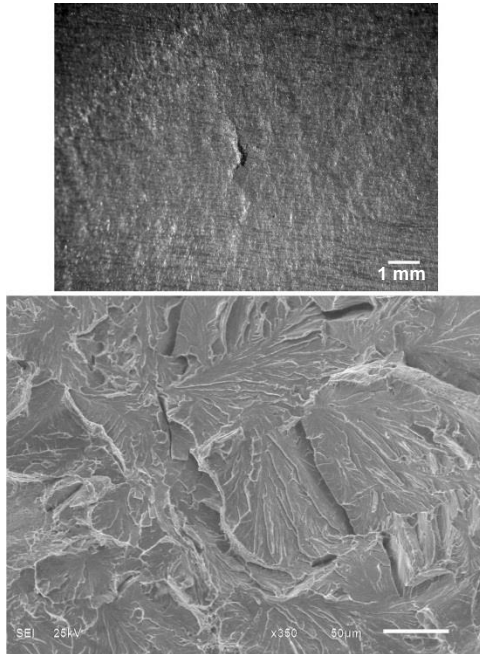
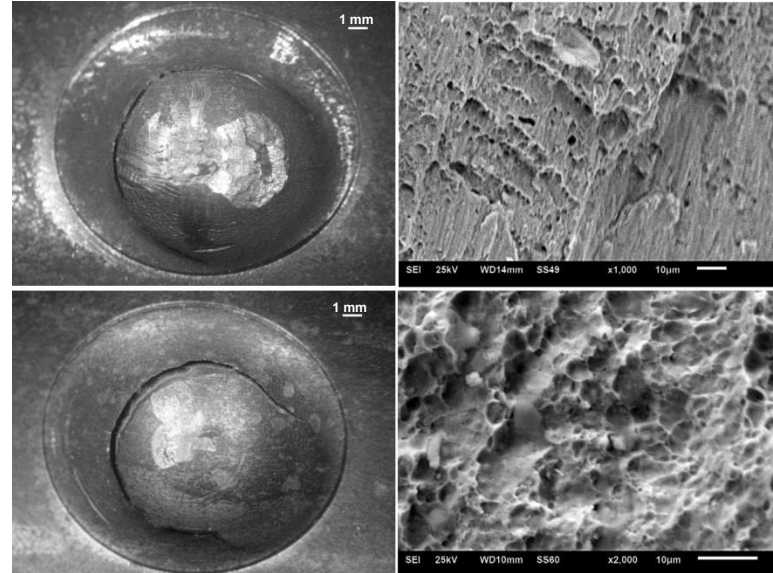
Cleavage on secondary crack (after opening) – MIC failure

Cracks on dimple on connection –
Elongated dimples (shear) on cracks

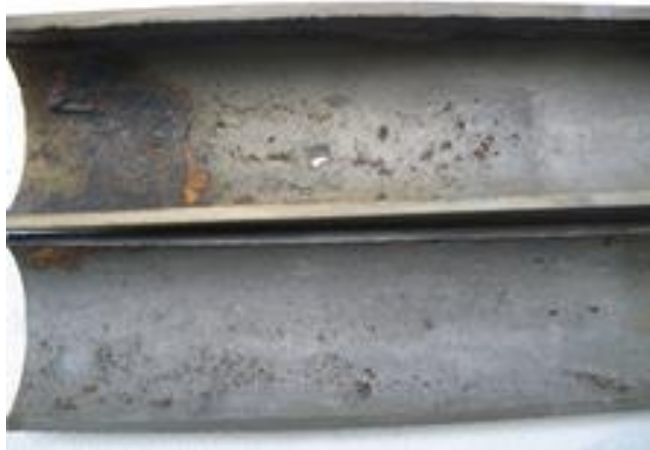
Internal storage-corrosion example

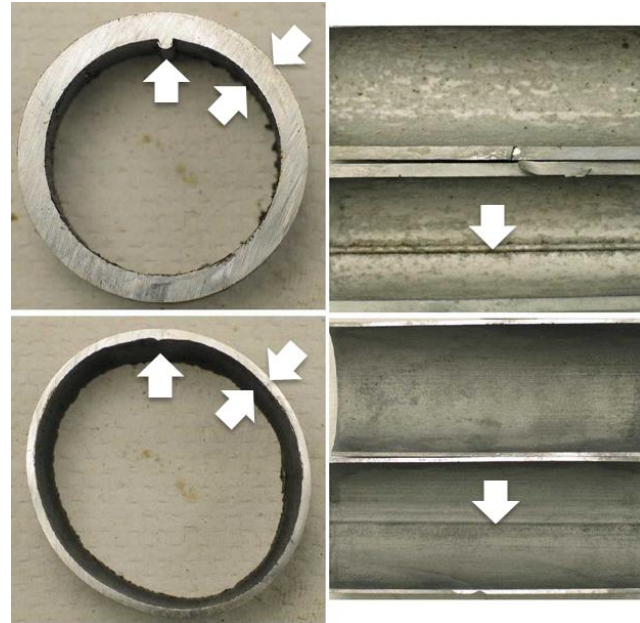
Acid internal-corrosion example

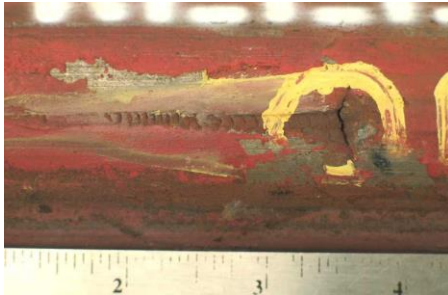
Longitudinal plow mark

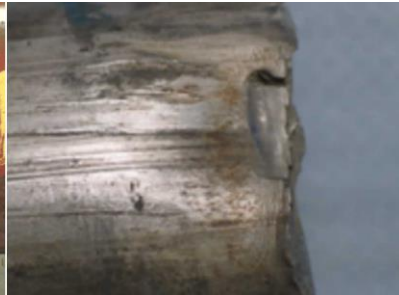
External dent

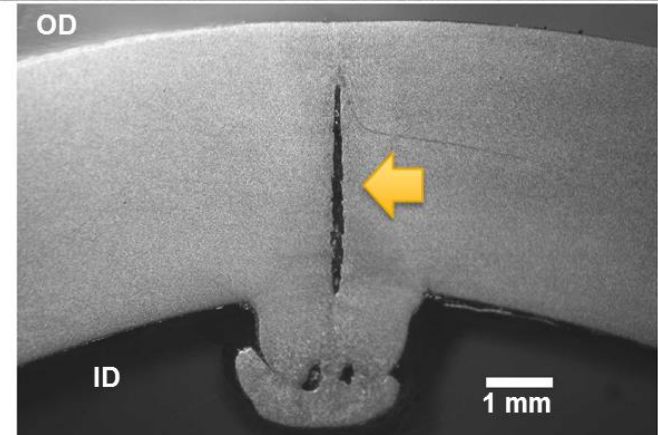
“Cold weld” example

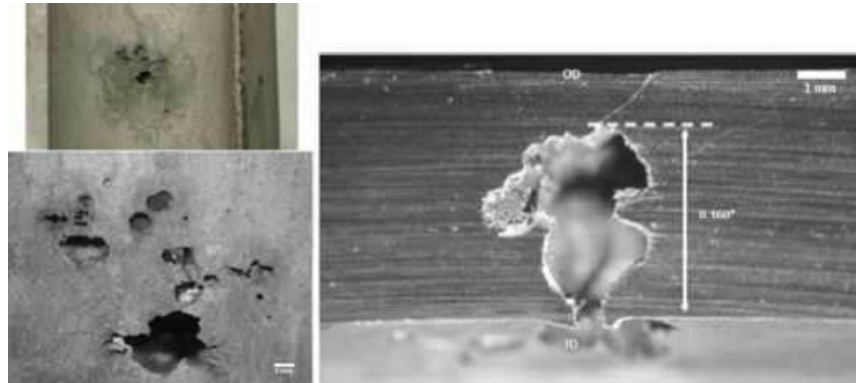
Internal MIC

MIC (Microbiological influenced corrosion): corrosion failure due to the presence of certain specific type of bacteria within the fluid in contact with the pipe.

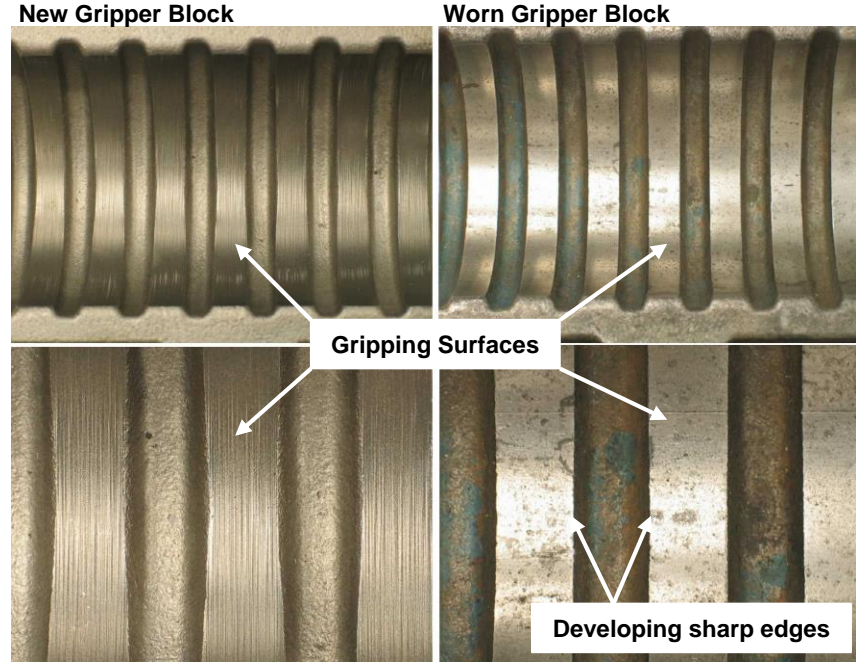
Frequently associated with worn gripper blocks
