Wellbore Diagnostics: Things I Thought I Knew!

- Mechanical inspections post frac

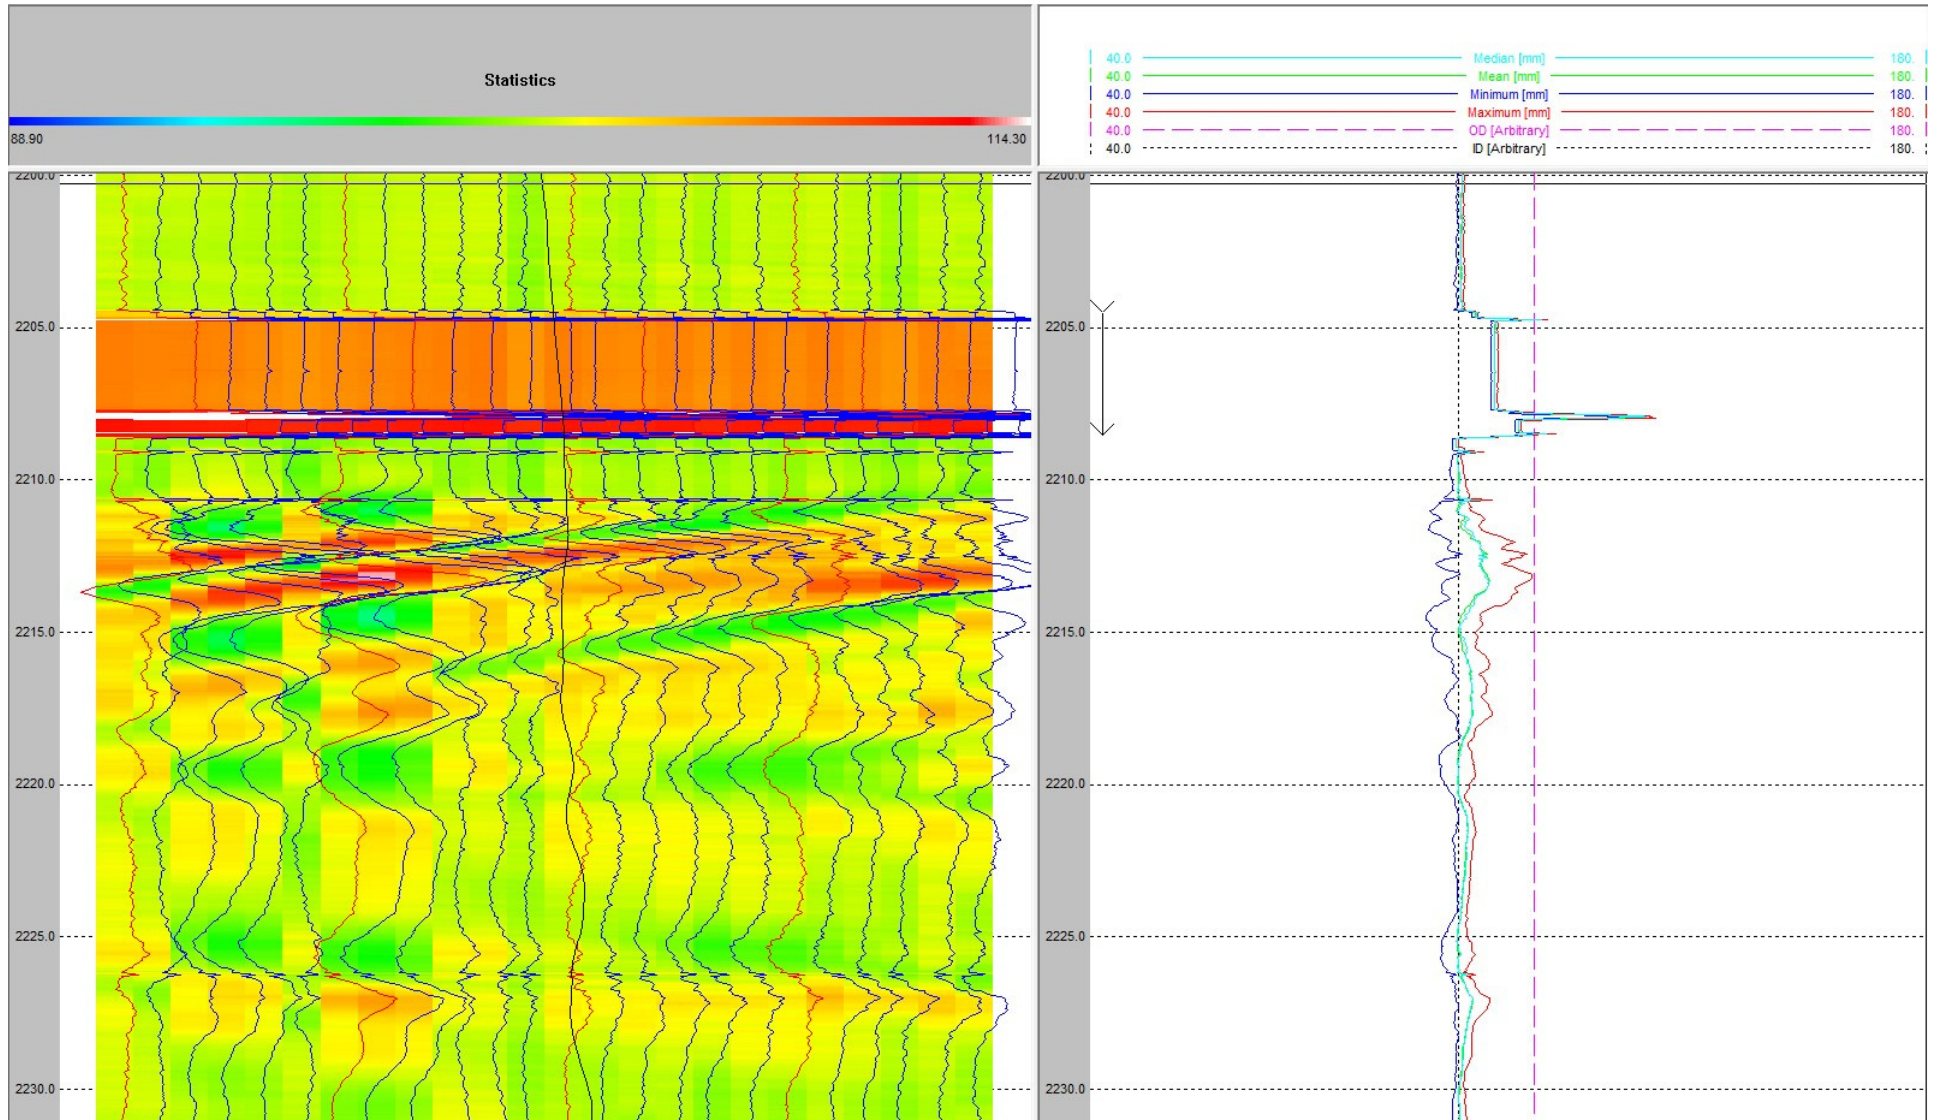
Case History: Casing Inspection- Centralized Data

The caliper was able to show some small internal damage on the centralized data. It was not until the data was uncentralized that the true story appeared!

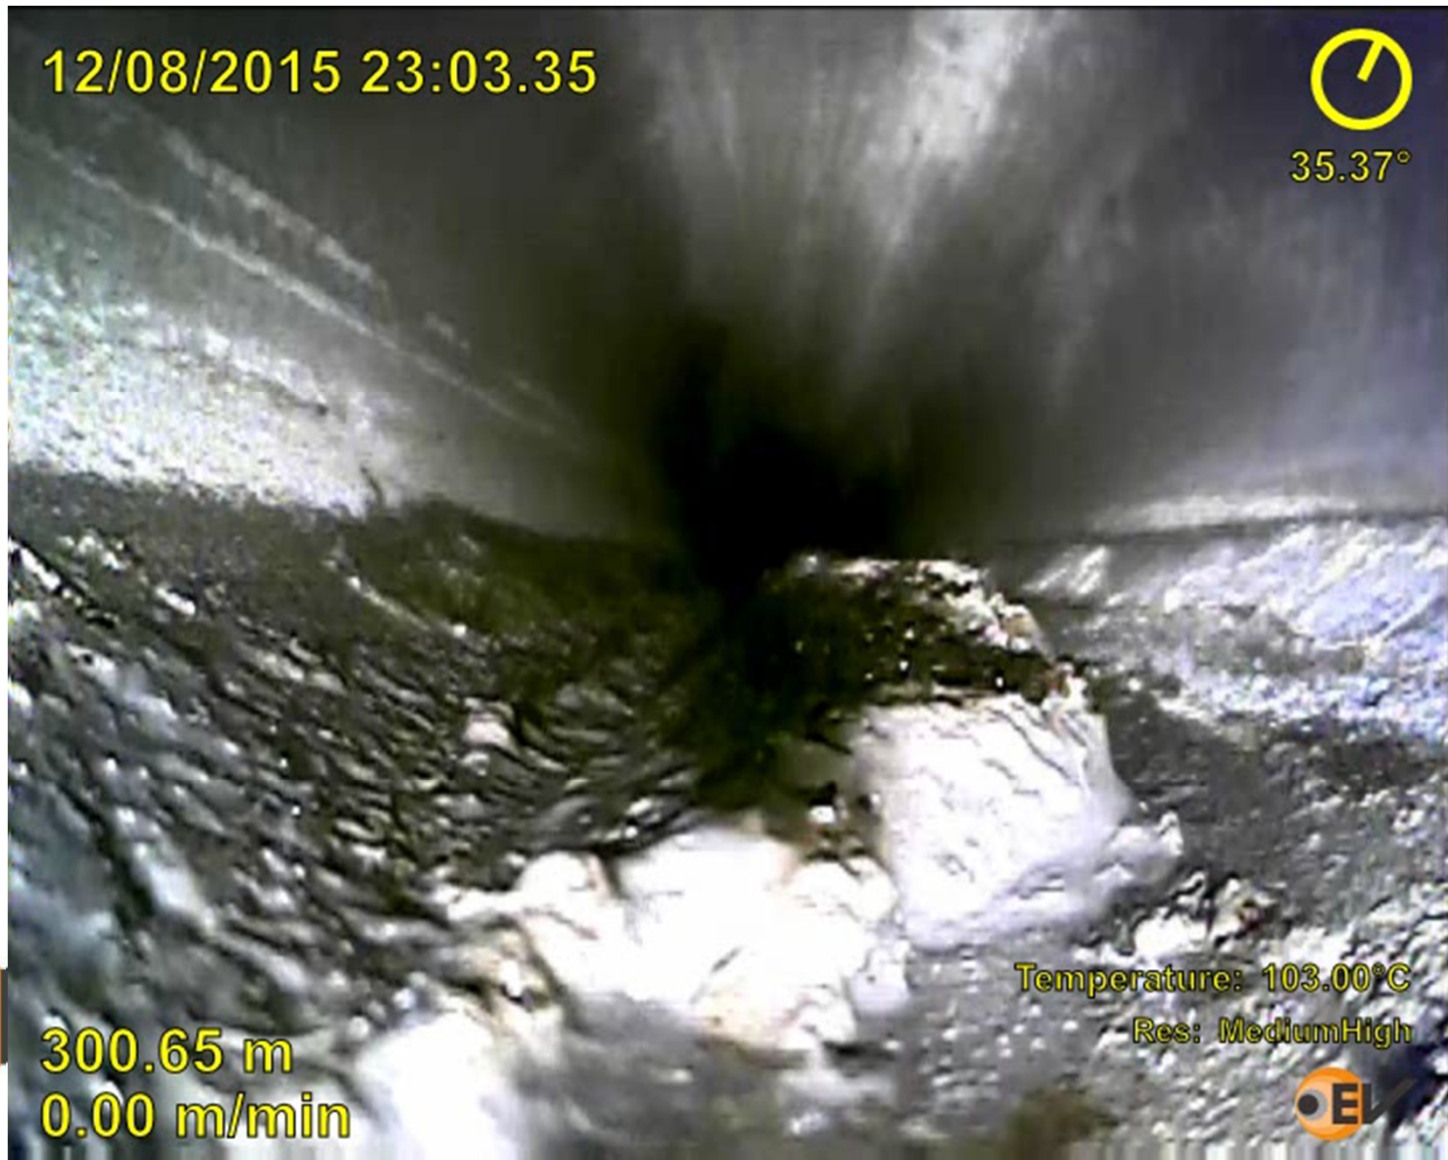
Case History: Camera Inspection for Multiple Obstructions

The camera was able to see multiple areas of sand deposition and buildup so it was determined that the caliper was not needed to investigate further since the sand would affect the caliper readings substantially.

The camera was able determine that the issue was heavily packed sand that was dehydrated from the Nitrofrac/Friction reducers and other chemicals. The calcified sand was able to be removed with chisels and jars and the coil was able to proceed to the bottom to finish the cleanout procedure. No mechanical issues were found thankfully!
