# Field Performance of BlueCoil Including Performance of Mechanically Damaged CT

Radovan Rolovic & Bruce Reichert  
Tenaris Coiled Tubes

ICoTA Roundtable, Calgary, Canada  
October 25, 2017

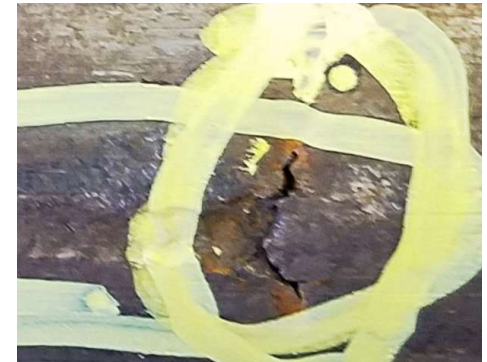
- Field damaged CT section - plough mark (no pinhole leak)
- HT-125, 2.375" x 0.190"
- Field used fatigue life was 25%
- Fatigue tested to failure at 7,100 psi on 48" bending radius
- Deep end of plough mark was on intrados in fatigue machine gage section at typical failure distance along the gage section
- Additional fatigue machine life was 45% (failed at the deep end of plough mark)
- Total life = 70%

Photo after  
sample  
failure in  
fatigue  
machine

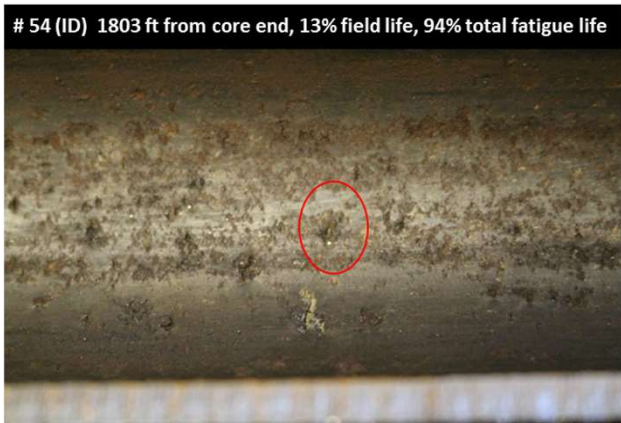
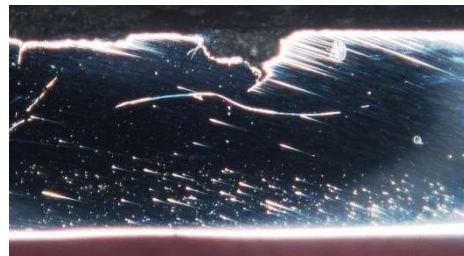
- Field damaged CT section – Internal corrosion pitting (no field failure)
- HT-125, 2.375" x 0.204", used on 26 South Texas jobs, 504k running feet
- Field used fatigue life was 13% at corrosion damage (41% for CT string)
- Fatigue tested to failure at 6,700 psi
- Additional fatigue machine life was 81% (failed at a corrosion pit)
- Total life = 94%

Pitting depth up to 15% of wall thickness (up to ~0.030")

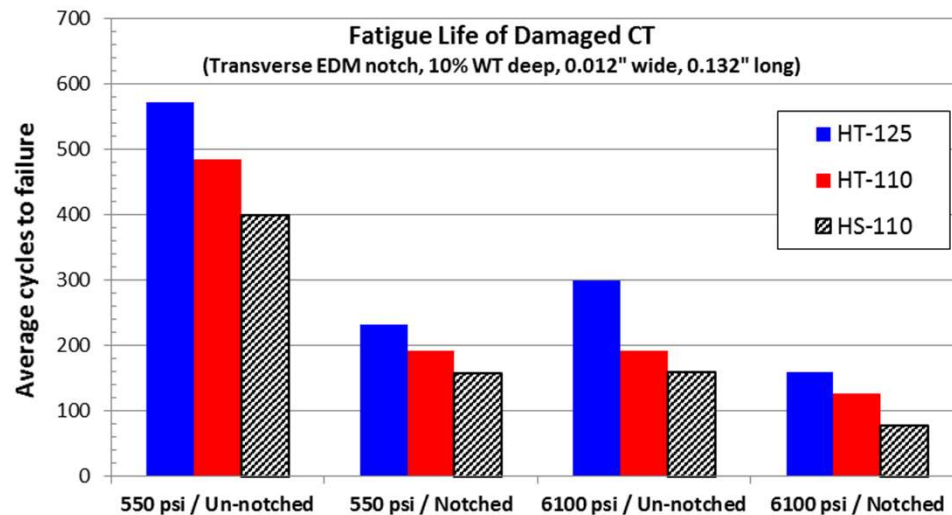
**Test results for 10% deep transverse notches in HT-125, HT-110 and Conventional HS-110 base tube (averages of 3 tests)**

Remaining Life Ratio, sharp transverse cut, 10% WT deep		
Grade/Grade	Low Pressure	Mid Pressure
HT-110/HS-110	123%	163%
HT-125/HS-110	148%	204%

**HT CT advantage increased after CT damage**

**Much more HT CT residual life after CT damage, with even bigger advantage at bias weld**

**Removing/grinding out these notches (up to ~15% deep) to a smooth surface restores the fatigue life close to 100%**
