Coiled Tubing Bias Welds Recent Failures Trend

Tomas Padron, Coiled Tubing Research and Engineering (CTRE)

October 29th, 2014 ICoTA Roundtable, Calgary, Canada

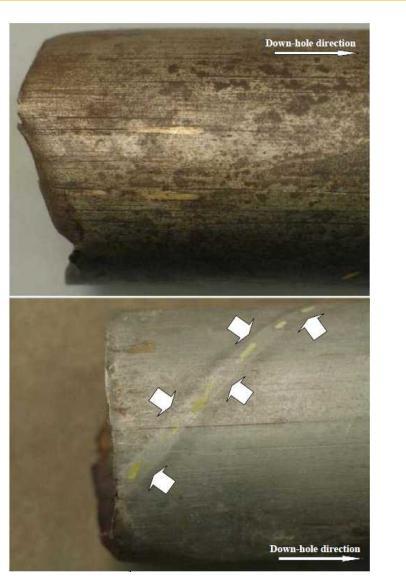
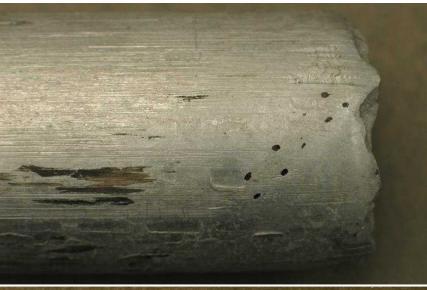
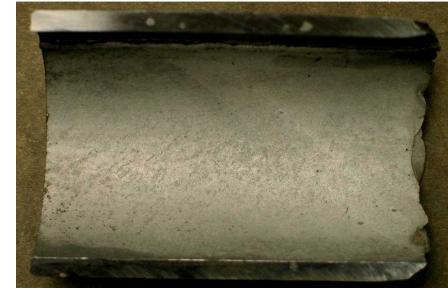
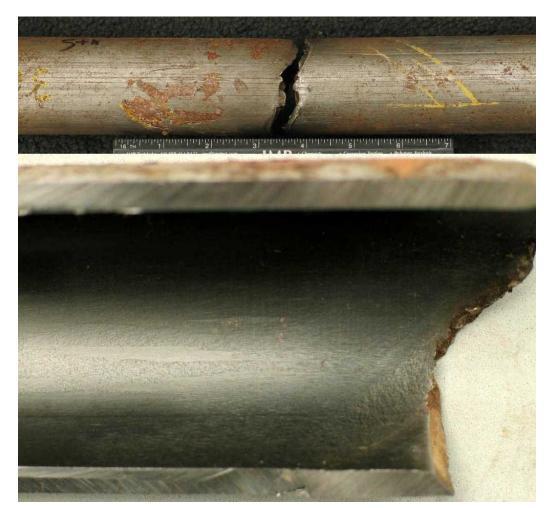
- Six (6) CT failures occurred while milling plugs in Alice – USA.
- String characteristics:
 - 2" OD x tapered
 - 90 Grade
 - Basically new strings
- All the failures occurred on bias welds.

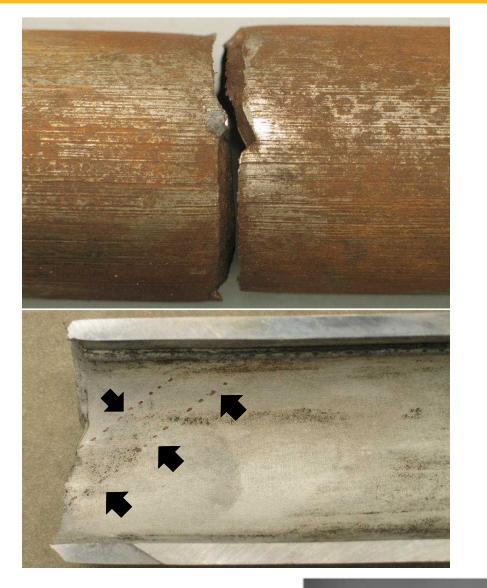
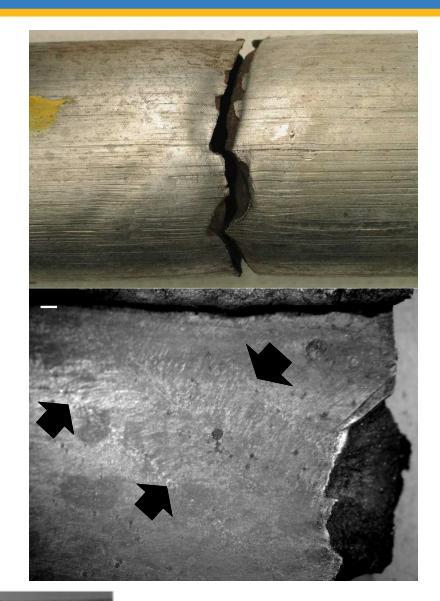
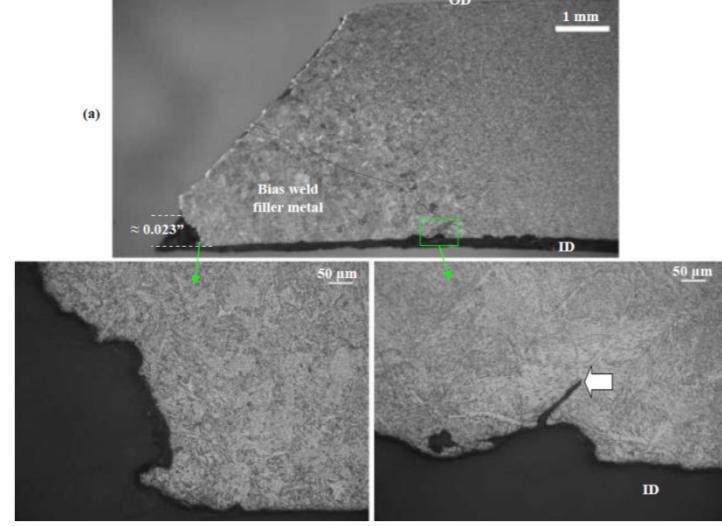
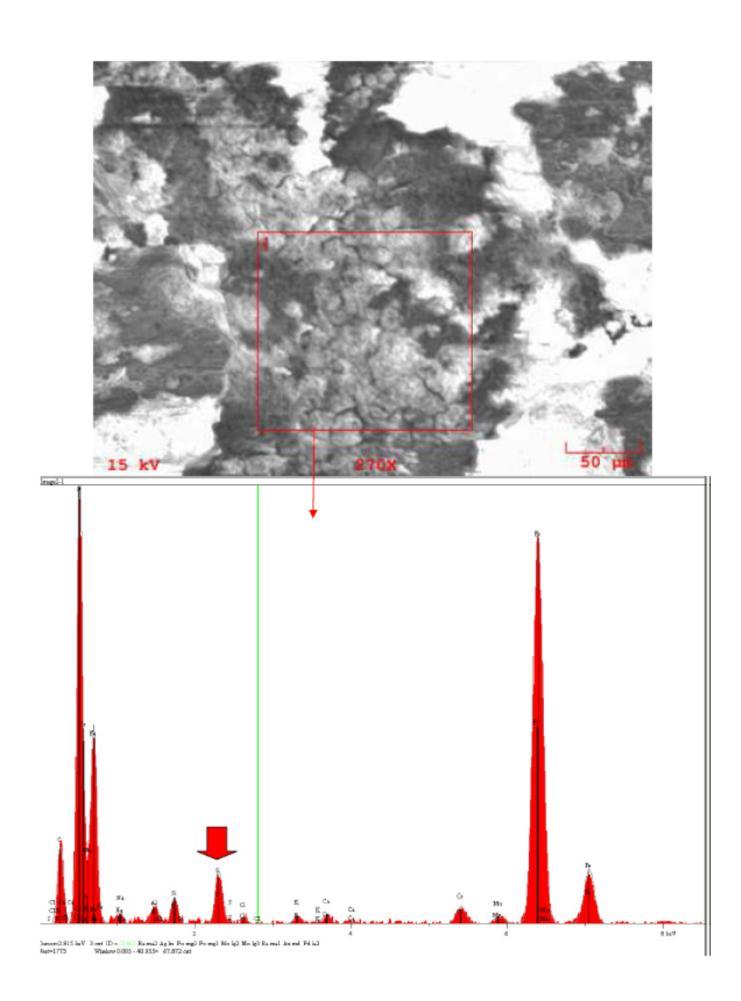
- On 3 failures: internal pitting corrosion on the bias weld region.
- Fatigue cracks starting at these pits
- High pressure regime (around 7,000 psi).
- Fluid: recycled fluid "treated" with biocide.

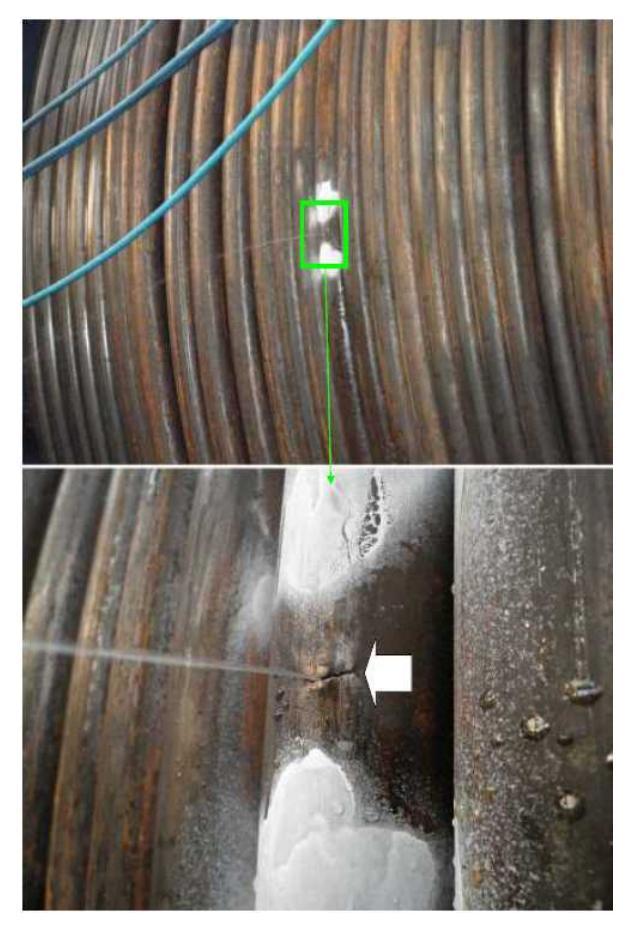
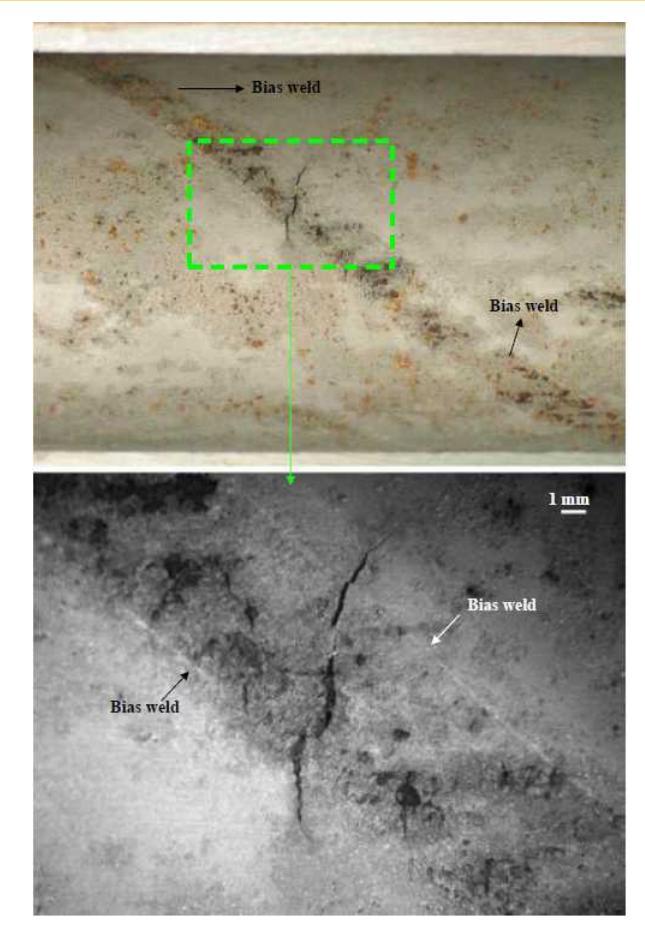
- Sulfur (S) was found within the internal pits
- Recycled fluid analyses revealed:
 - Sulfur, pungent odors of rotten eggs, and sulfide in the form of black precipitates
 - 4.2 5.2 million bacteria per ml
 - APBs and SRBs

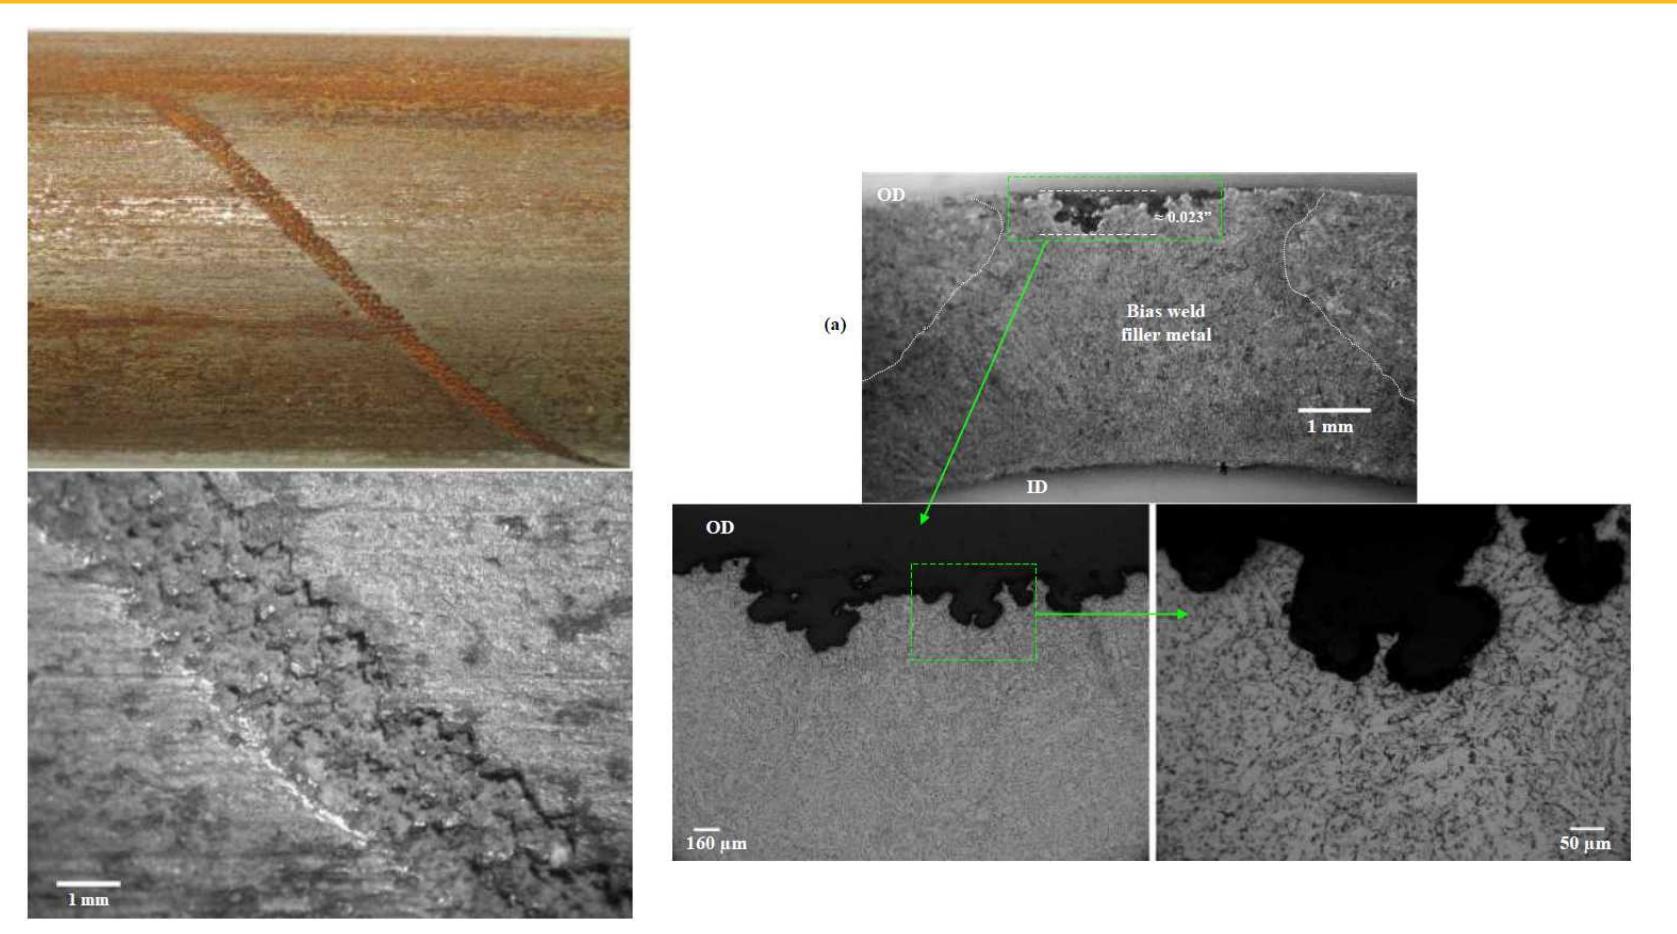
Failure: Pinhole; Date: November 2013; String: 2-3/8" x 0.156" – CT100+ Fluid: Customer supplied "treated" sea water (oxygen scavenger + biocide)

Failure: Ext. corrosion on bias weld; Date: October 2013; String: 2" x Tapered – CT90 Fluids: fracturing fluid + acid mix with inhibitor

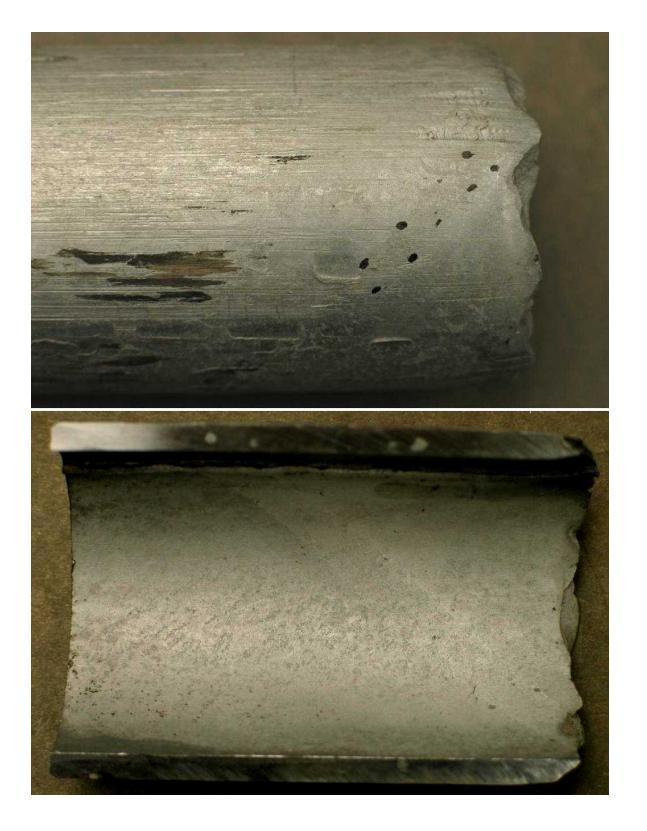
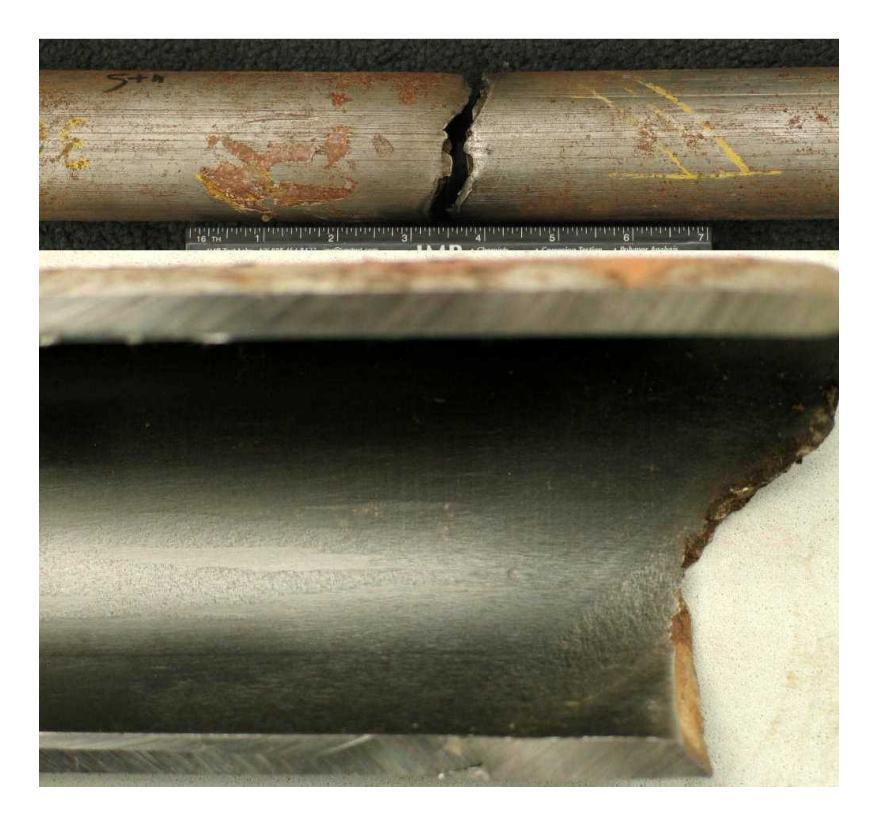
- Three (3) CT failures occurred while milling plugs in Alice USA.
- String characteristics: 2" OD x tapered 90 Grade / Basically new strings
- Failures occurred as fractures at bias welds

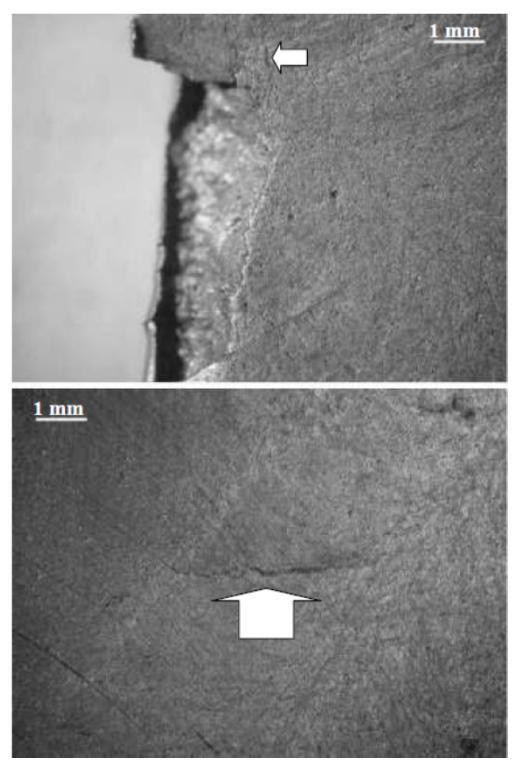
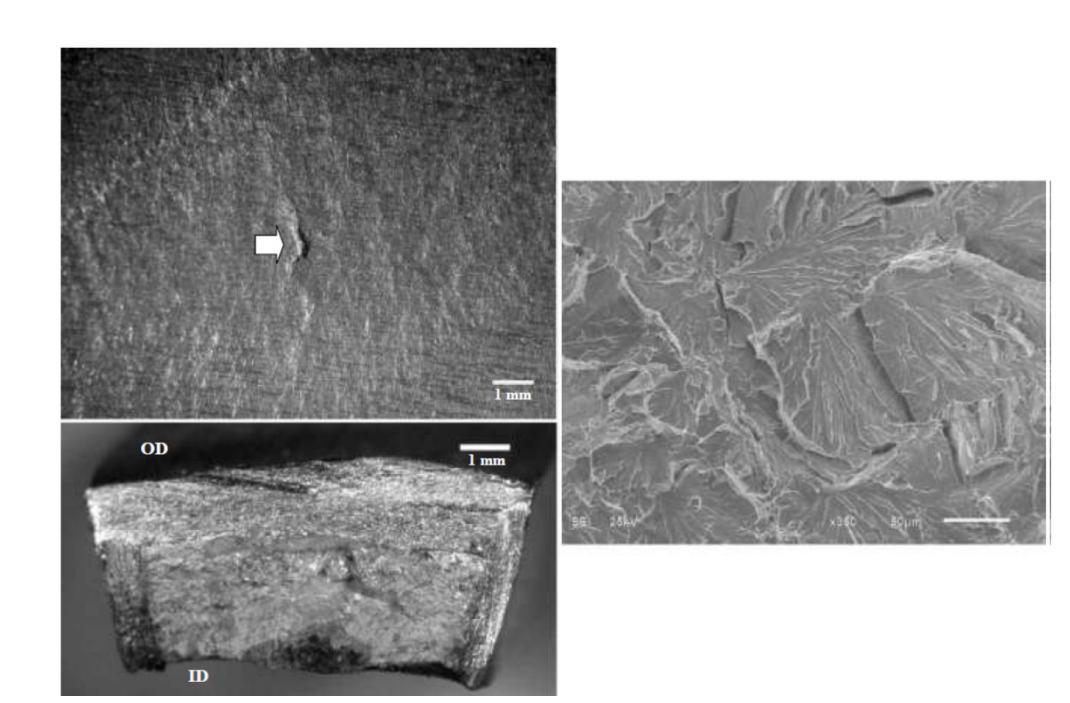
- Internal corrosion damage very mild or absent no fatigue cracking associated with isolated pits
- Internal cracking on the bias welds "cleavage" features similar to cracking due to exposure to H2S

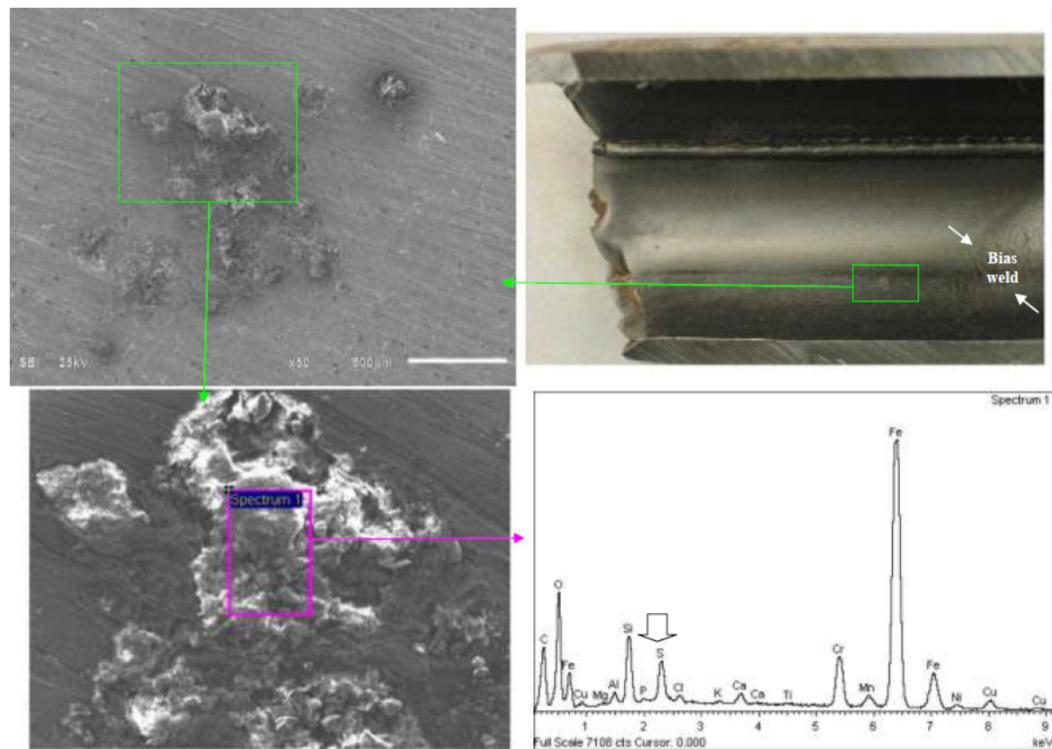
- Fluid: recycled fluid "treated" with biocide
- Sulfur was observed on some shallow pits
- Fluid analyses revealed the presence of SRBs
- "Localized sour environments" – Bias weld weakest point

- Corrective actions:
 - Treating for bacteria in the system (including tanks)
 - Treating circulating fluid
 - Treating stagnant fluid

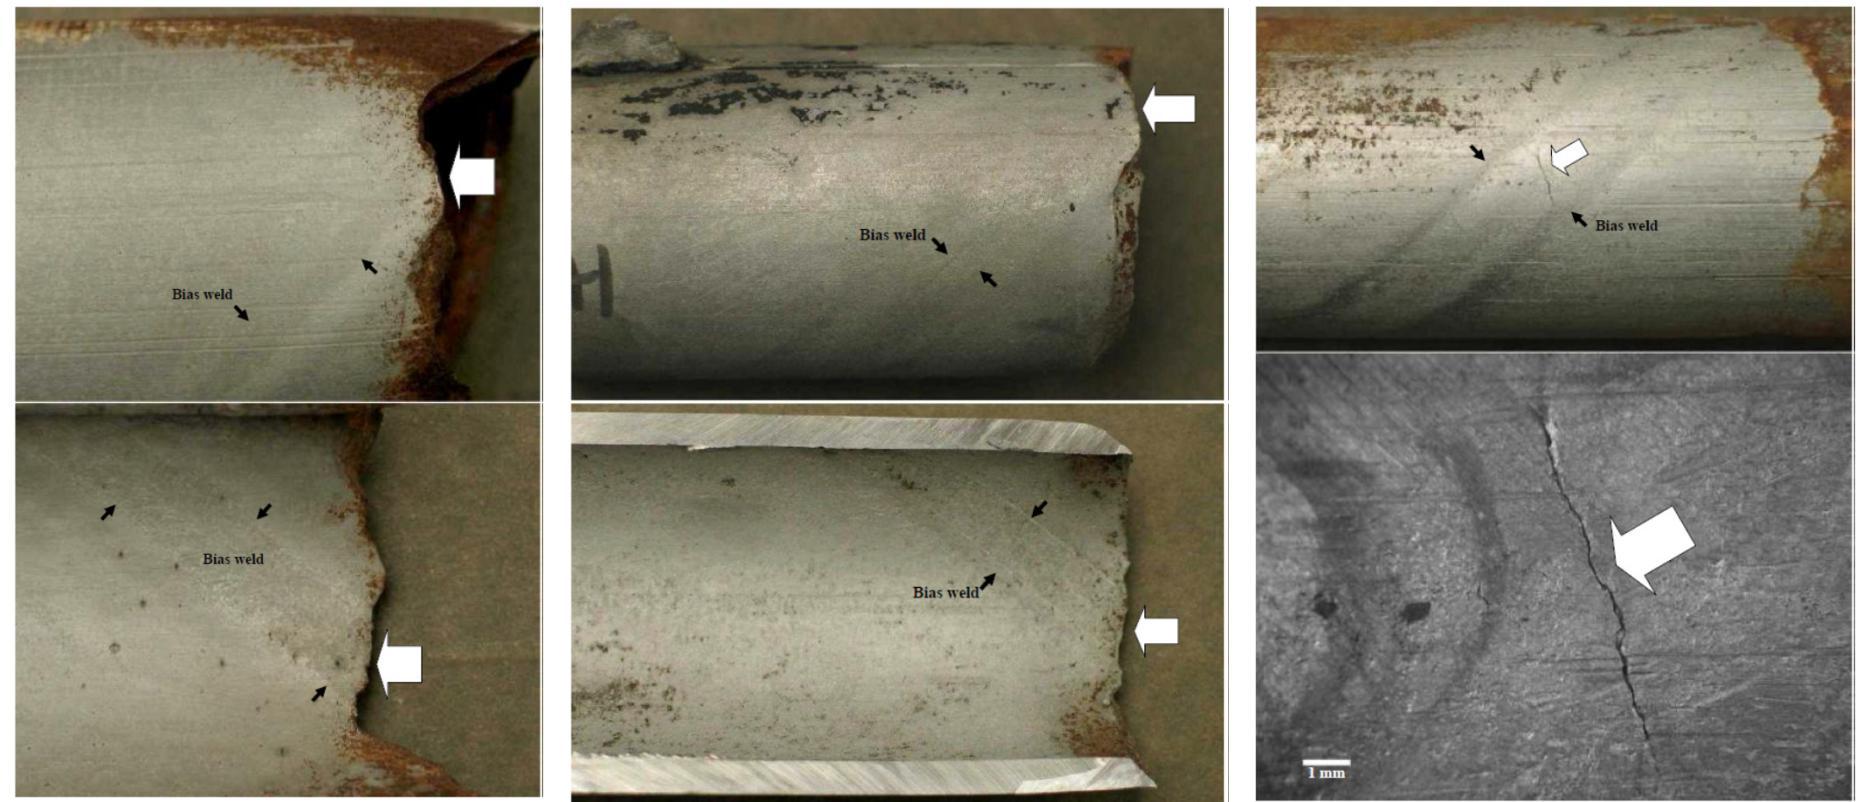
- Strings: 2" x tapered CT100+
- Operating Pressure: 6,000 7,000 psi
- Strains at bias weld locations: 1.8% 2.3%
- SFL used at bias weld locations: around 50%

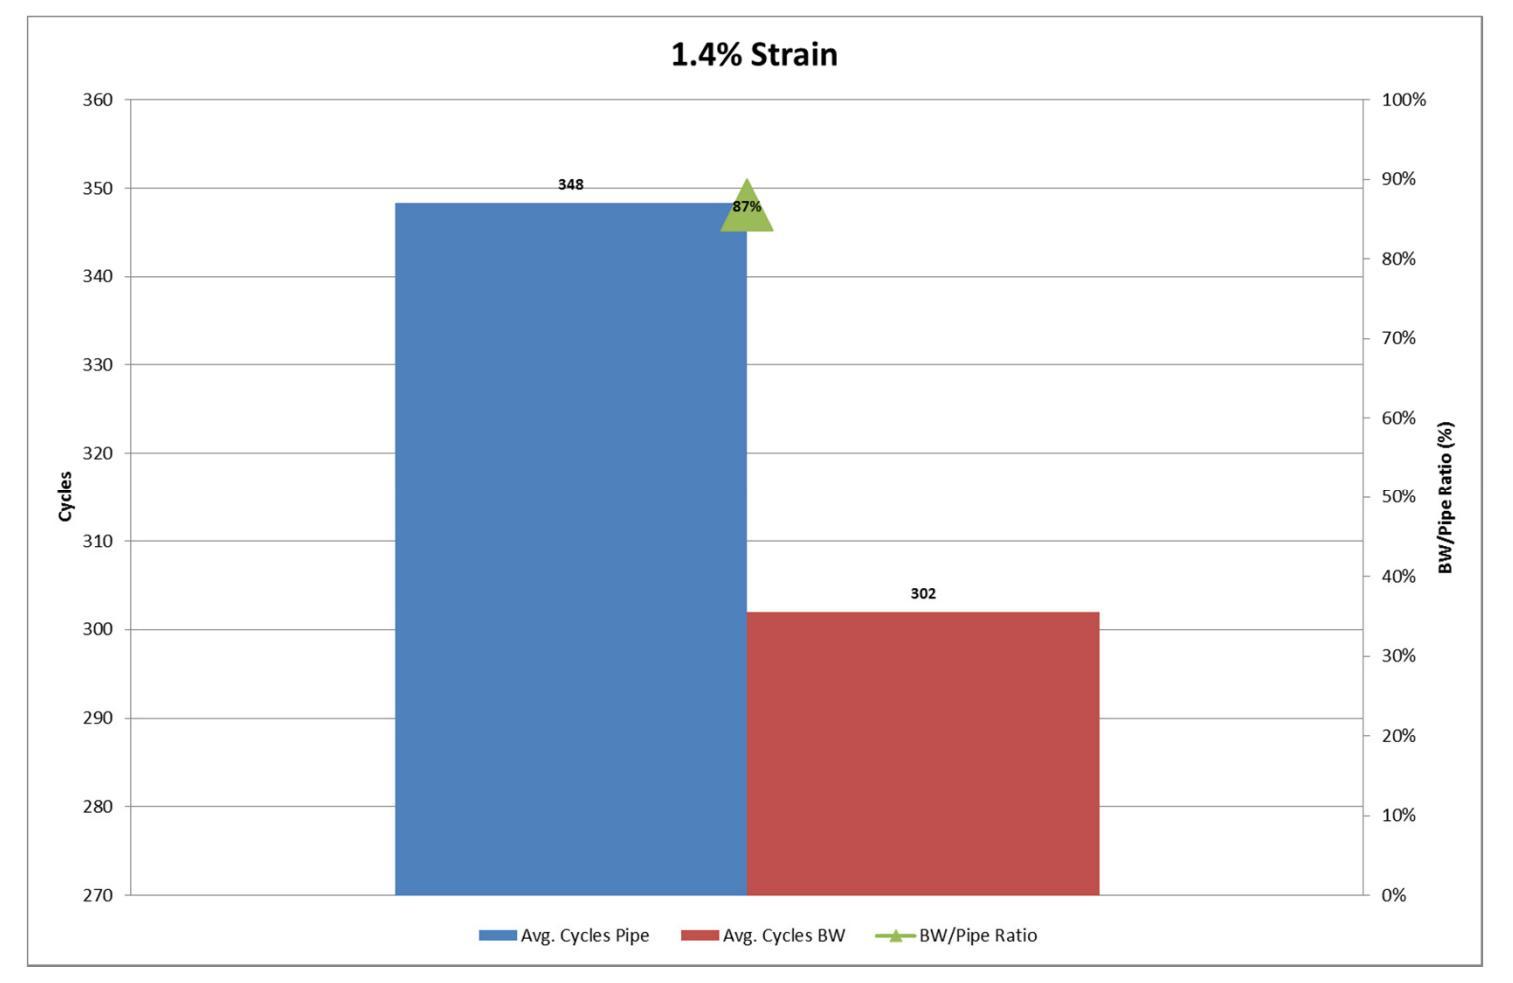
At low strain (1.4%) the measured bias weld fatigue life was 87% of the pipe base material

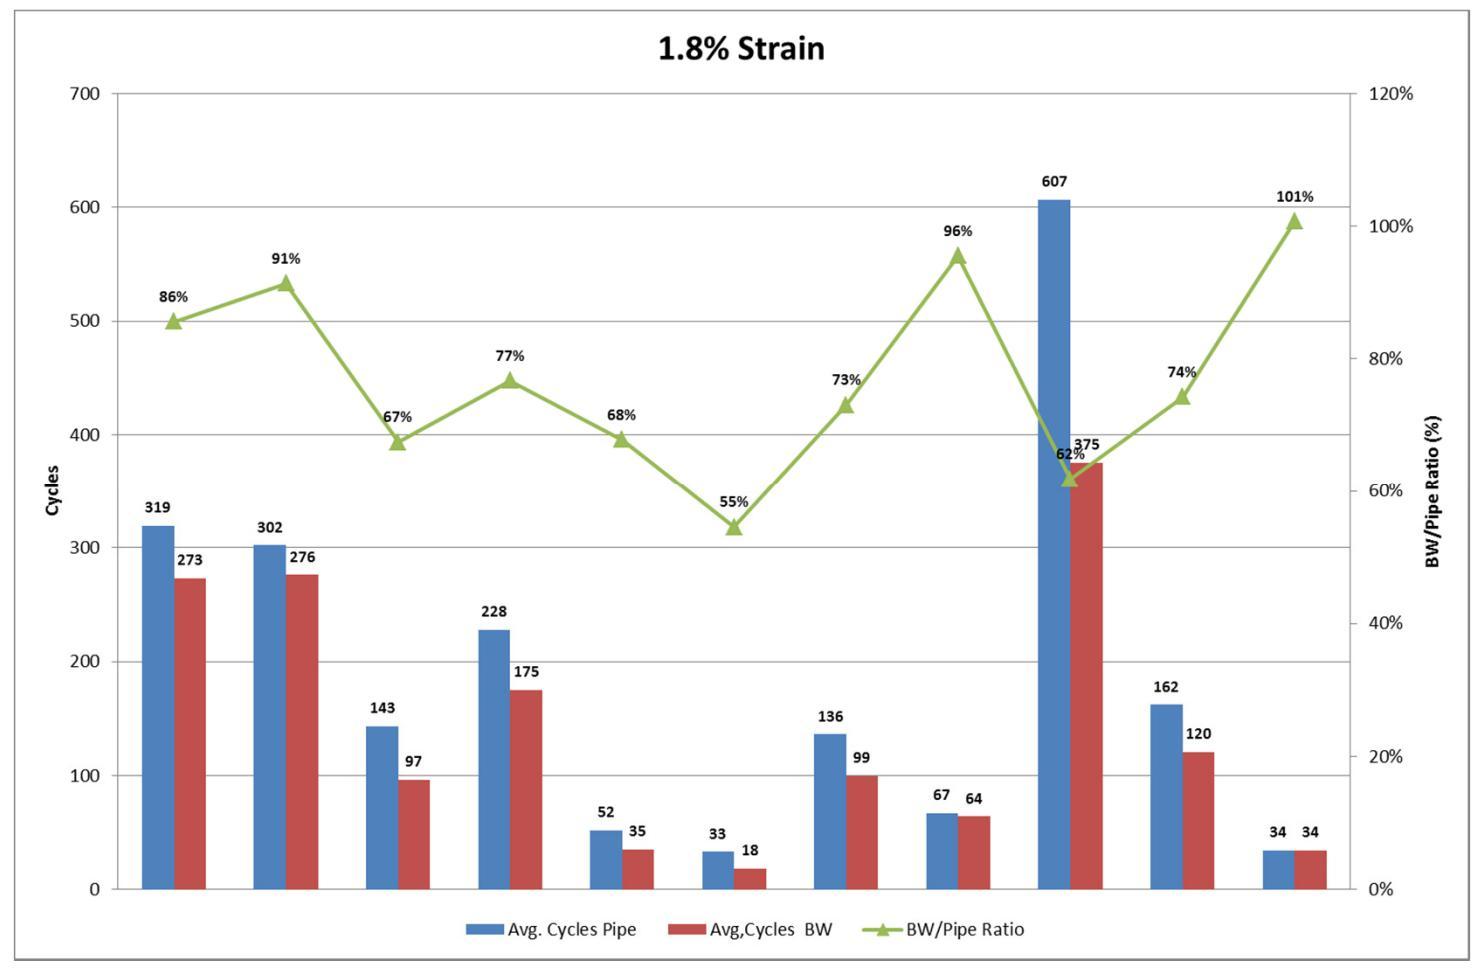
At 1.8% strain most of the values were lower than 80% (55% - 77%)

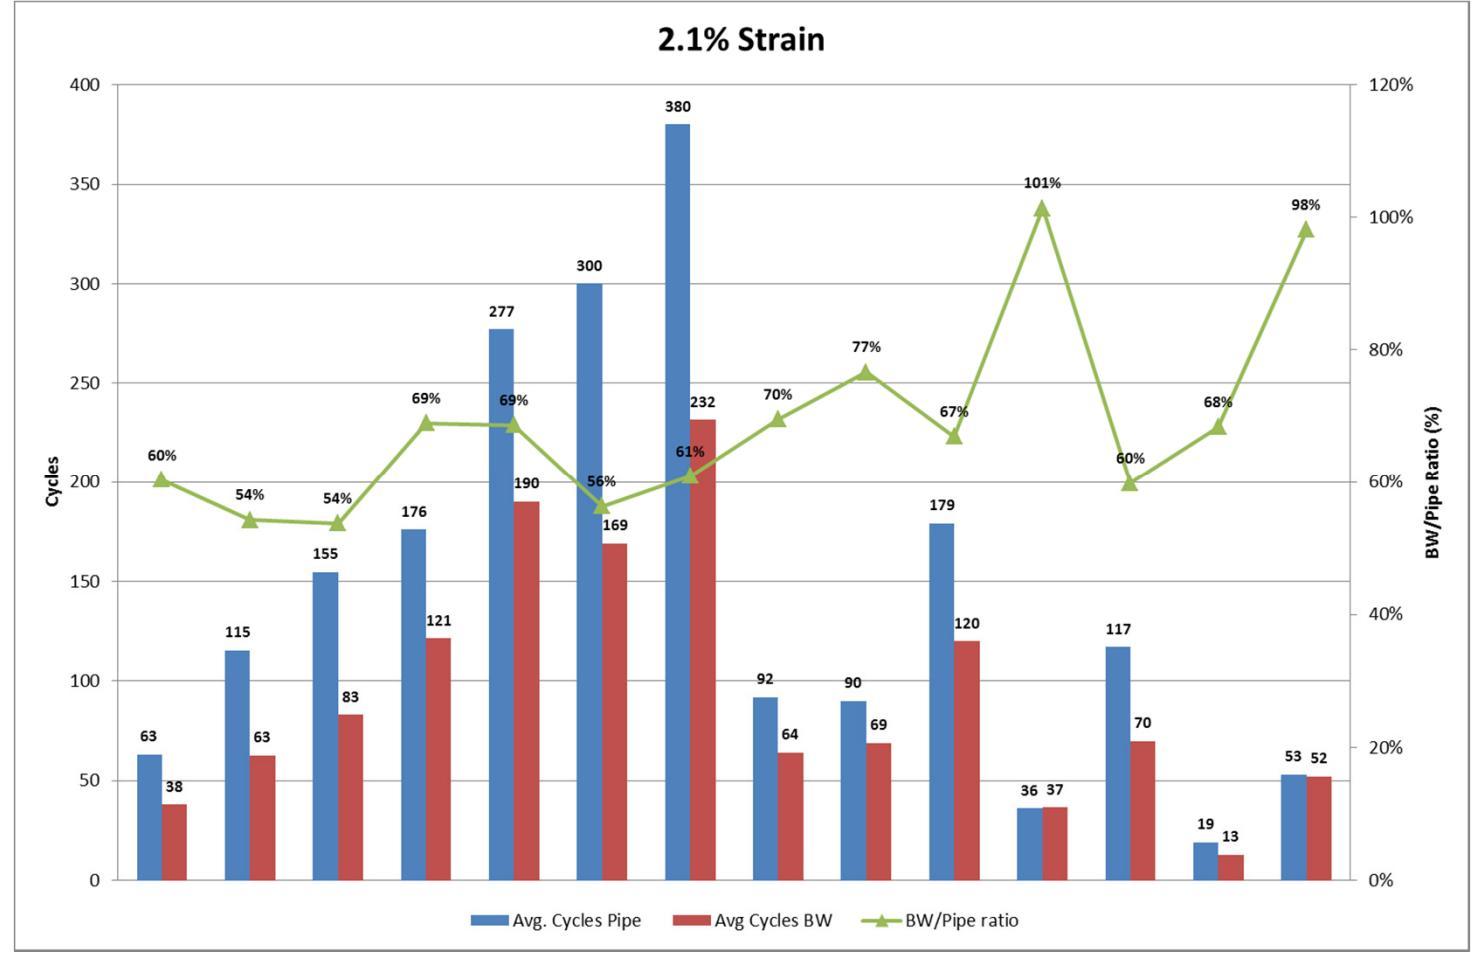
At 2.1% strain the reduction of fatigue life at the bias weld is more significant (below 70%)

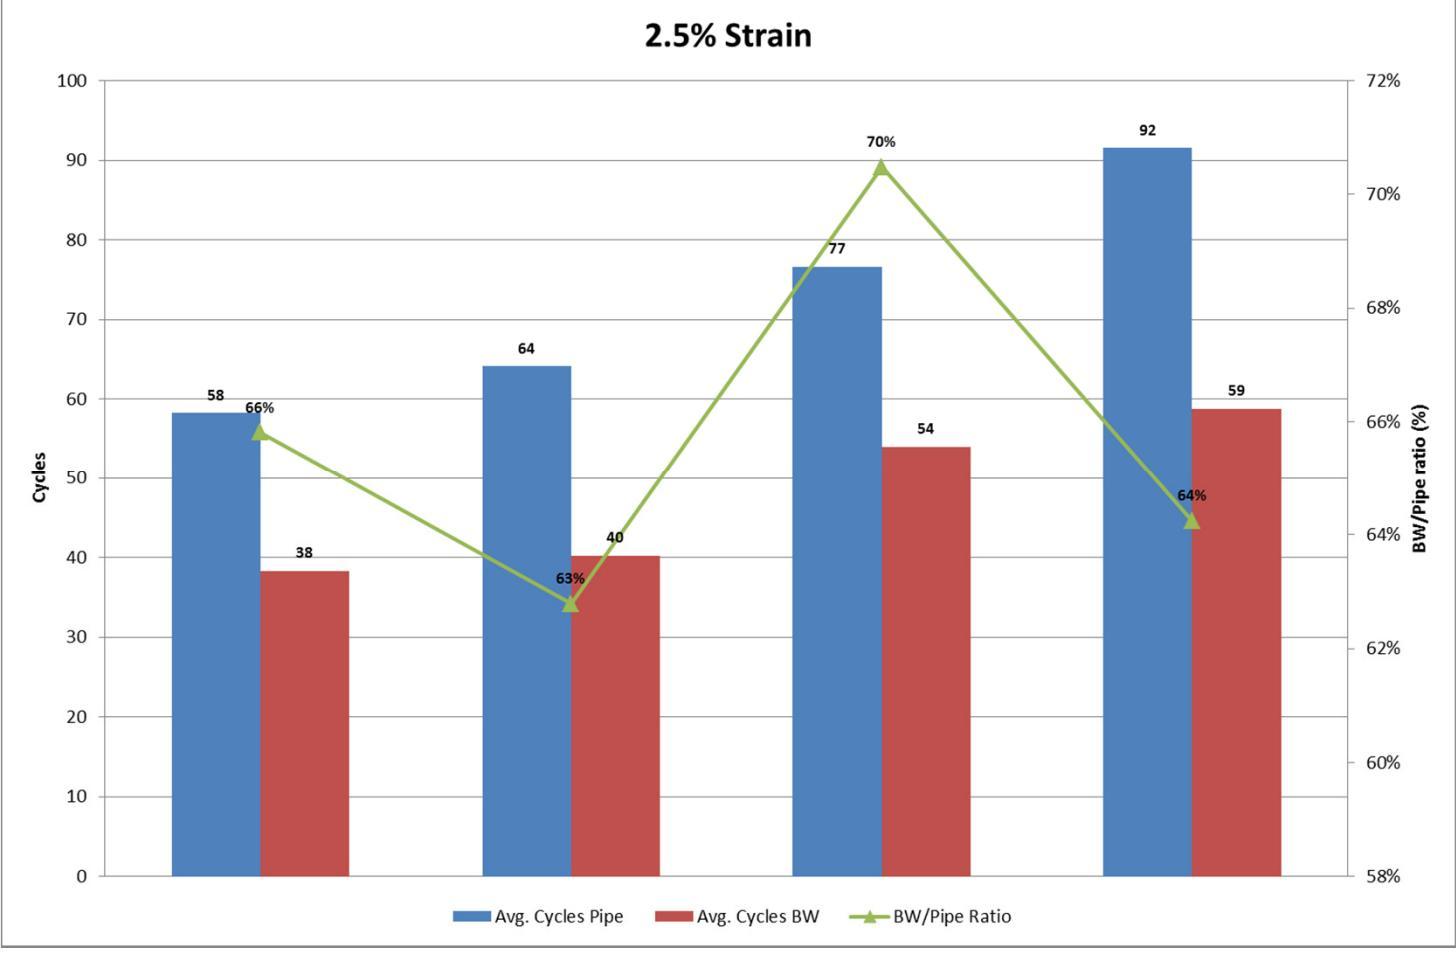
Similar to 2.1% strain (bias weld fatigue life around 60s% of the pipe)

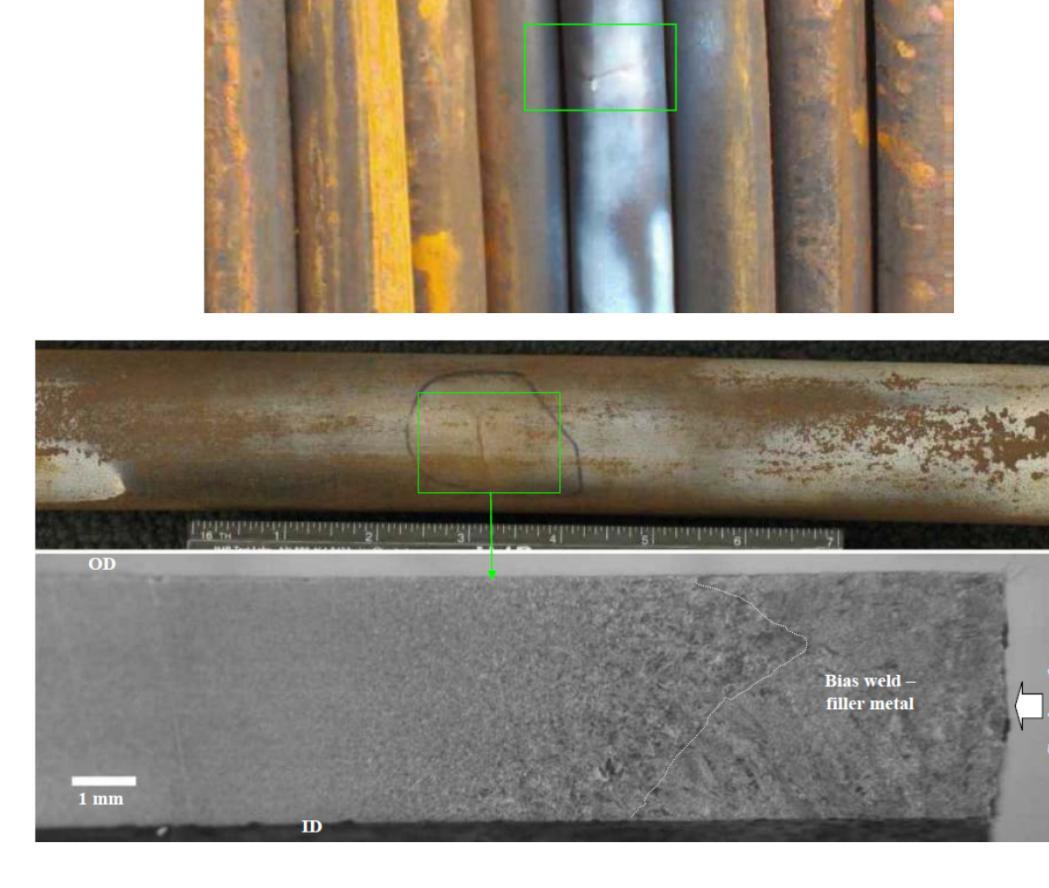
- Date: January 2013
- String: 1-3/4" x tapered CT80
- Failure: two cracks on bias welds
- Well: 37 psi H2S partial pressure
- Use of only H2S scavenger not anti-cracking inhibitor
- Cracking on bias welds due to Sulfide Stress Corrosion Cracking (SSCC).
