# Microbial Induced Corrosion, Premature CT Failures, & Remediation Practices

Heath Myatt

October 29th, 2014

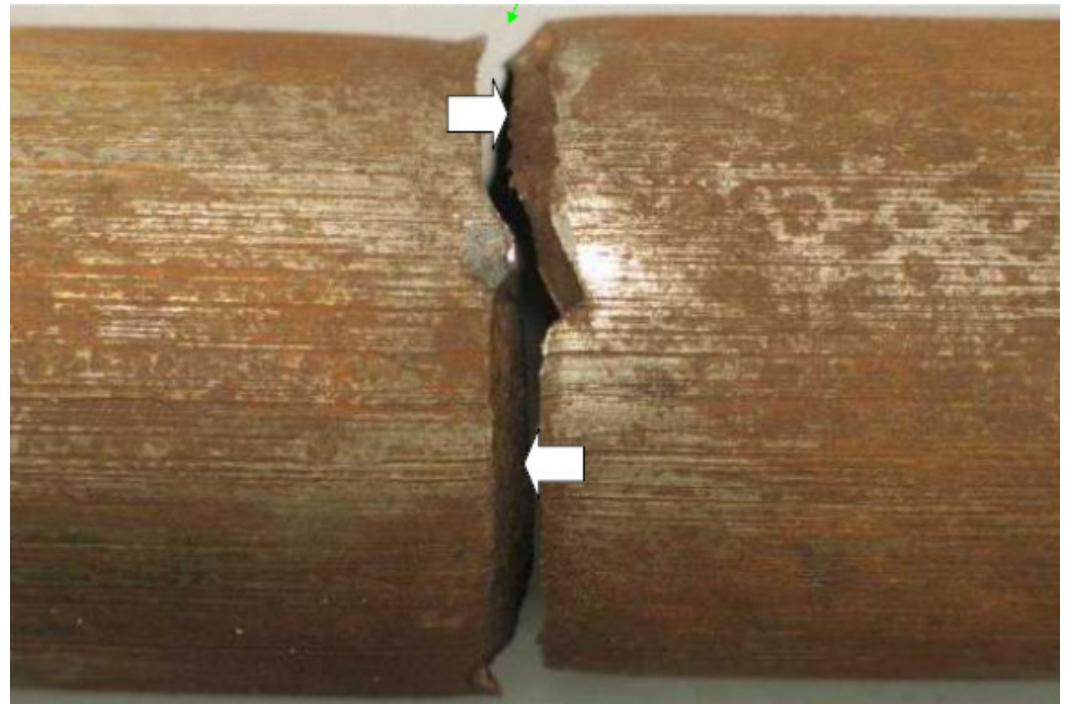
## Coiled Tubing Failures - Overview

- No equipment failure
- No external damage to coiled tubing
  - Pinhole
  - Mechanical
- No operator error
- Metallurgical testing was conducted
- Low fatigue life
- No Sour exposure reported

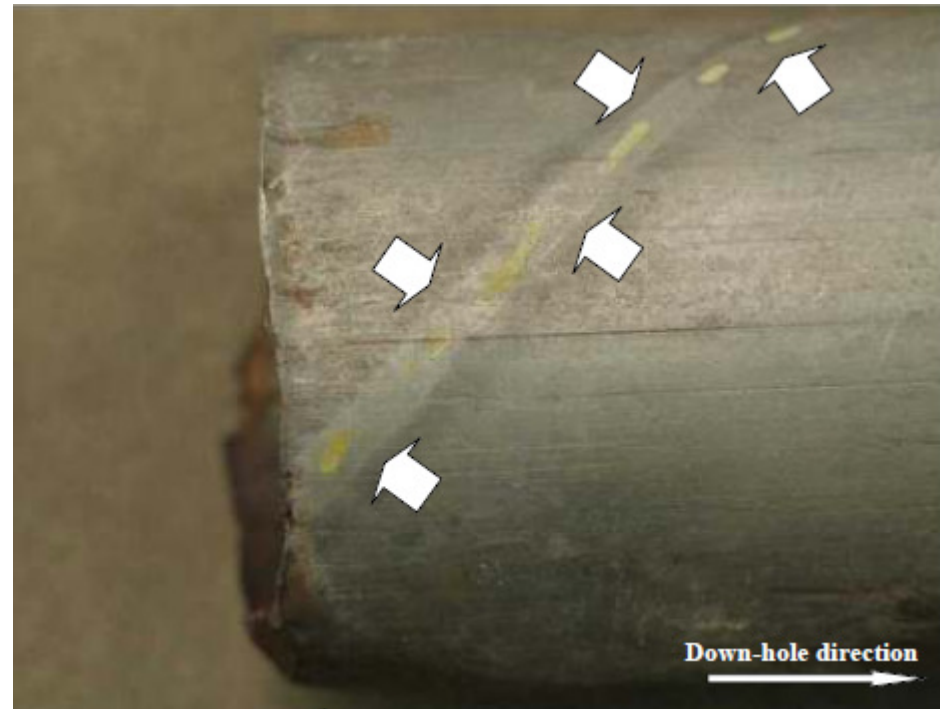
## Coiled Tubing Failures - Similarities

- Working for the same Operator
- All 90ksi grade tubing
- Multiple manufacturers
- All failures initiated at bias weld

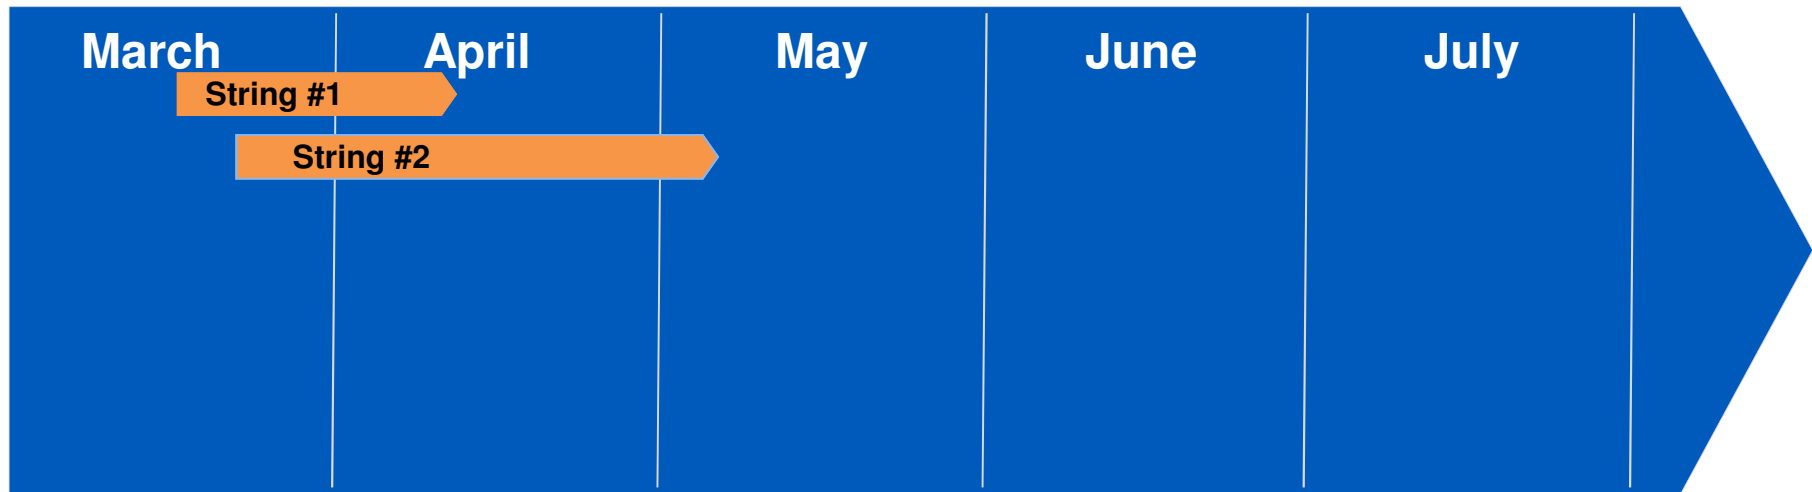
# Pipe Failure Timeline

Pumped Through CT

- No Specific Treatment
- Corrosion inhibitor
- H<sub>2</sub>S anti-cracking inhibitor

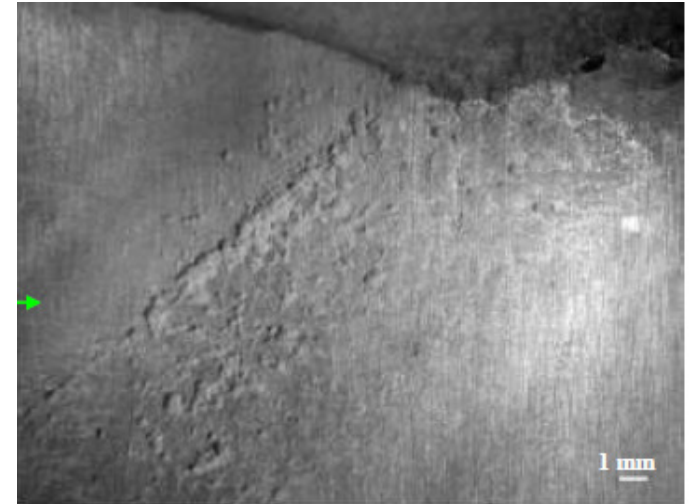
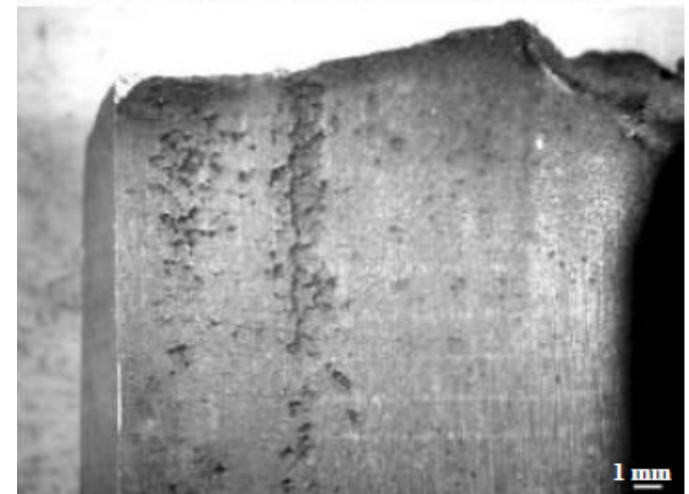
## Coiled Tubing Failure # 1

- April 9<sup>th</sup>
- 90k Grade
- 14,098'
- 0.190" Wall
- 26% Fatigued
- 478KRft
- 21 Runs, 6 wells
- Client A
- Premature fatigue at bias weld due to internal pitting
  - Pitting on some regions of the pipe parent material
  - 42 hours wet stagnation
  - 7 days storage

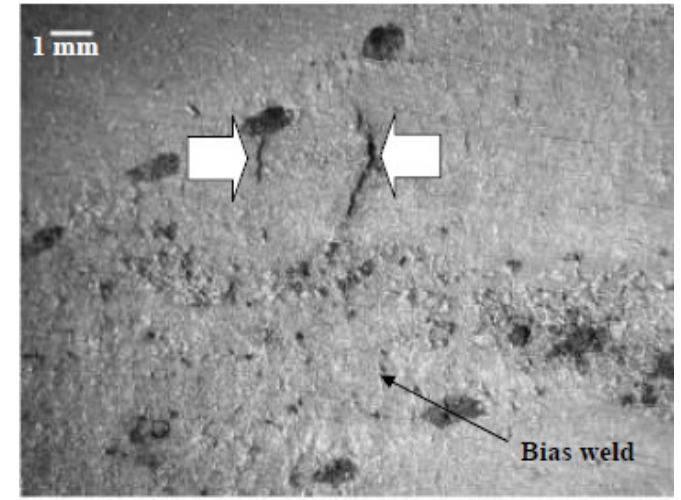
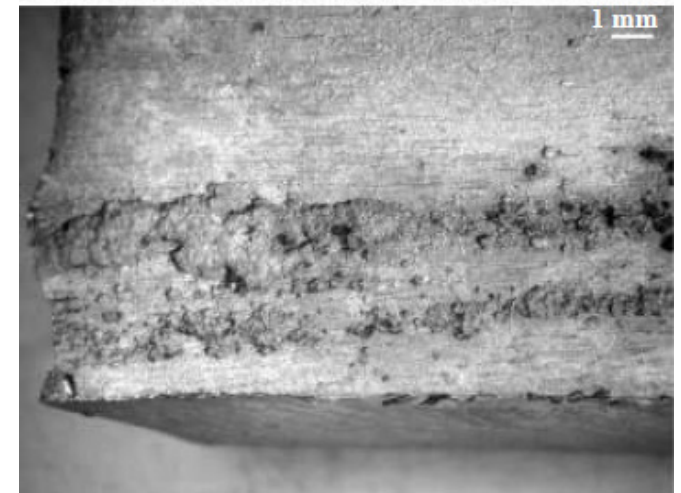
## Coiled Tubing Failure # 2

- May 6<sup>th</sup>
- 90k Grade
- 11,327'
- 0.190" Wall
- Premature fatigue at bias weld due to internal pitting
  - Pitting on some regions of the pipe parent material
  - Some cracks observed
  - 29 hours wet stagnation
  - 38 days storage
- 28% Fatigued
- 505KRft
- 24 Runs, 5 wells
- Last 2 wells, Client A

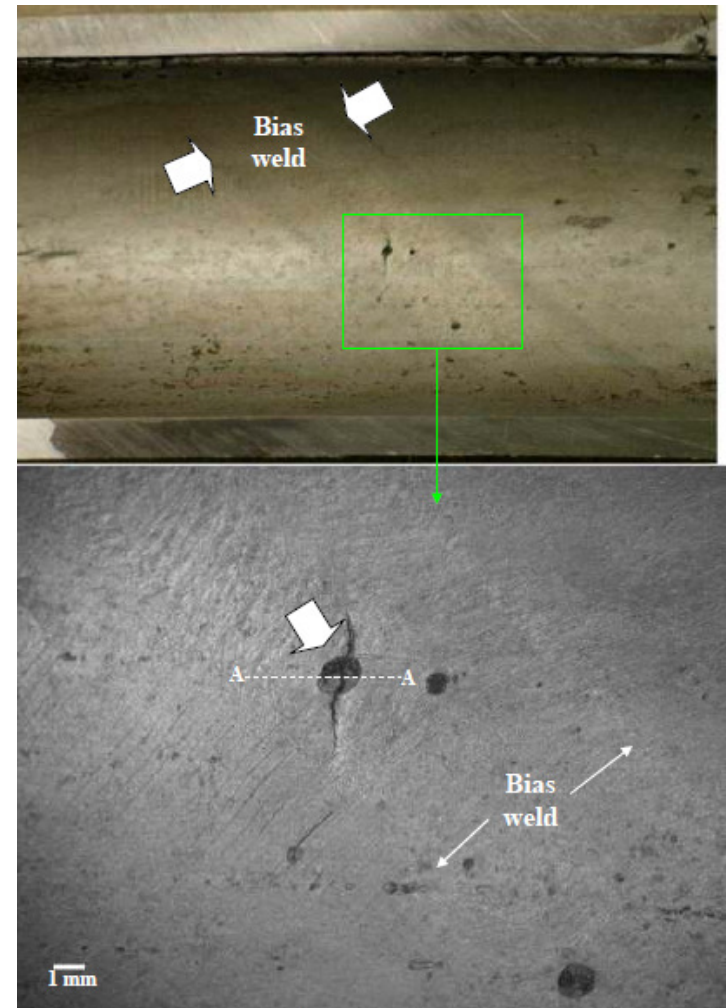
## Coiled Tubing Failure # 3

- May 18<sup>th</sup>
- 90k Grade
- 14,186'
- 0.188" Wall
- Premature fatigue at bias weld due to internal pitting
  - Corrosion Inhibitor sweeps circulated
  - Pitting less pronounced
  - Cracks observed in bias weld
  - 40 hours wet stagnation
  - 4 days storage
- 22% Fatigued
- 459KRft
- 13 Runs, 5 wells
- Client A

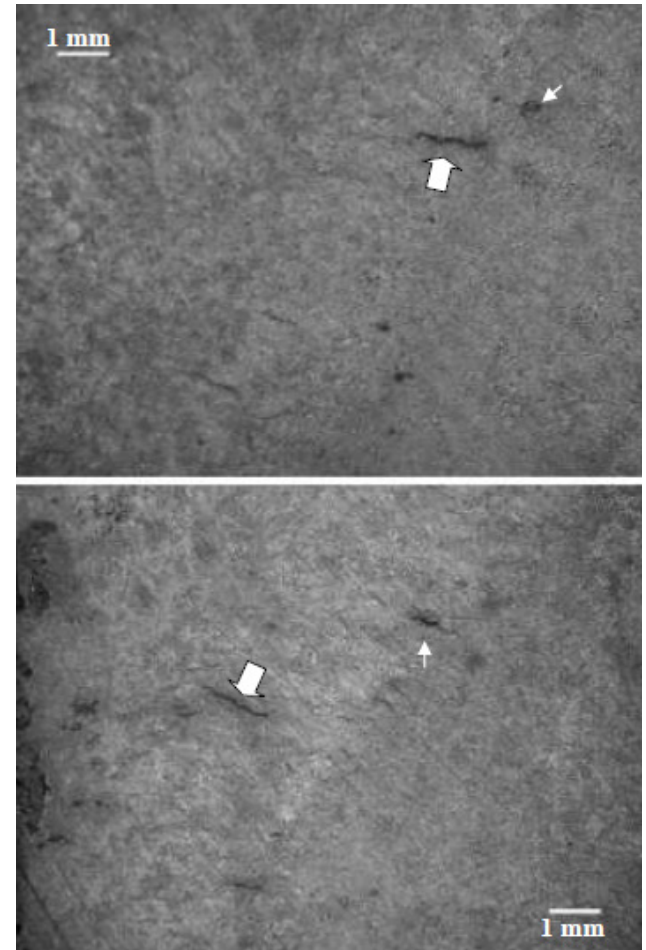
## Coiled Tubing Failure # 4

- May 20<sup>th</sup>
- 90k Grade
- 12,575'
- 0.188" Wall
- 15% Fatigued
- 282KRft
- 11 Runs, 4 wells
- Client A
- Premature fatigue at bias weld due to SSC cracks
  - Corrosion Inhibitor sweeps circulated
  - No Pitting
  - Cracks observed in bias weld
  - 14 hours wet stagnation
  - 4.5 days storage

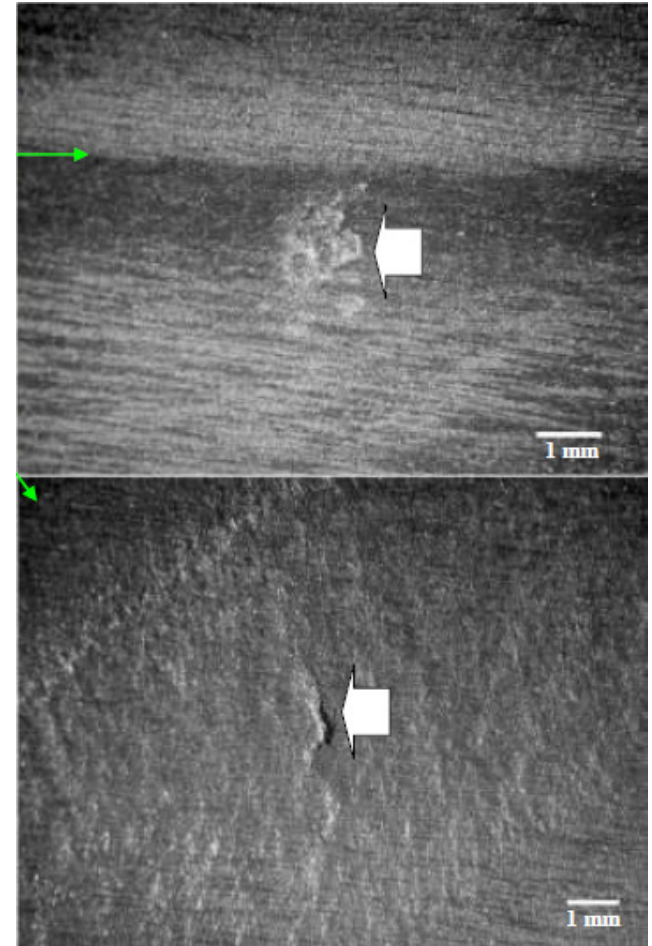
## Coiled Tubing Failure # 5

- July 5<sup>th</sup>
- 90k Grade
- 13,108'
- 0.190" Wall
- 40% Fatigued
- 498KRft
- 22 Runs, 4 wells
- Client A
- Premature fatigue at bias weld due to SSC
  - Corrosion Inhibitor sweeps circulated
  - Pitting less pronounced
  - Cracks observed in bias weld
  - Introduced Biocide & H<sub>2</sub>S anti-cracking inhibitor
  - 21 hours wet stagnation
  - 19 days storage

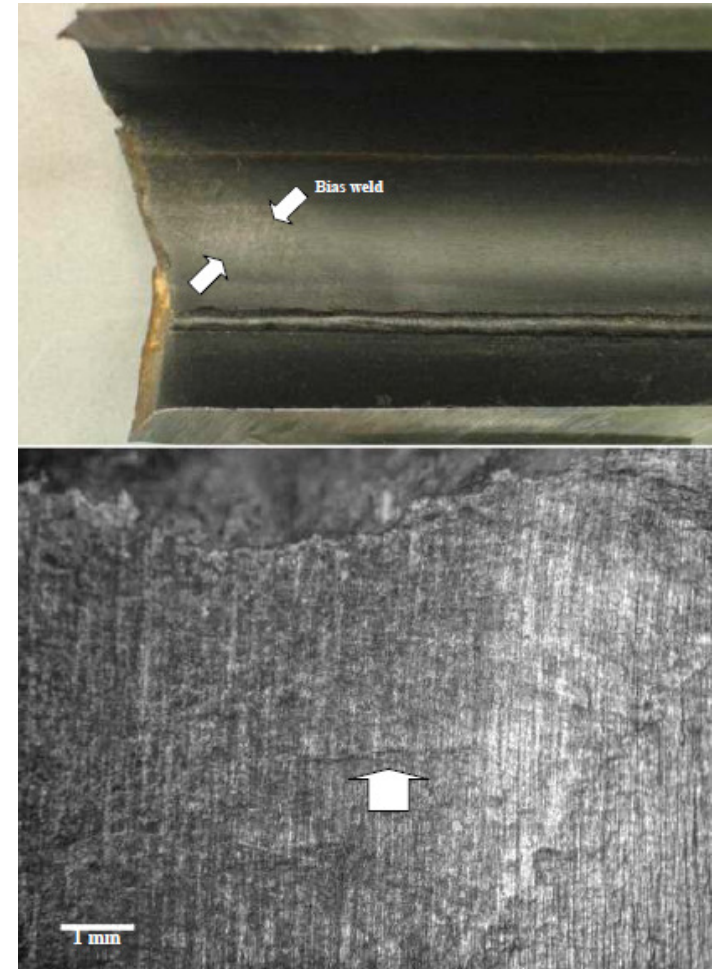
## Coiled Tubing Failure # 6

- July 24<sup>th</sup>
- 90k Grade
- 12,963'
- 0.190" Wall
- 25% Fatigued
- 239KRft
- 9 Runs, 3 wells
- Client A
- Premature fatigue at bias weld due to SSC cracks
  - Corrosion Inhibitor sweeps circulated
  - No Pitting
  - Cracks observed in bias weld
  - 14 hours wet stagnation
  - 0 days storage

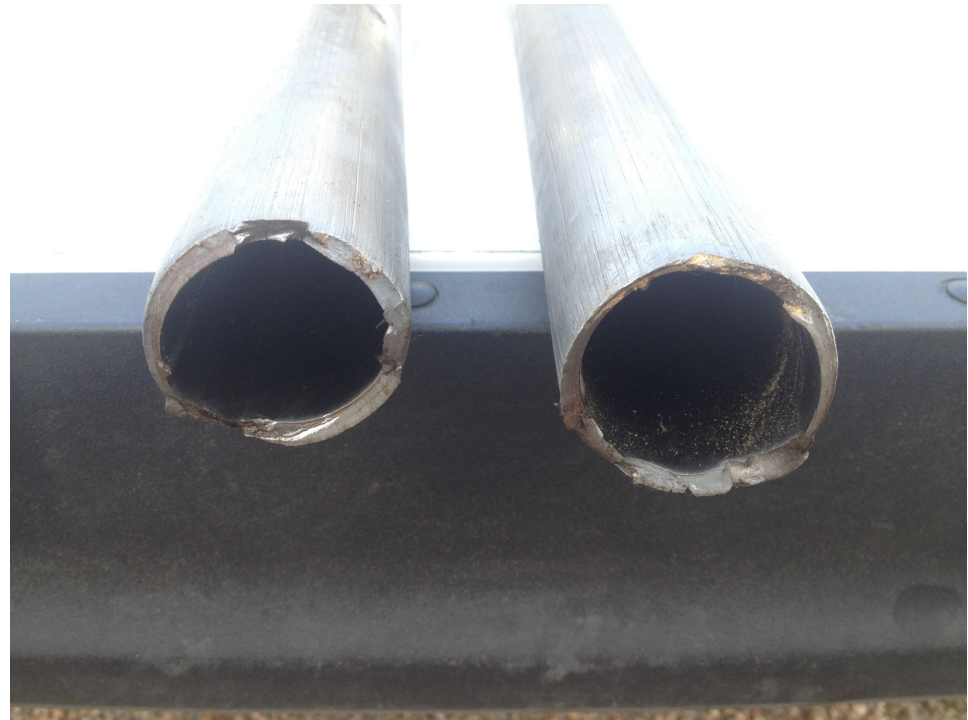
## Coiled Tubing Failures

- Initial mitigation factors ultimately unsuccessful
- Additional information gathered from treatments

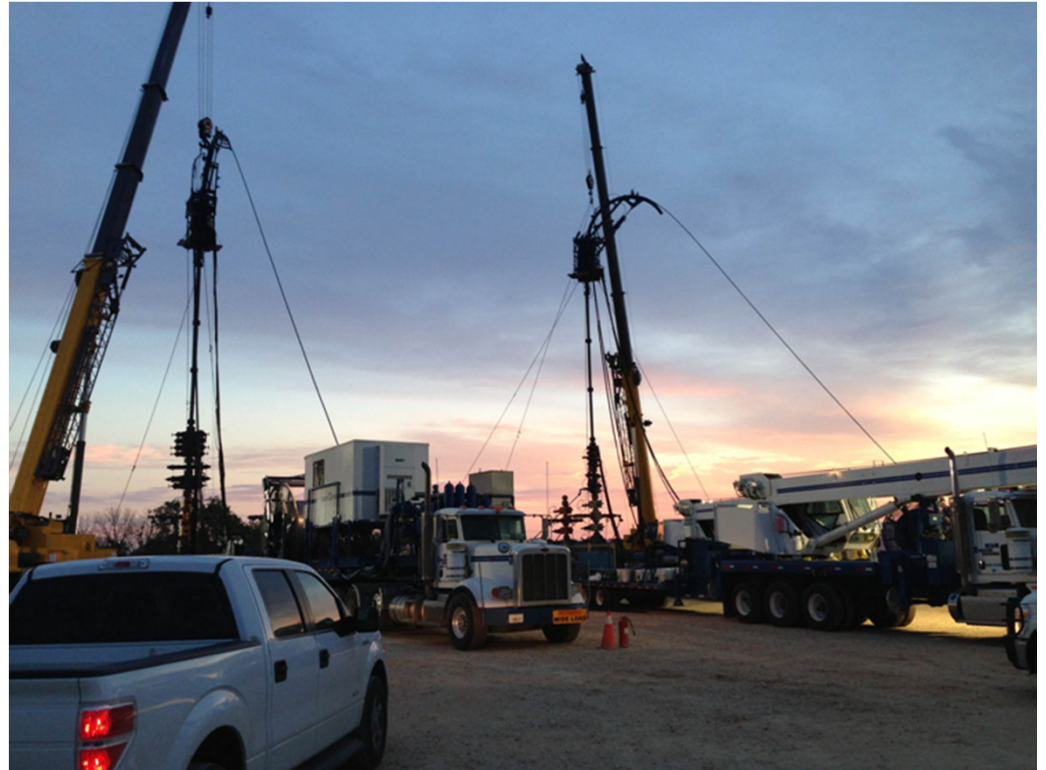
## Multi-Well Pads

- Small surface volumes
  - Circulation Temp: 180°F
- Stagnation time between wells
  - Rig up/Rig down on same pad

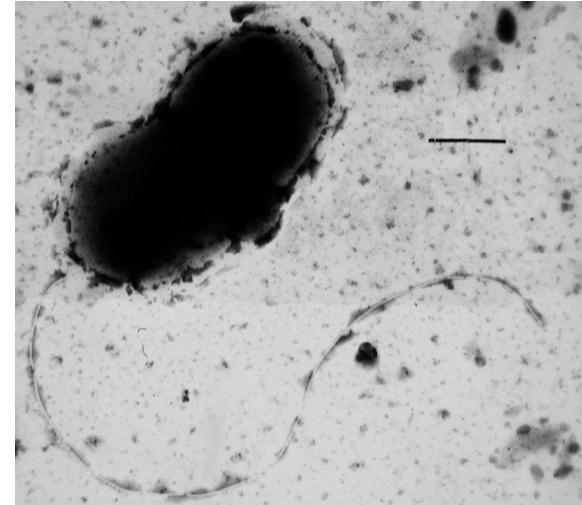
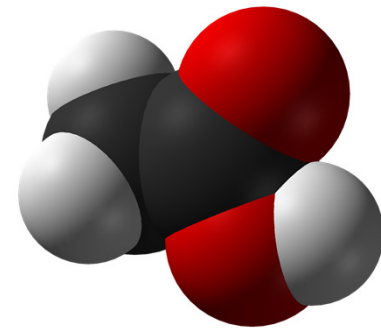
## Bacteria

- Water treatment testing done in recirculated fluid
- Extremely high values of bacteria observed
  - ATP control B – 1.6M bacteria per mL of fluid
  - 4.2-5.2M bacteria per mL of fluid

<b>Bacteria Corrosion Prevention - Actions</b>
Step 1	Clean tanks – High End Biocide
Step 2	Fresh water circulate (5 to 10 bbls) – Mixture of treatments (inhibitors & biocide)
Step 3	Nitrogen Purge
