Novel Coating to Prevent Corrosion of Coiled Tubing Bias Welds

Yunhao Li, Quality Tubing

ICoTa Canada Roundtable
Calgary, AB
October 24, 2018

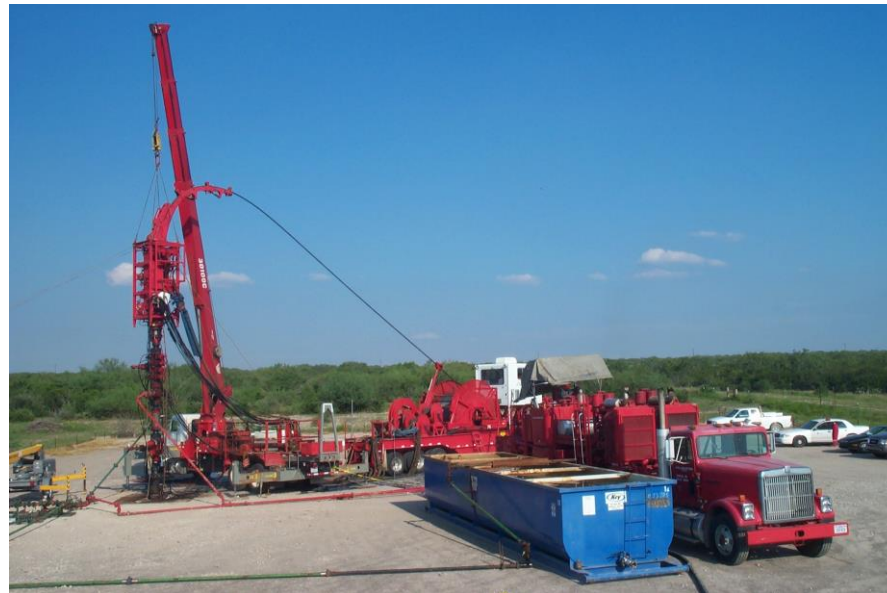
- Coiled tubing work strings are made from high strength low alloy steel strips welded end-to-end (plasma arc weld; we call it the bias weld) and seam welded into tubing
- Tubing is pressurized and used for intervention and completion operations
- Tubing is bent plastically while under pressure
- Primary failure mechanism is low cycle fatigue (LCF)

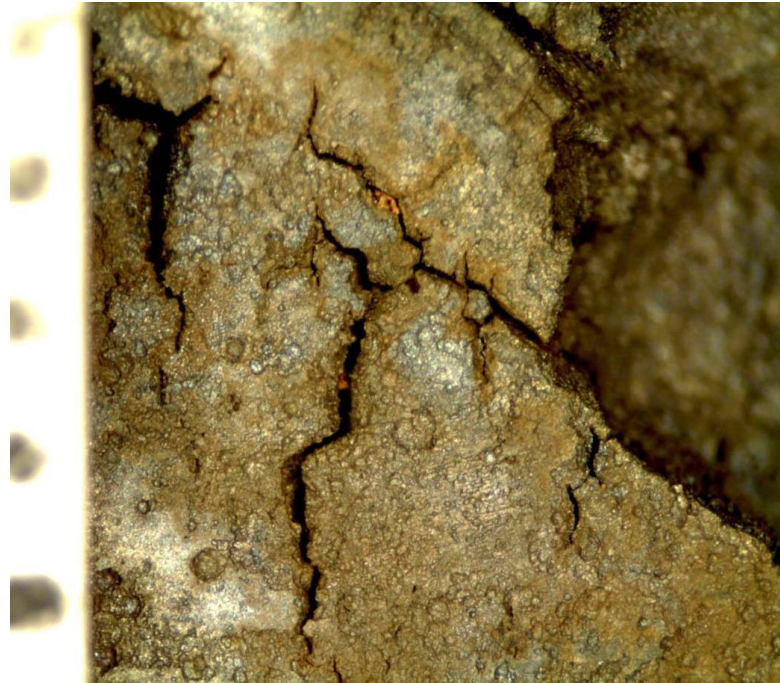
- Shale plays have led to a new type of corrosion mechanism

- Microbiologically Induced Corrosion (MIC). Why?

- Recirculated fluids
 - High temperature
 - Friction Reducer

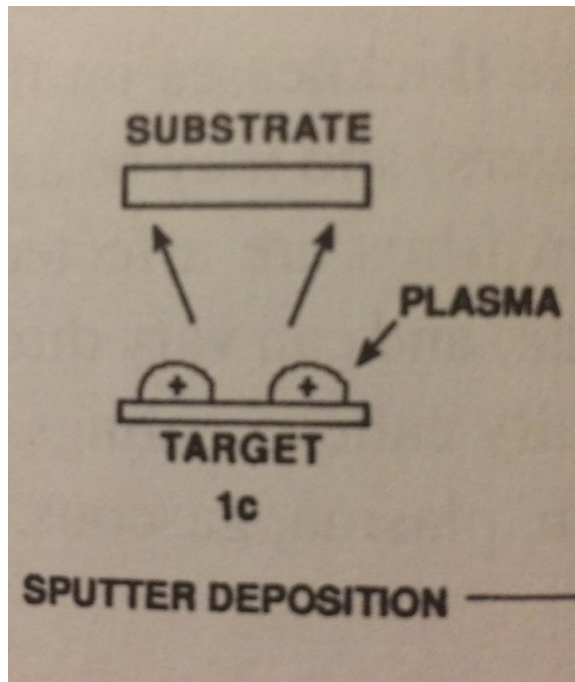
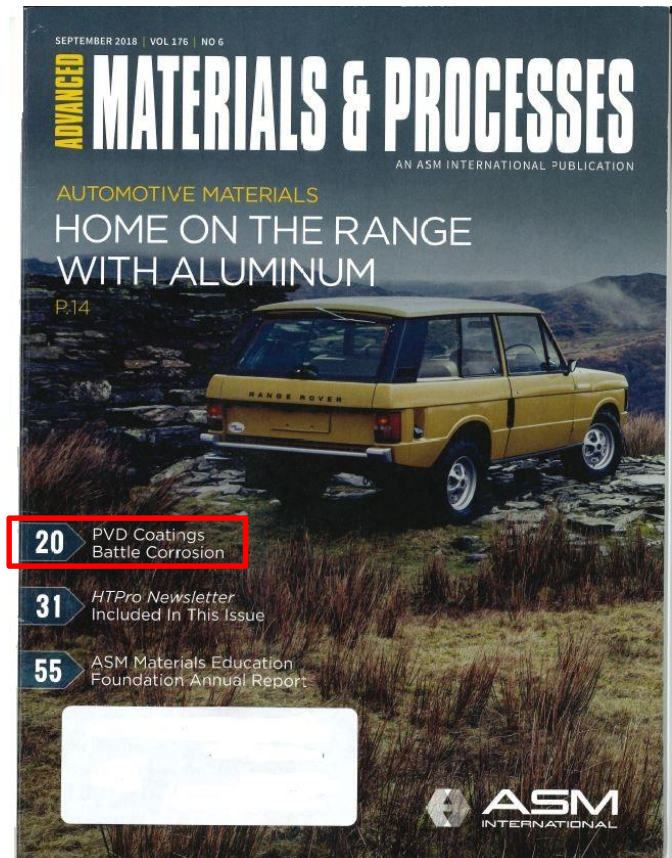
- The target and substrate are placed within a vacuum chamber
- The target is ionized to become a plasma
- A thin film is deposited onto the substrate

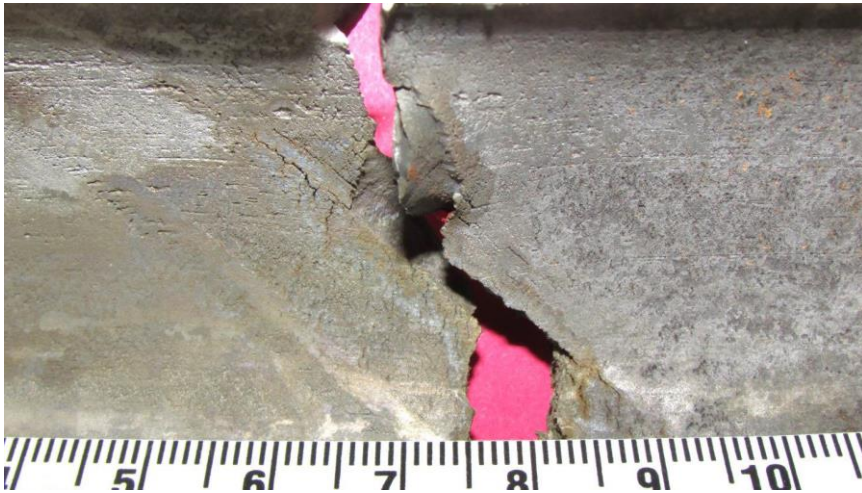
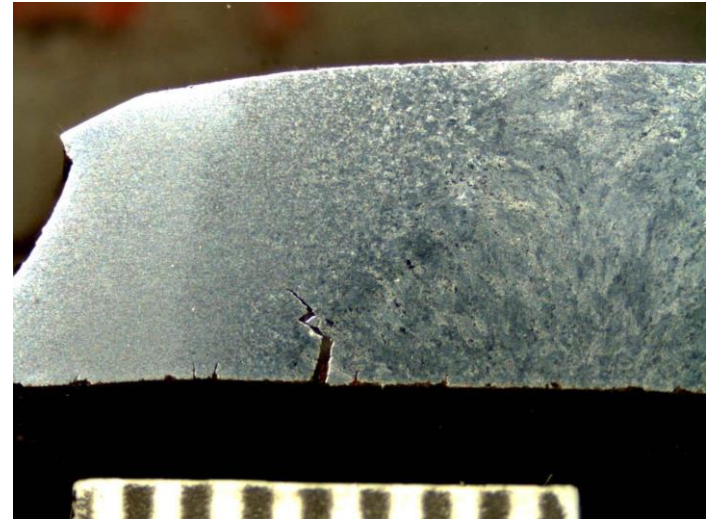
- The corrosion is not a manufacturing defect
 - Exists primarily on the tubing ID due to corrosive fluids
 - Shale plays generate the worst corrosive fluids

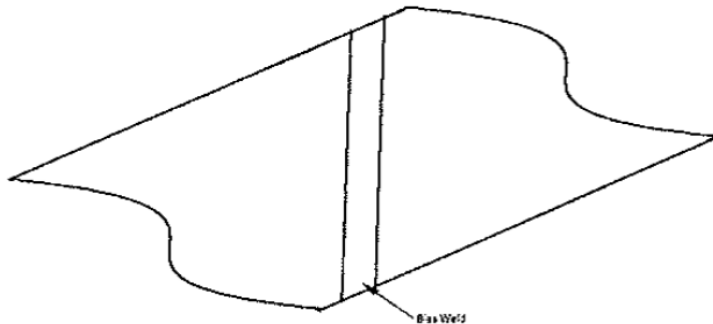
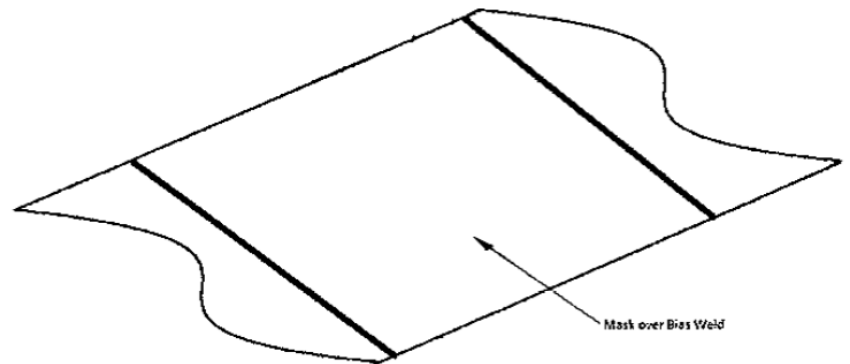
- We can locally coat the strip joining weld (weld cap)
- The opportunity:
 - Mitigating corrosion issue can improve CT performance reliability
 - An industry-leading vendor licenses to NOV/QT and transfers the technology
 - Good bond strength, thin film
- Why have we not coated in the past?
 - Coatings have adhesion issues

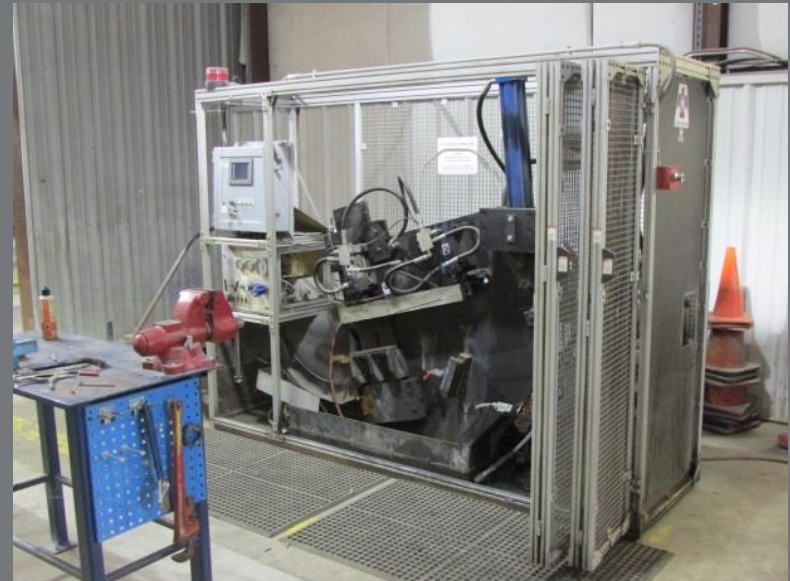
- StageGate Program Developed
- Goals: Prove the concept and select a coating/thickness
 - 1st Test: Coat our steel
 - *Bend Test*
 - *Acid Exposure*
 - 2nd Test: Coat our steel and make tubing
 - *Make Tubing*
 - *Low Cycle Fatigue Testing*
 - 3rd Test: Apparatus Installation

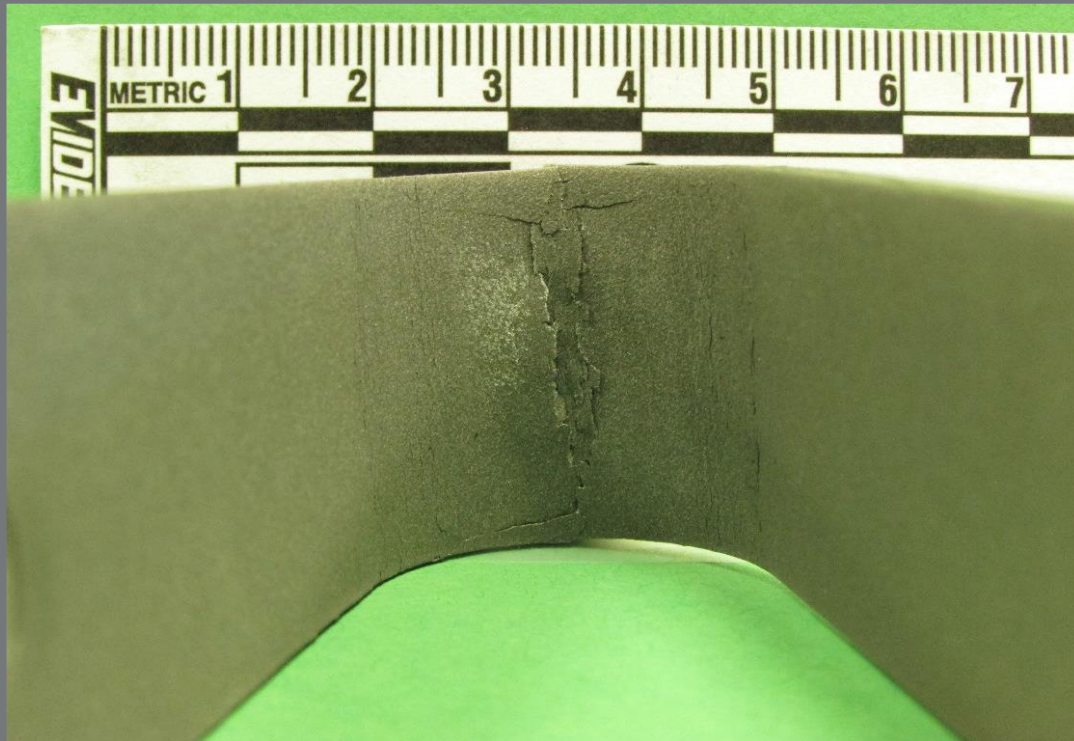
- 1st Test: Bend Test
 - Tested 10 different coating/thickness variations
 - Only one cracked

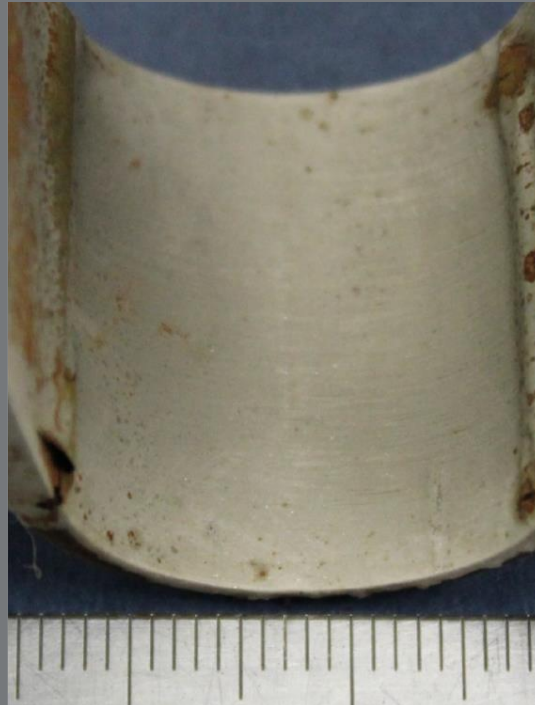
- 1st Test: Acid Exposure
 - Tested 4 different coatings types
 - Immersed in 15% uninhibited HCl for 7 days
 - Only one coating resisted the acid

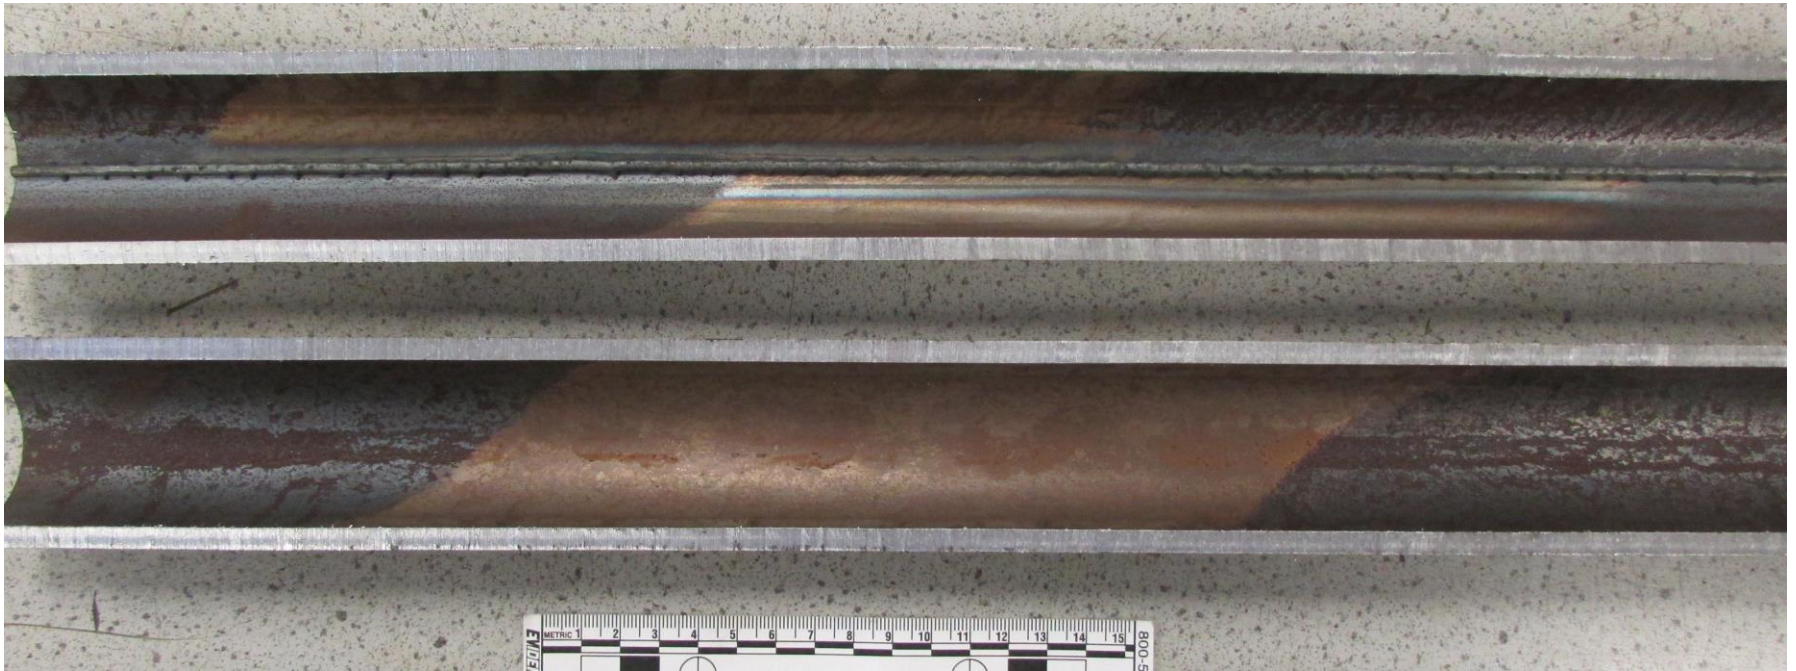
- 2nd Test: Make Tubing and Test for Low Cycle Fatigue

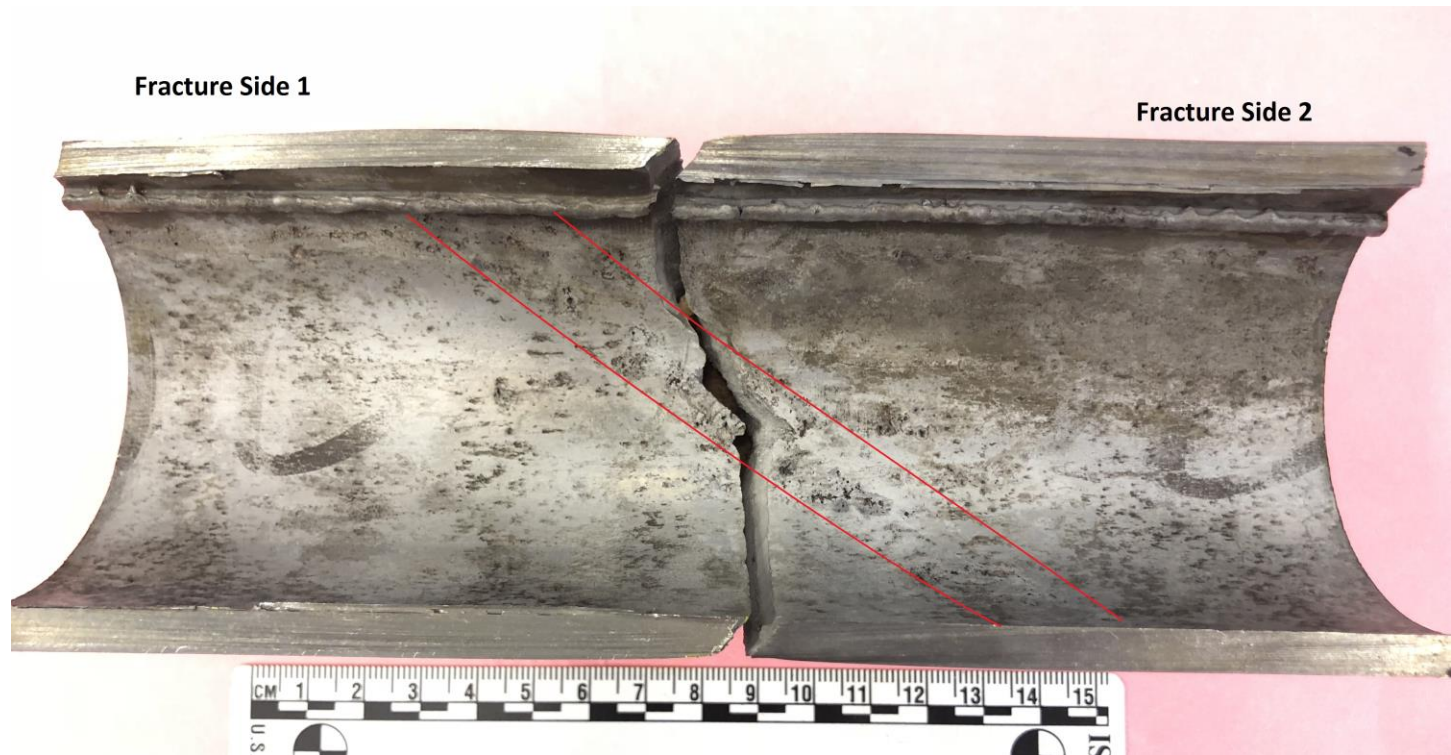
- Weld seam not coated
- 0 out of 102 corrosion pitting failure at bias weld were also at seam

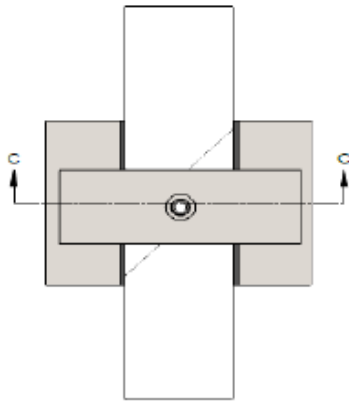
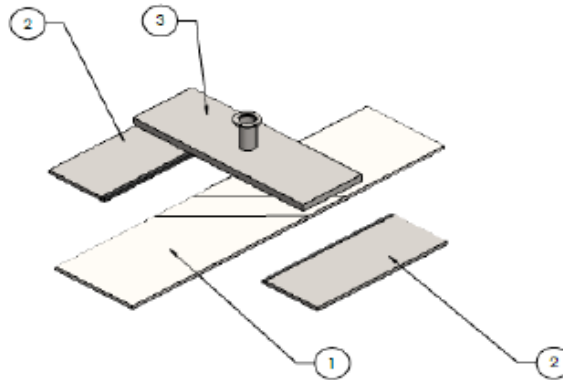
- Testing program successful
- We need to build a working prototype
- The challenge: how to achieve a vacuum with our geometry
