Biocide Water Treatment Program to Mitigate Coiled Tubing Failure

***Case Study for Monitoring and
Treating Bacteria in Coiled Tubing Fluids***

ICoTA Calgary 2015

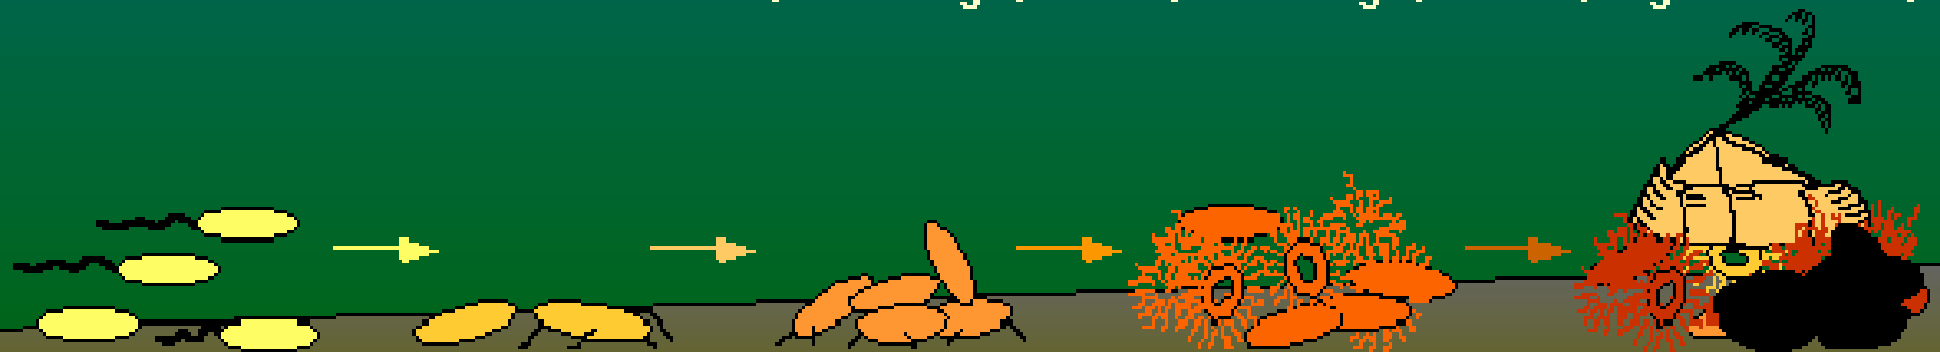
Biofilm Formation

REVERSIBLE
ADSORPTION
OF BACTERIA
(sec.)

IRREVERSIBLE
ATTACHMENT
OF BACTERIA
(sec.-min.)

GROWTH &
DIVISION
OF
BACTERIA
(hrs.-days)

EXOPOLYMER
PRODUCTION
& BIOFILM
FORMATION
(hrs.-days)

ATTACHMENT
OF OTHER
ORGANISMS TO
BIOFILM
(days-months)
