The Challenges of Coiled Tubing Failure Analyses

Coiled Tubing

Coiled tubing is a well completion and intervention tool for the upstream oil and gas industry.

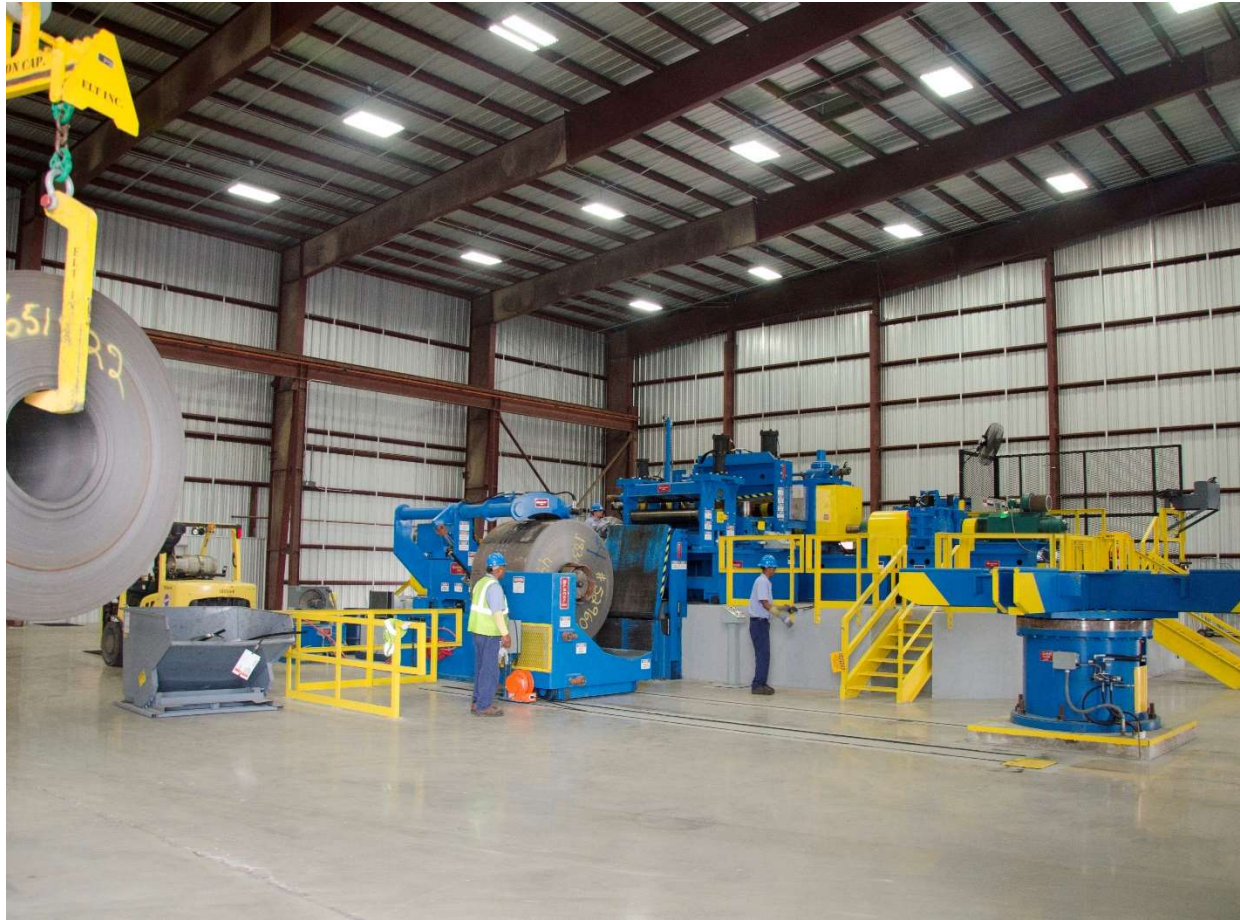
Manufacture of Coiled Tubing

High quality steel strip is slit to the desired width, based on $\pi \times \text{dia.}$

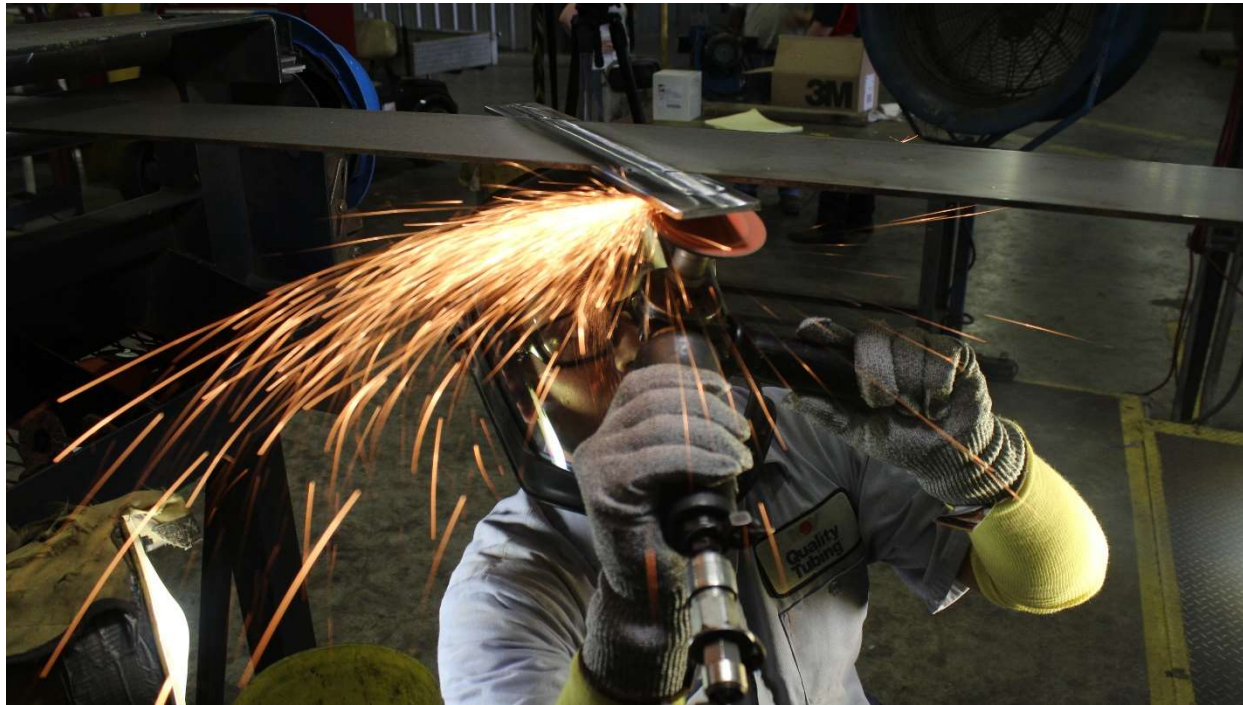
Strips are welded end to end. To improve fatigue performance of the weld, the ends are cut on a bias before joining. The “bias welds” are ground smooth and carefully inspected using digital radiography.

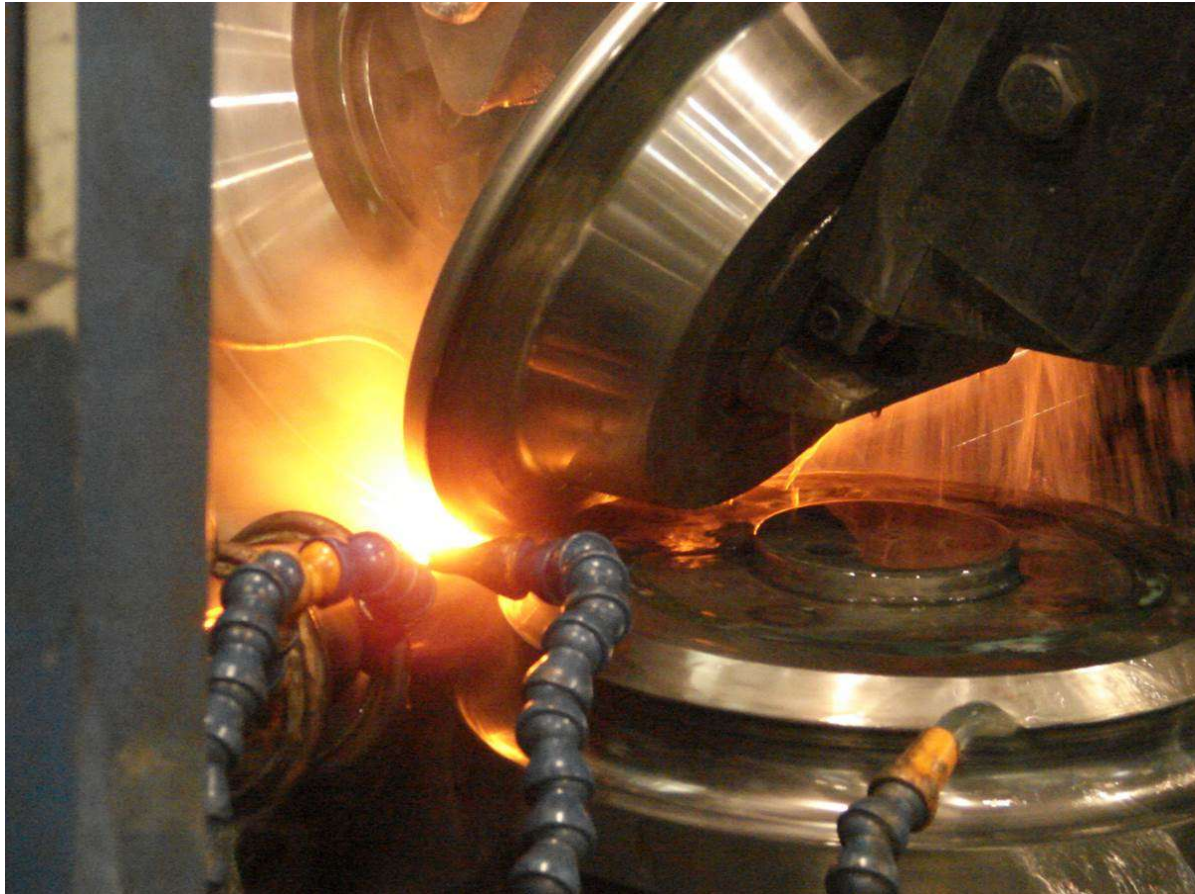
- The assembled strip is wound onto a large reel and fed into a high-frequency induction welding pipe mill.

- The flash is removed from the outside surface, but usually not from the inside surface. (The variation in wall thickness creates a variable inside diameter, which complicates the design of an internal trimming tool.)
- The weld is seam annealed and the tubing is stress-relieved.
- The tubing is cooled before being coiled onto a large reel.
- An end fitting is welded to the “uphole” or “reel” end and a bottom hole assembly is welded to the “downhole” or “free” end.
- Hydrostatic testing is performed with inhibited water. A wiper ball is run through the tubing to remove residual water and the string is purged with nitrogen.

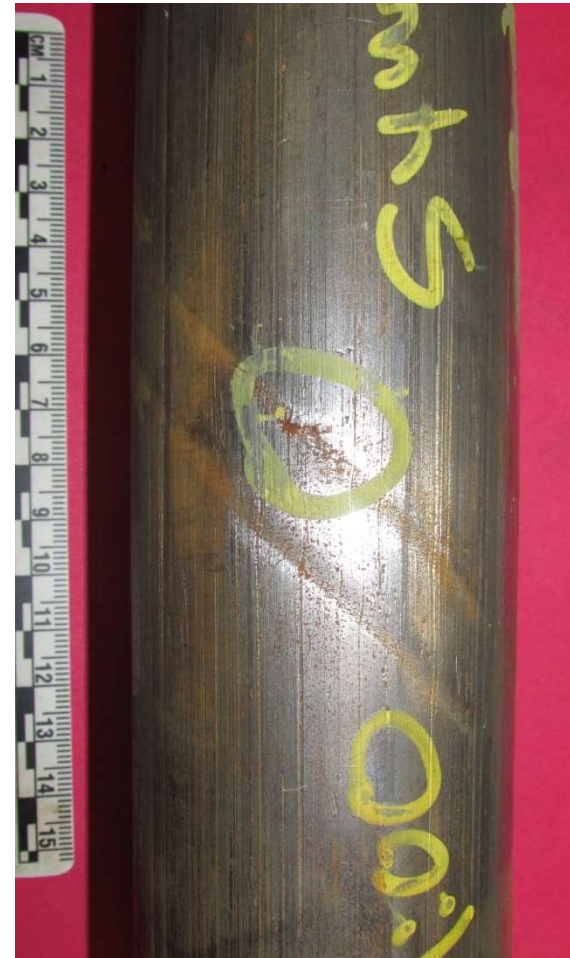
Consequences of Use

- Plastic deformation
- Yield strength drops due to Bauschinger effect
- Diameter growth
- Localized plastic deformation of bias weld HAZ, termed “striping”

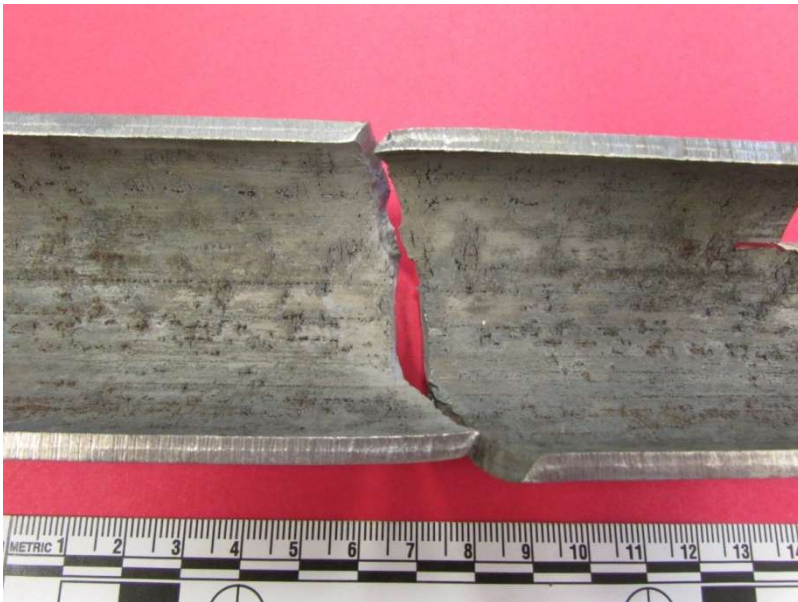
Corrosion Fatigue

- Note internal pitting and small cracks extending from pits.

Corrosion fatigue

Corrosion pits initiate fatigue cracks

- Acidic well treatment chemicals
- Dissolved oxygen
- Microbiologically influenced corrosion
- Corrosive formation fluids
- Improper storage—ponding of residual water

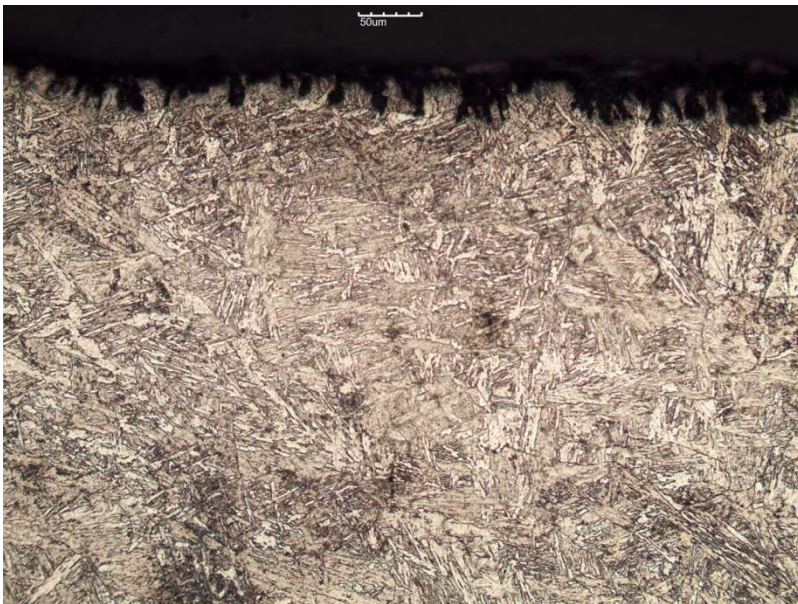
Sour Corrosion and SSC

- Note angular corrosion, termed “trenching” on outside surface (near crack). This is a form of incipient sulfide stress cracking.

Sulfide Stress Cracking

Coiled tubing generally sees a controlled (non-sour) environment and at most short-term exposure to hydrogen sulfide. Nonetheless, the most commonly used grades are susceptible to hydrogen stress cracking if exposed to sour conditions and failures can occur.

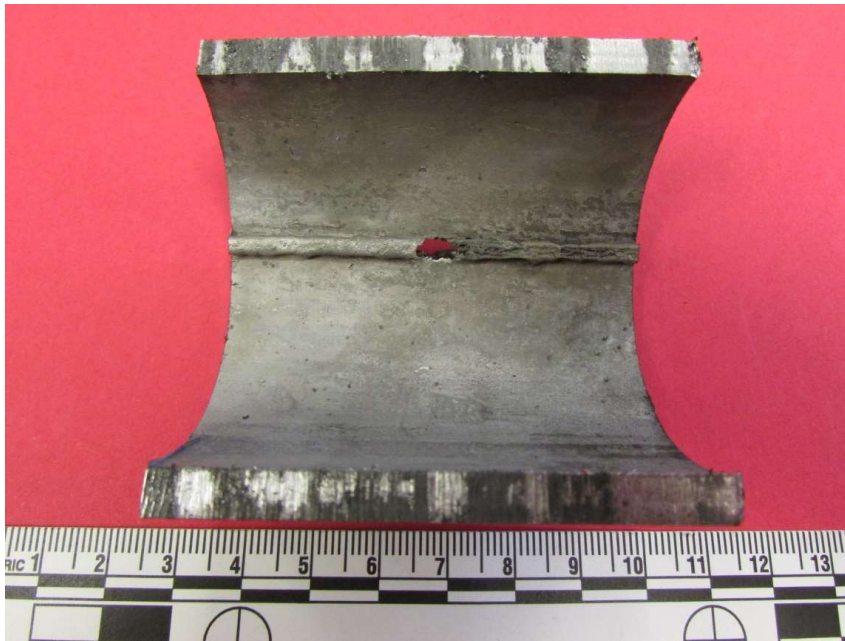
Seam weld defect

- Note variation in internal flash adjoining eroded hole.

Seam Weld Defects

Because coiled tubing is made using a standard high frequency electric welding process, the same defects occur in it as can occur in other electric-welded pipe. Often related to interrupted electrical power or strip edge condition. Usually detected during hydrostatic testing. Unusual irregularities in the internal flash may provide confirmation.
