Case Studies on High Pressure Milling in the Duvernay

Presented by Lem Edillon, STEP Energy Services Ltd.
Lunch and Learn Presentation – March 8, 2017

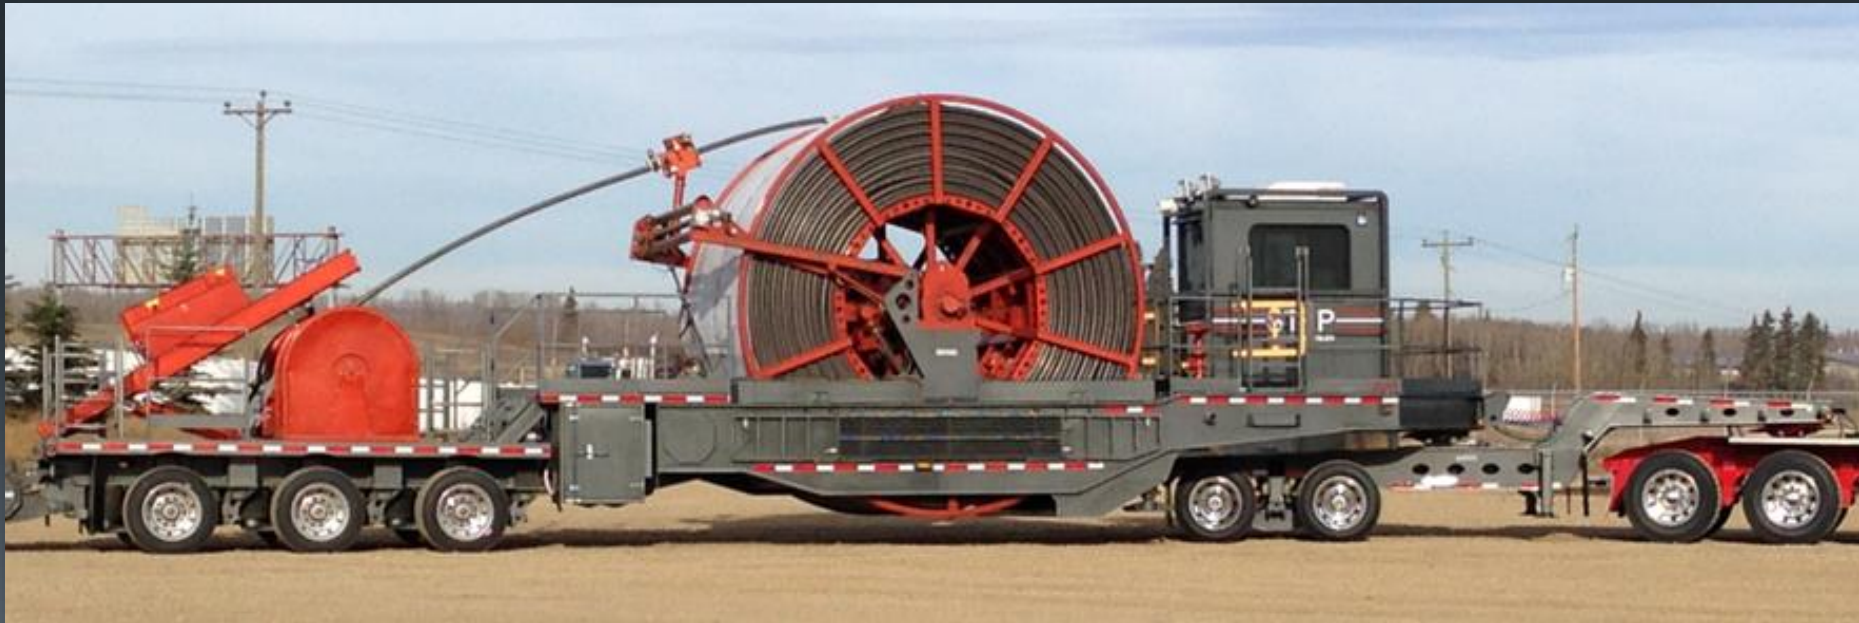
Reel Capacity

- 12' wide reel trailer
- 96" Core, 182" Flange, 110" Wide
- 2-3/8" CT Capacity = 9,900m (Cerberus)
- 2-5/8" CT Capacity = 7,900m (Cerberus)
- Maximum Lifting Weight Limitation = 180,000 lbs.
- Target Maximum String Weight = 168,000 lbs.

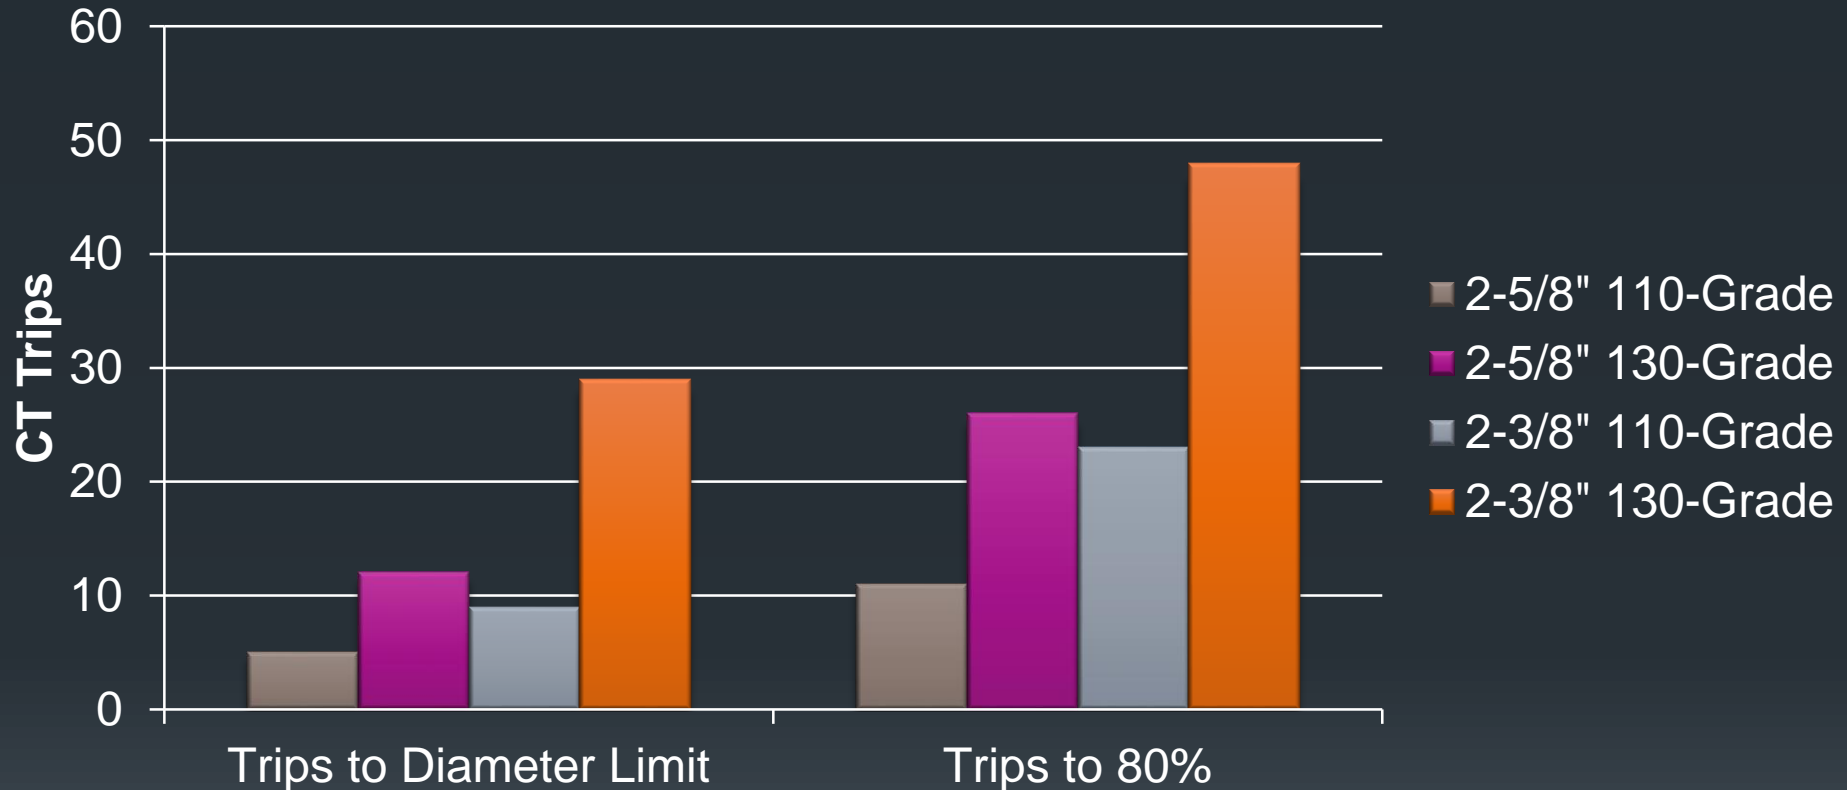
CT Fatigue Performance

- Fatigue model: Achilles 5.0
- Simulated circulating pressure: 70.7 MPa
- 244 cm reel diameter, 279 cm arch radius
- Diameter limit = ~103% original (e.g. 62.4 mm for 60.3 mm CT)

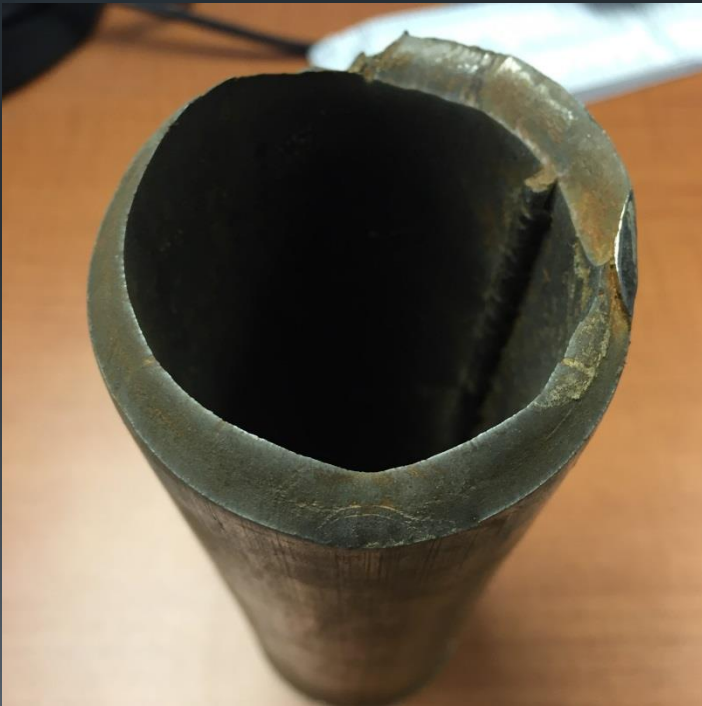
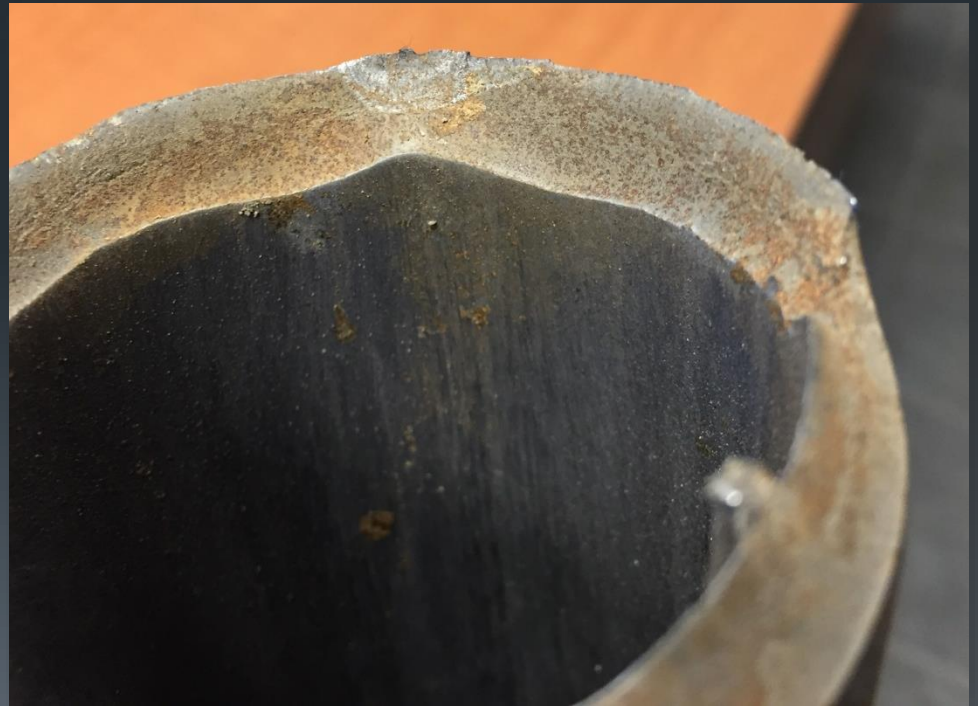
String Failure

- Occurred at 3,957m from the whip end. 30% fatigue (using a 1.2 application factor).
- Performed an ultrasonic and MFL inspection on the entire string
- Third party failure analysis: fracture occurred due to a high stress, low cycle, crack on the CT OD initiated shallow mechanical damage.
- No evidence of substandard material supported by a tensile test performed by the manufacturer.

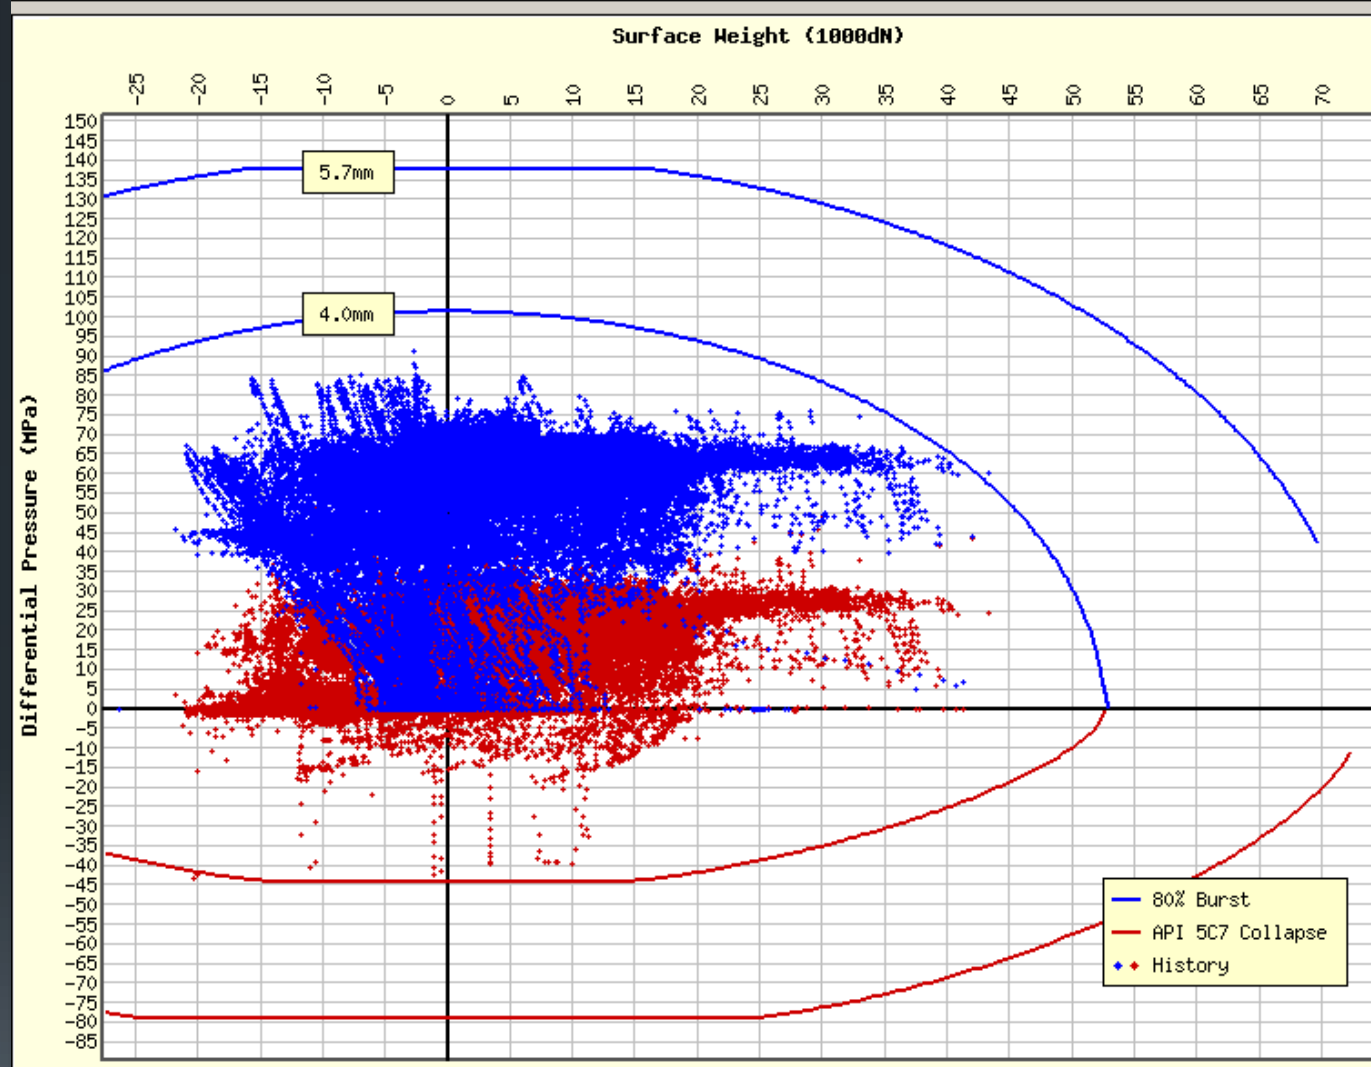
Tubing Limits

Average Lifetime Moving Pressure = 64 MPa

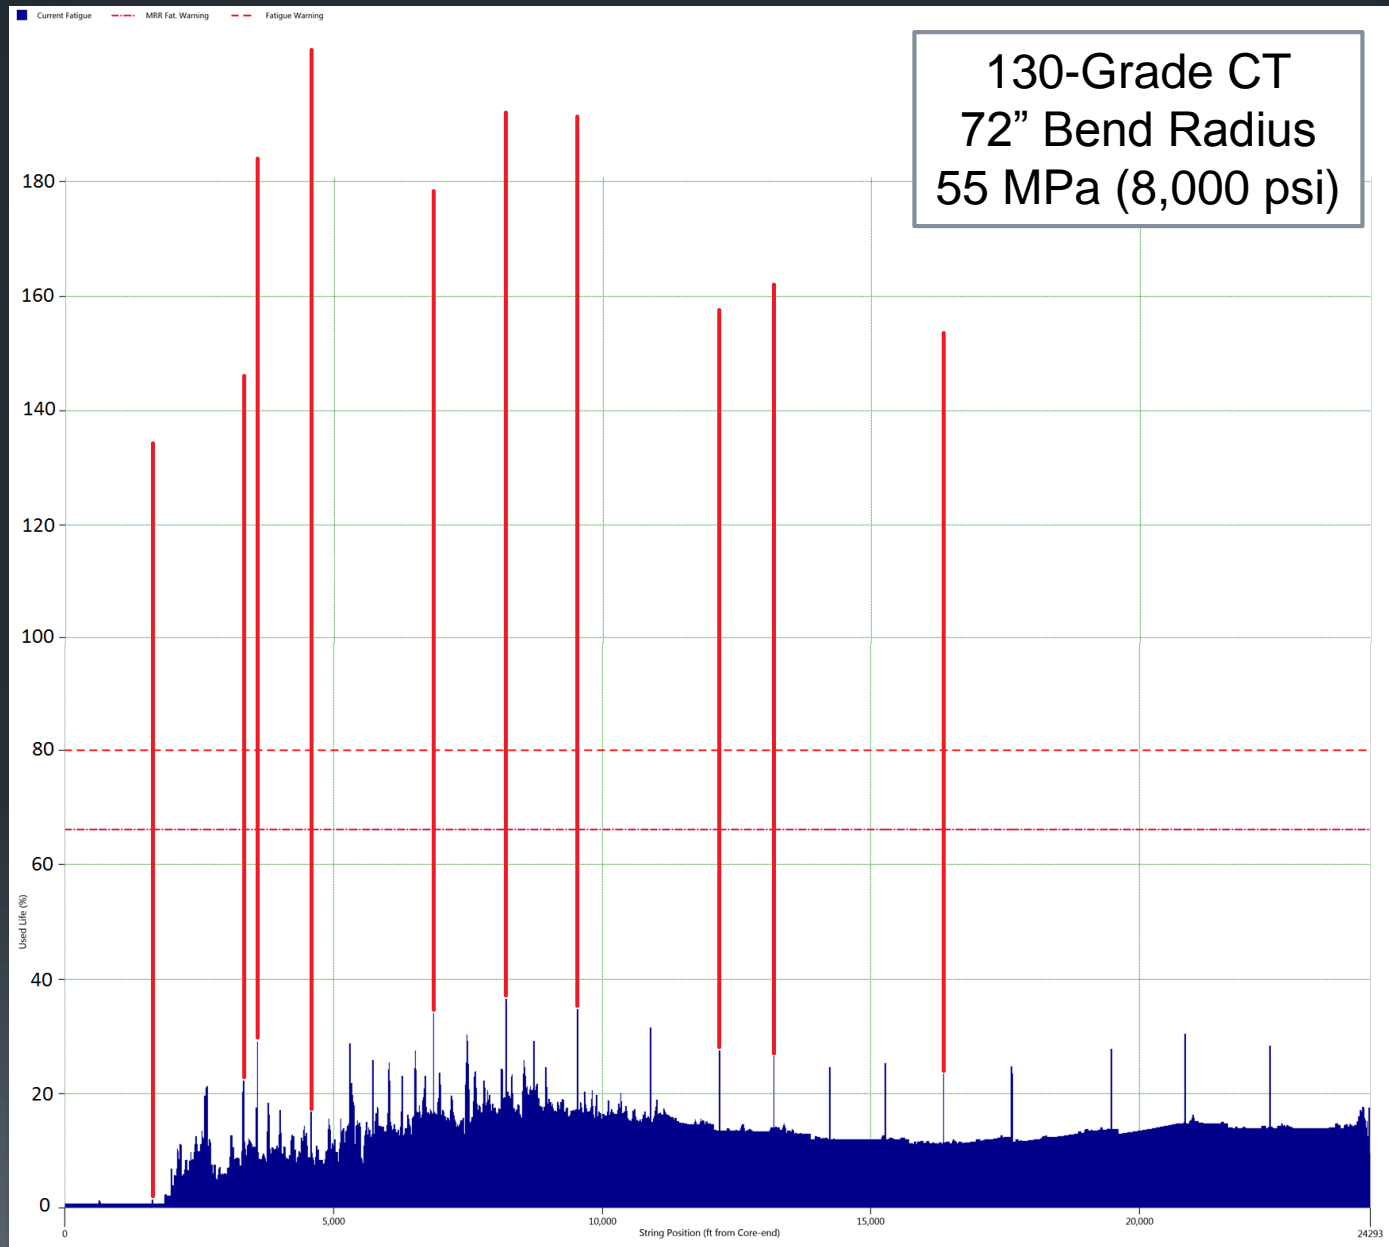
CT String #4 - Fatigue Bend Testing

- Manufacturer performed fatigue bend testing on String # 4 post-retirement
- Extracted and tested 14 bias welds out of 21
- Bend radius = 72", Circ. Press. 55 MPa (8000 psi)
- Pitting corrosion found on samples 2, 3, and 4

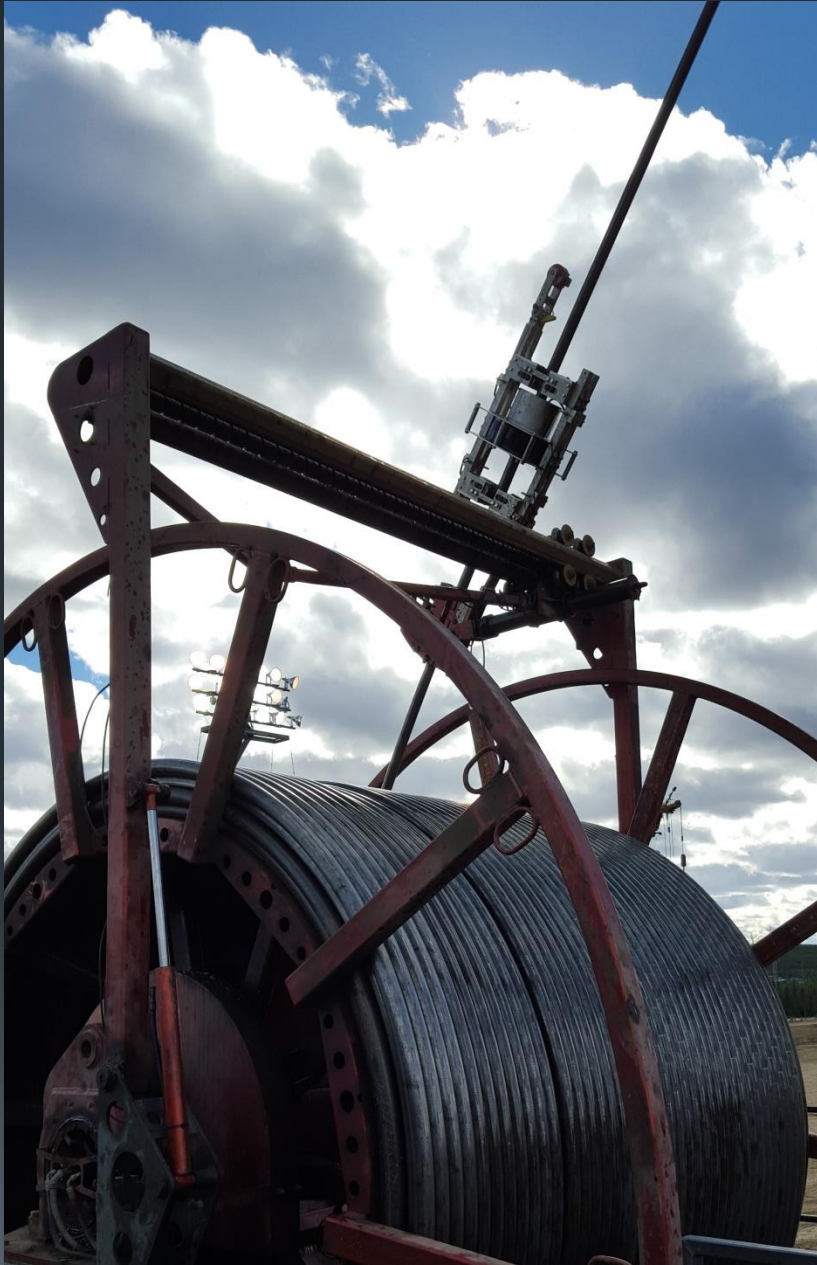
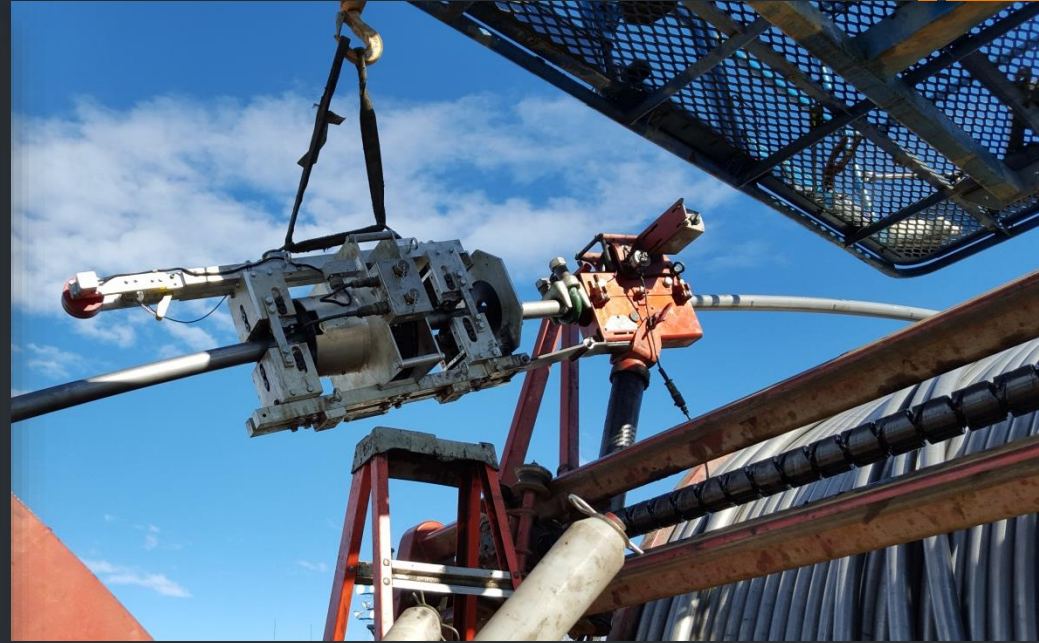
String #6 - CT Real-Time Inspection

- Using electromagnetic induction (EMI) measures wall thickness, ovality, and anomalies.
- Required securement to counter arm.
- Inspected CT while pulling out of hole.
- Required minimal vibration and consistent pull out of hole speed.
- Performed a single inspection, require additional opportunities.
