Coiled Tubing Vibrational Analysis

Dan Regehr - ICoTA Roundtable - October 25 / 2017

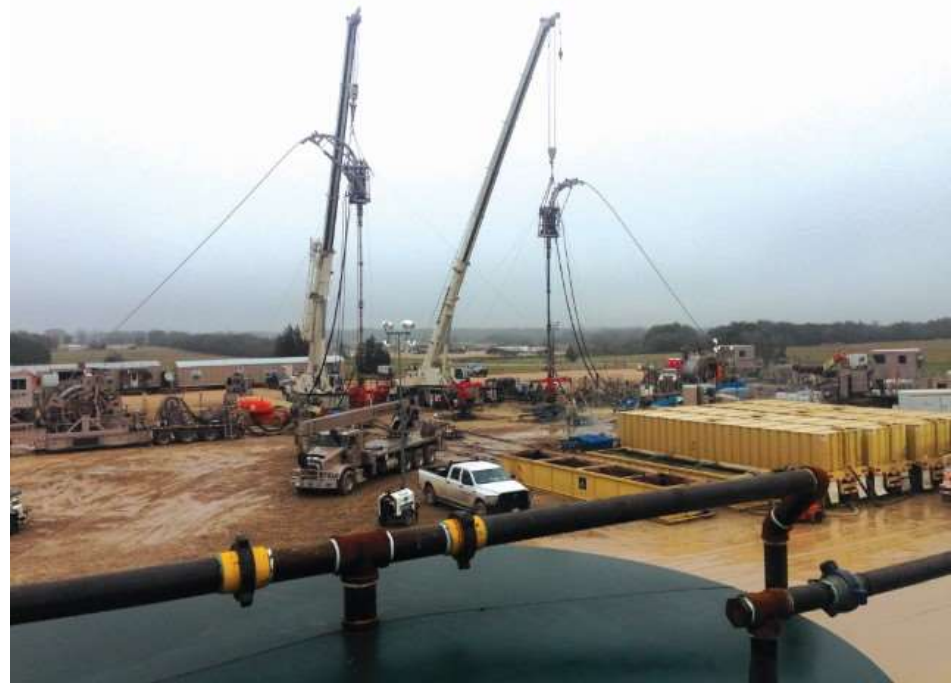
Severe vibration associated with water hammer tools cause premature wear / fatigue on surface equipment and coiled tubing.

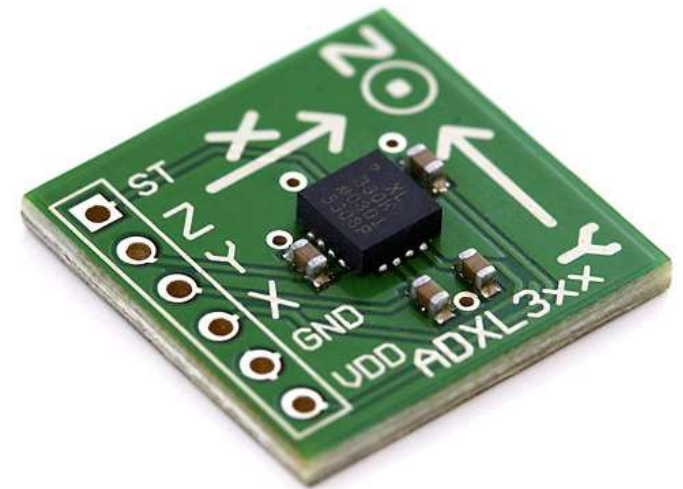
- 3-axis accelerometer to measure vibrations during milling
 - Mounted to injector at surface
 - Incorporate into bottom hole assembly
- Post job data analysis

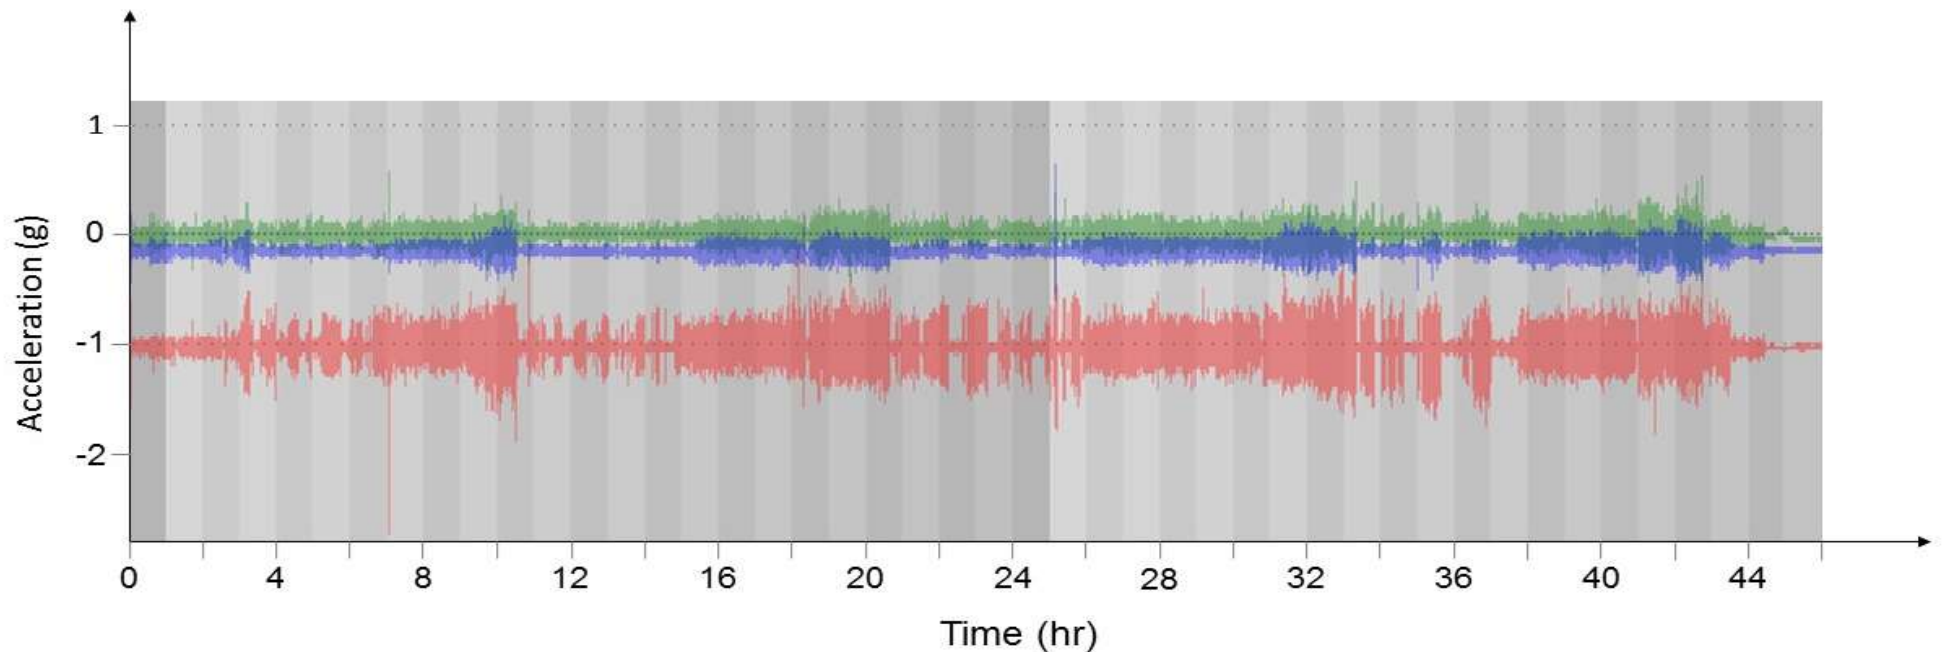
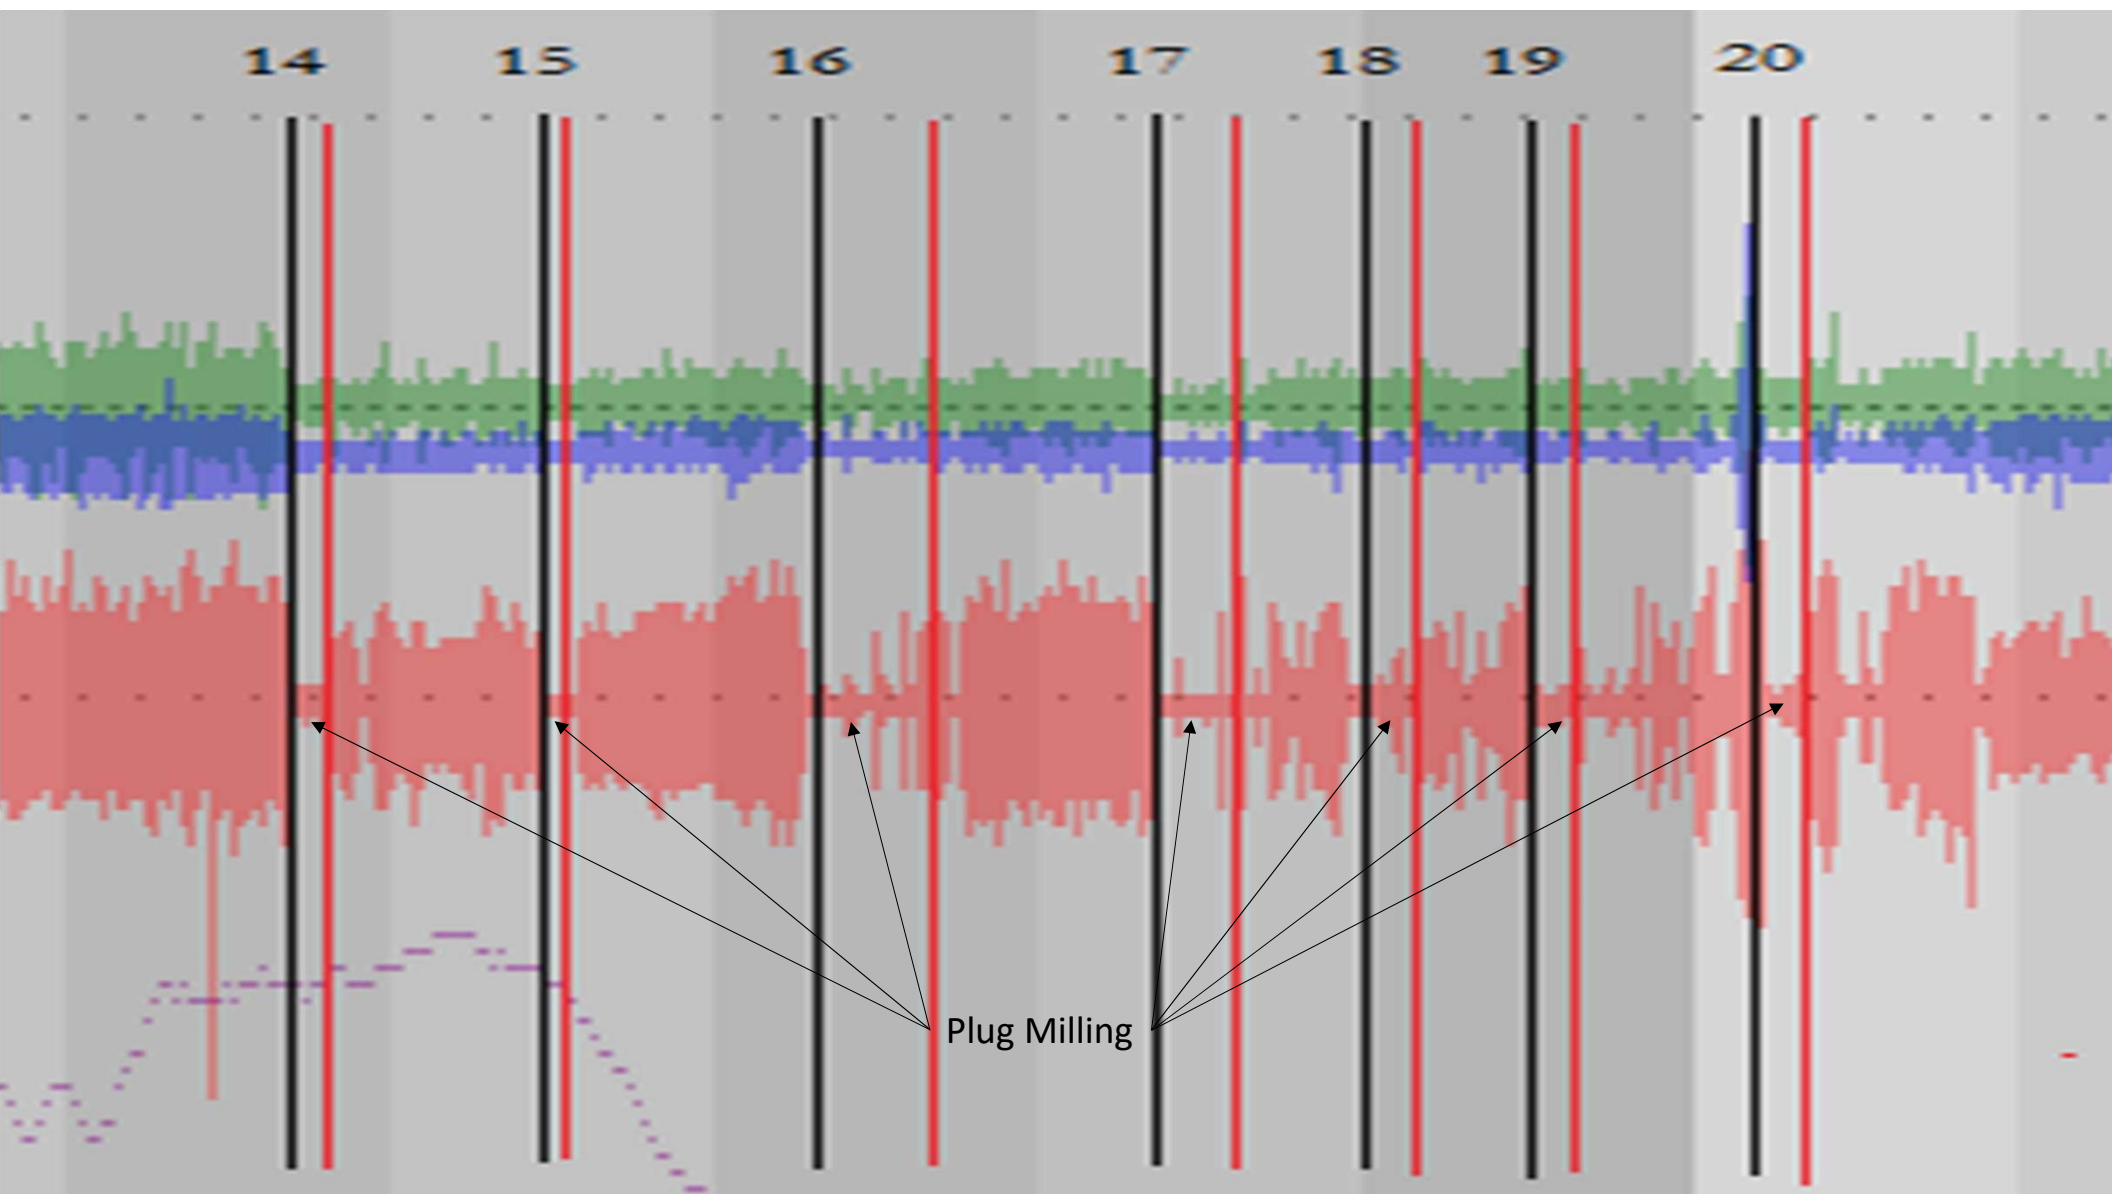
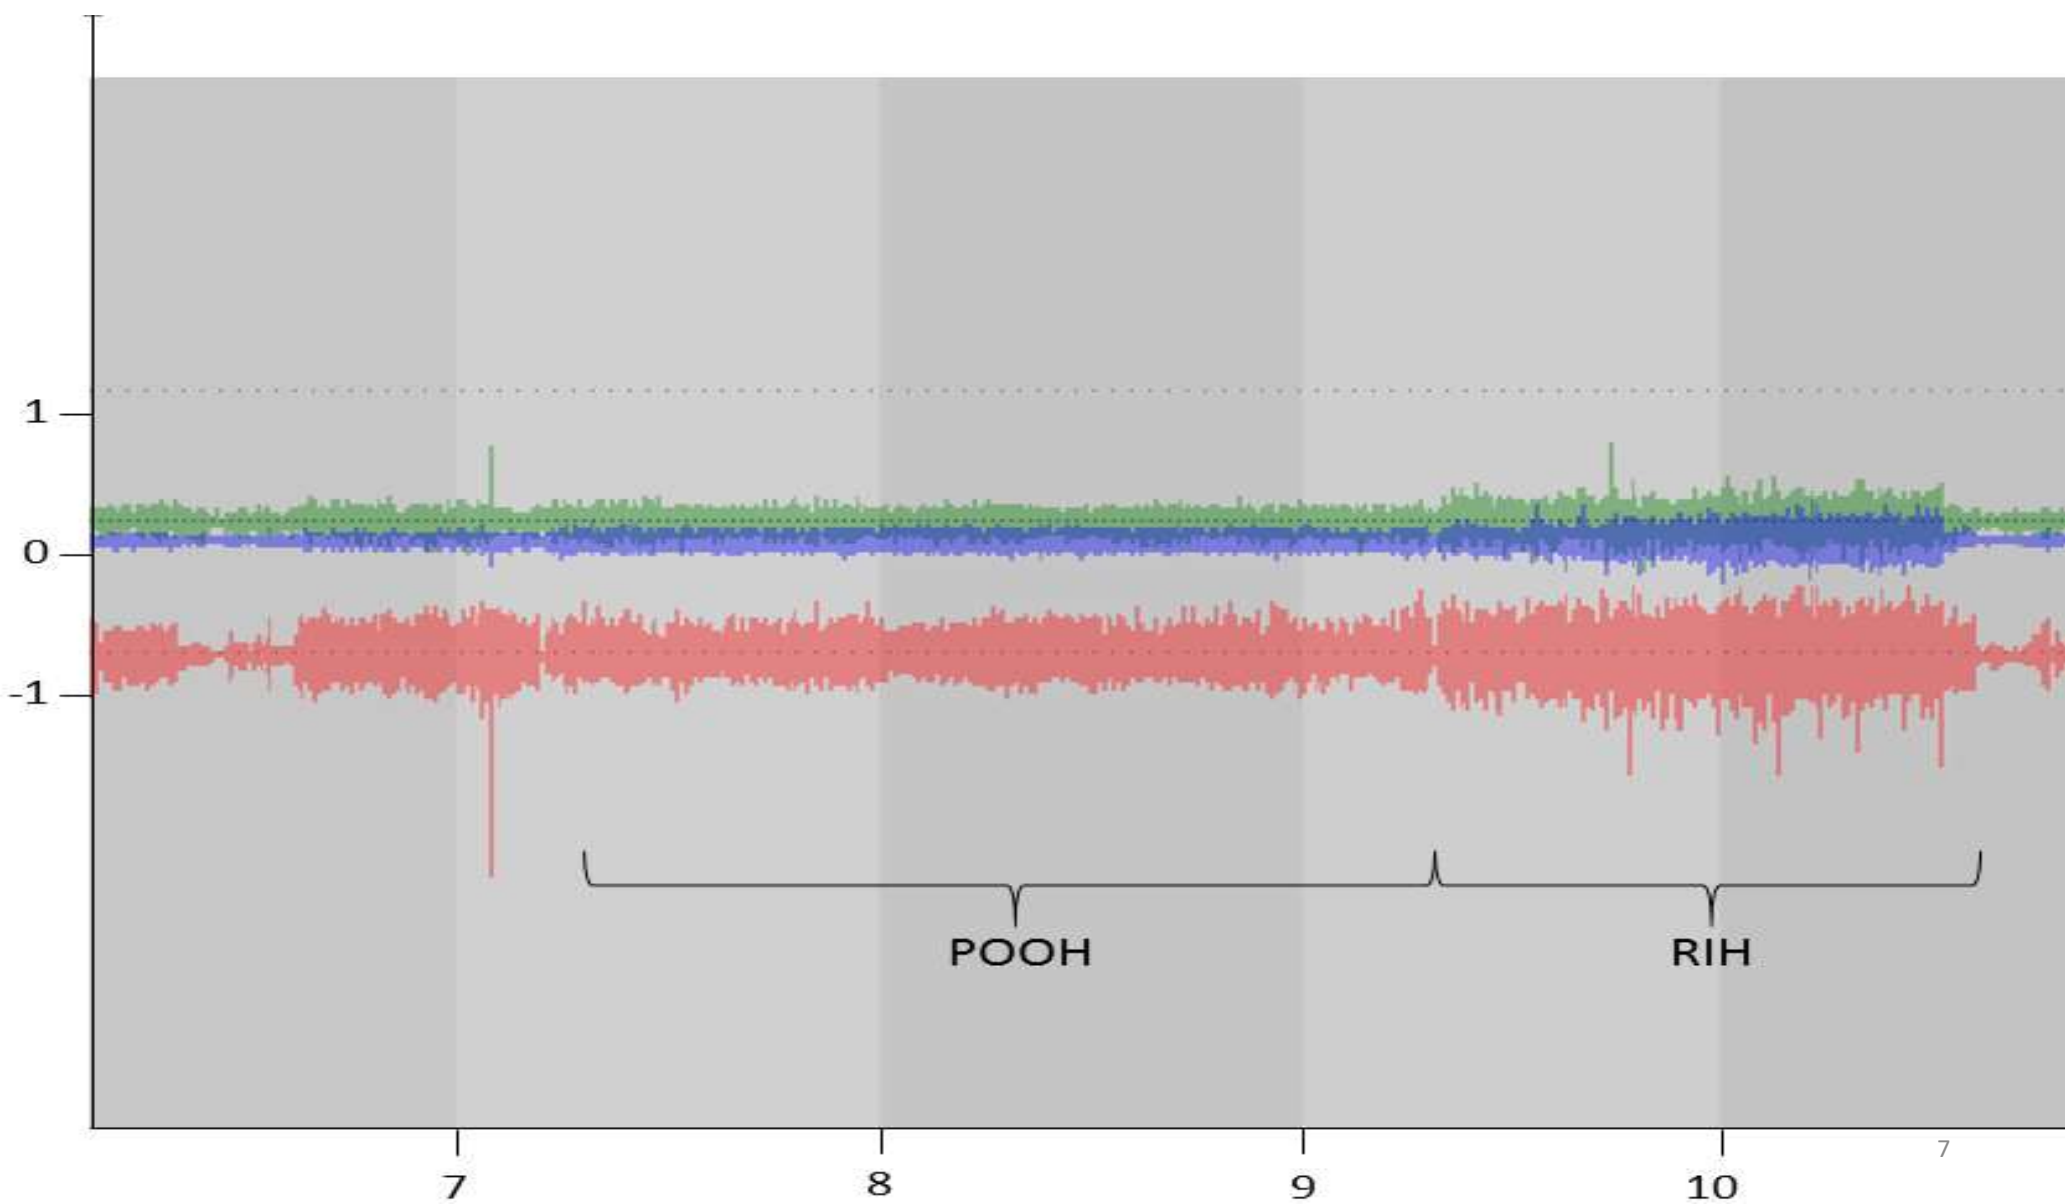
- On surface, vibrations from tool < vibrations from equipment
- No cause for concern – no damage to injector – nothing more than 1g

- Vibrations from the water hammer tools are much lower in magnitude than the vibrations from the equipment
- It is possible to see motor stalls / engagement with obstructions
- The vibration characteristics of the water hammer tools were not appreciably different at depth vs. at surface
