# Best Practice for Storage of Coiled Tubing

Kevin Elliott, Quality Tubing

ICoTA Roundtable  
Calgary, AB  
October 25, 2017

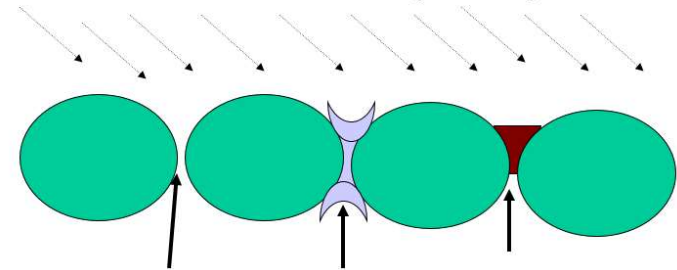
## External Corrosion Problem (Coiled Tubing Wraps on Reel)

Rain and Industrial Pollution (acid rain)

Crevice – Site  
for crevice  
corrosion

Meniscus to  
concentrate  
pollutants

Dirt / debris – Site  
for under deposit  
corrosion

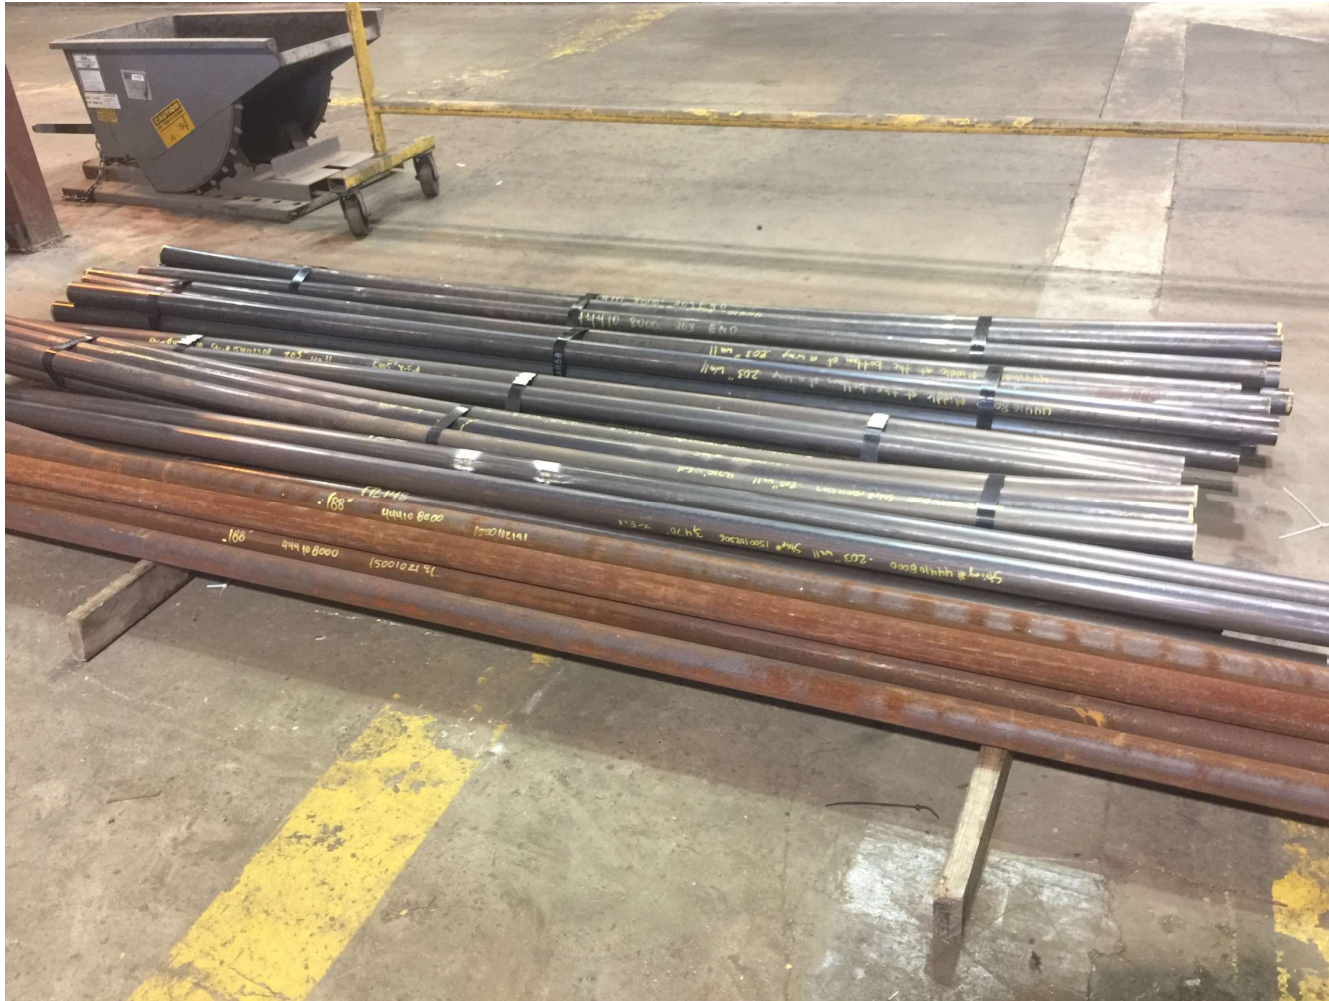
SN 444108000, Manufactured: 06/25/2015

# As-Received

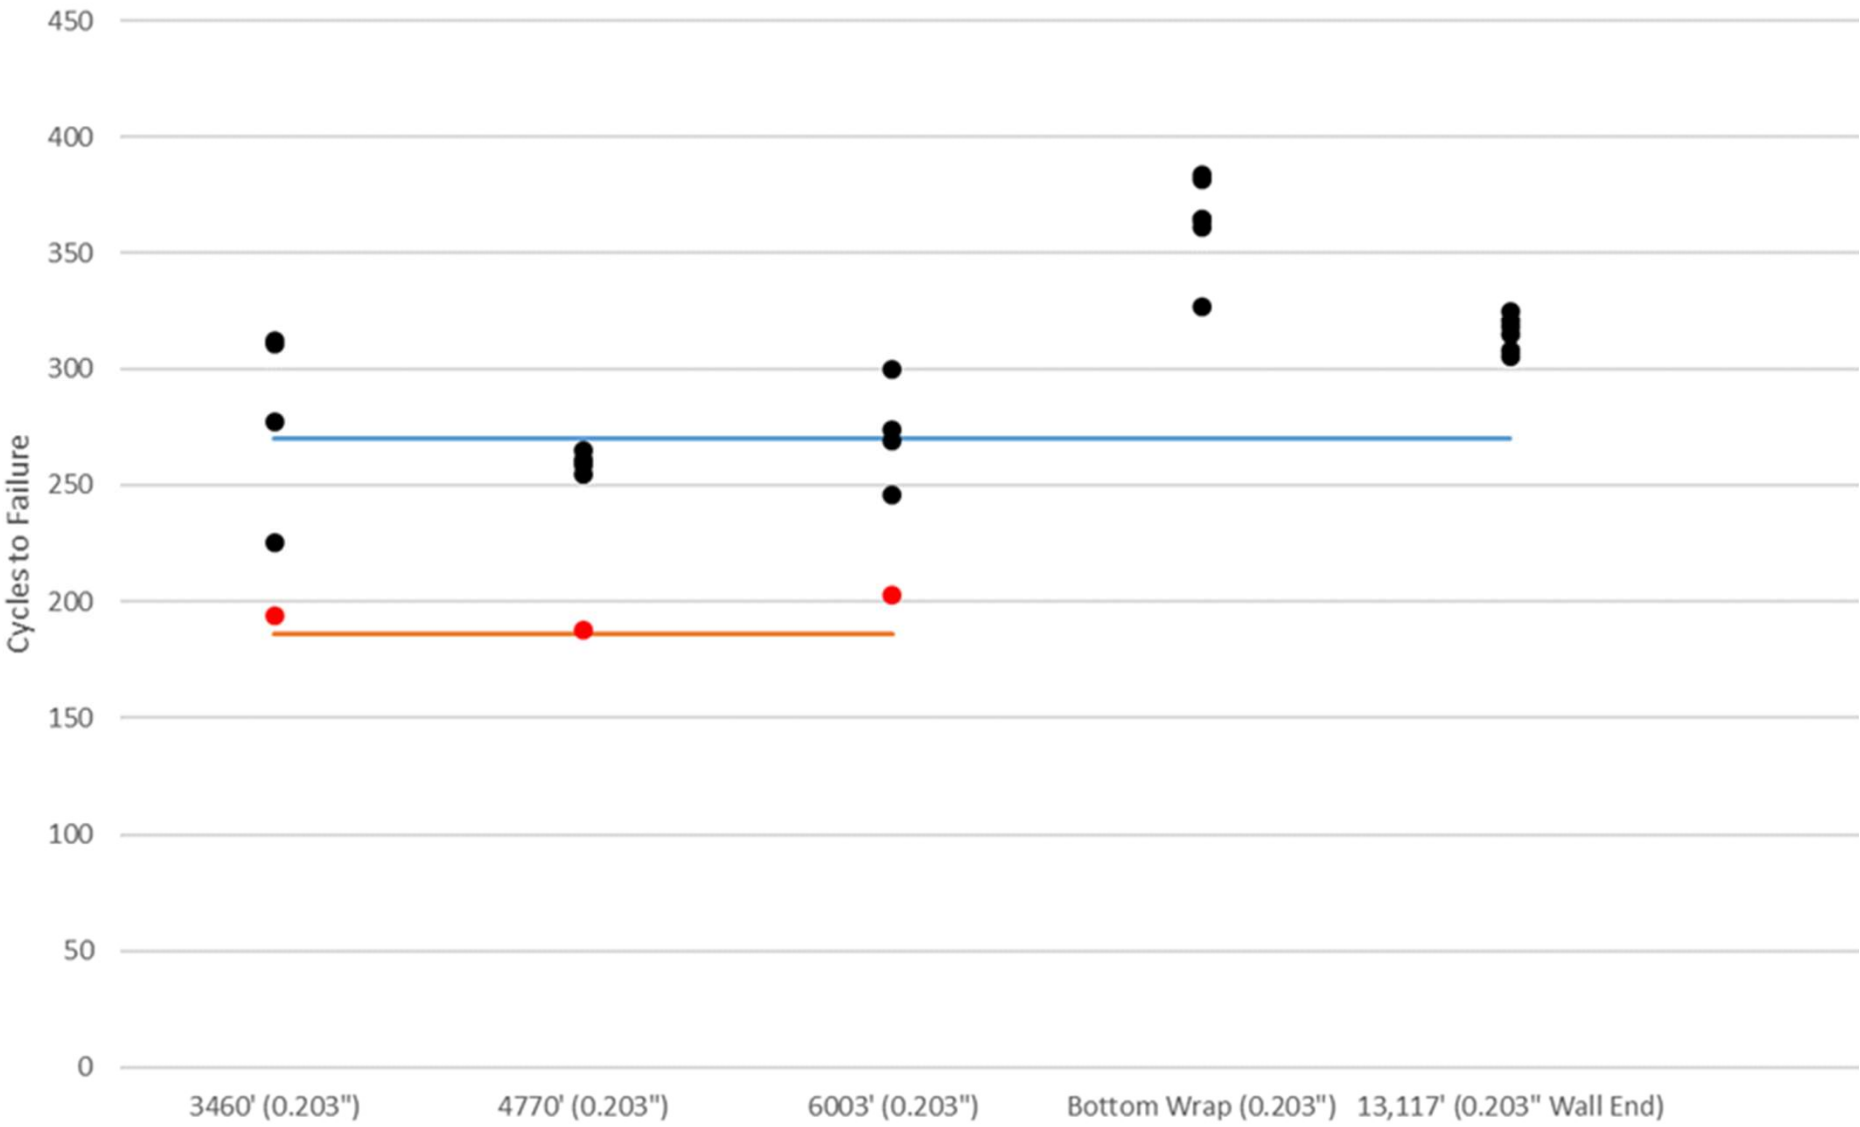
SN 444108000, QT-900, 2.375", 0.175"-0.203", Manufactured: 06/25/2015

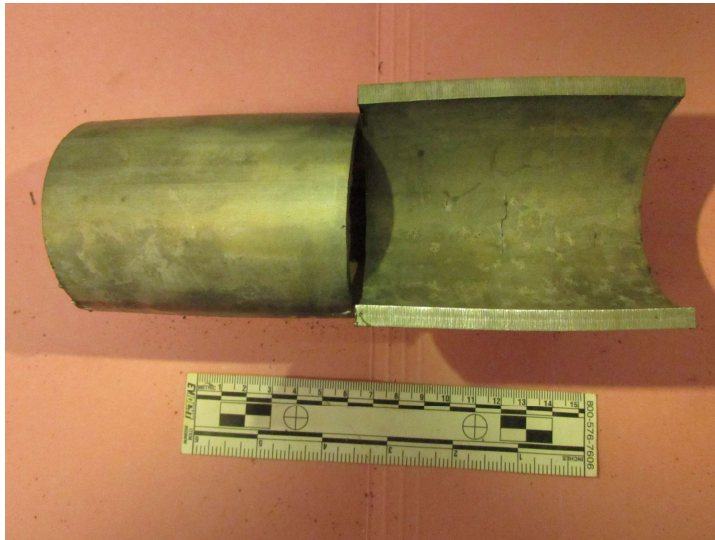
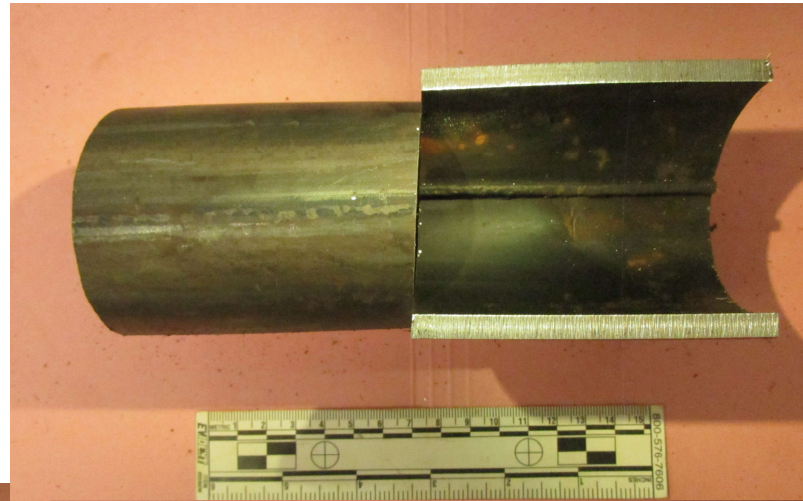
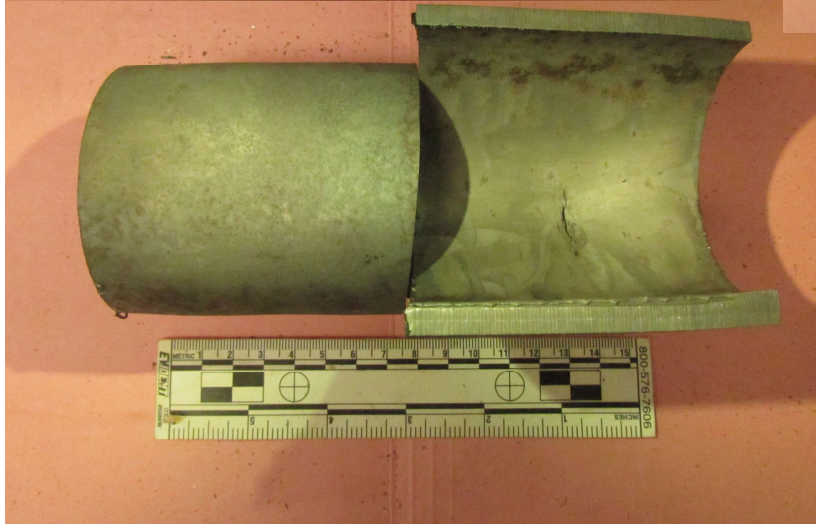
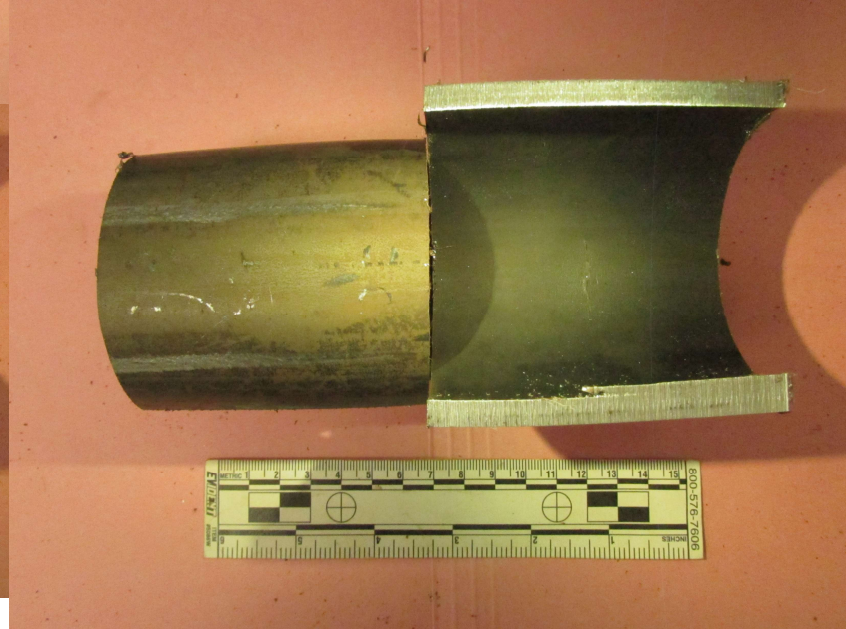
# Representative Views of SN 444108000

Post-Low Cycle Fatigue Testing

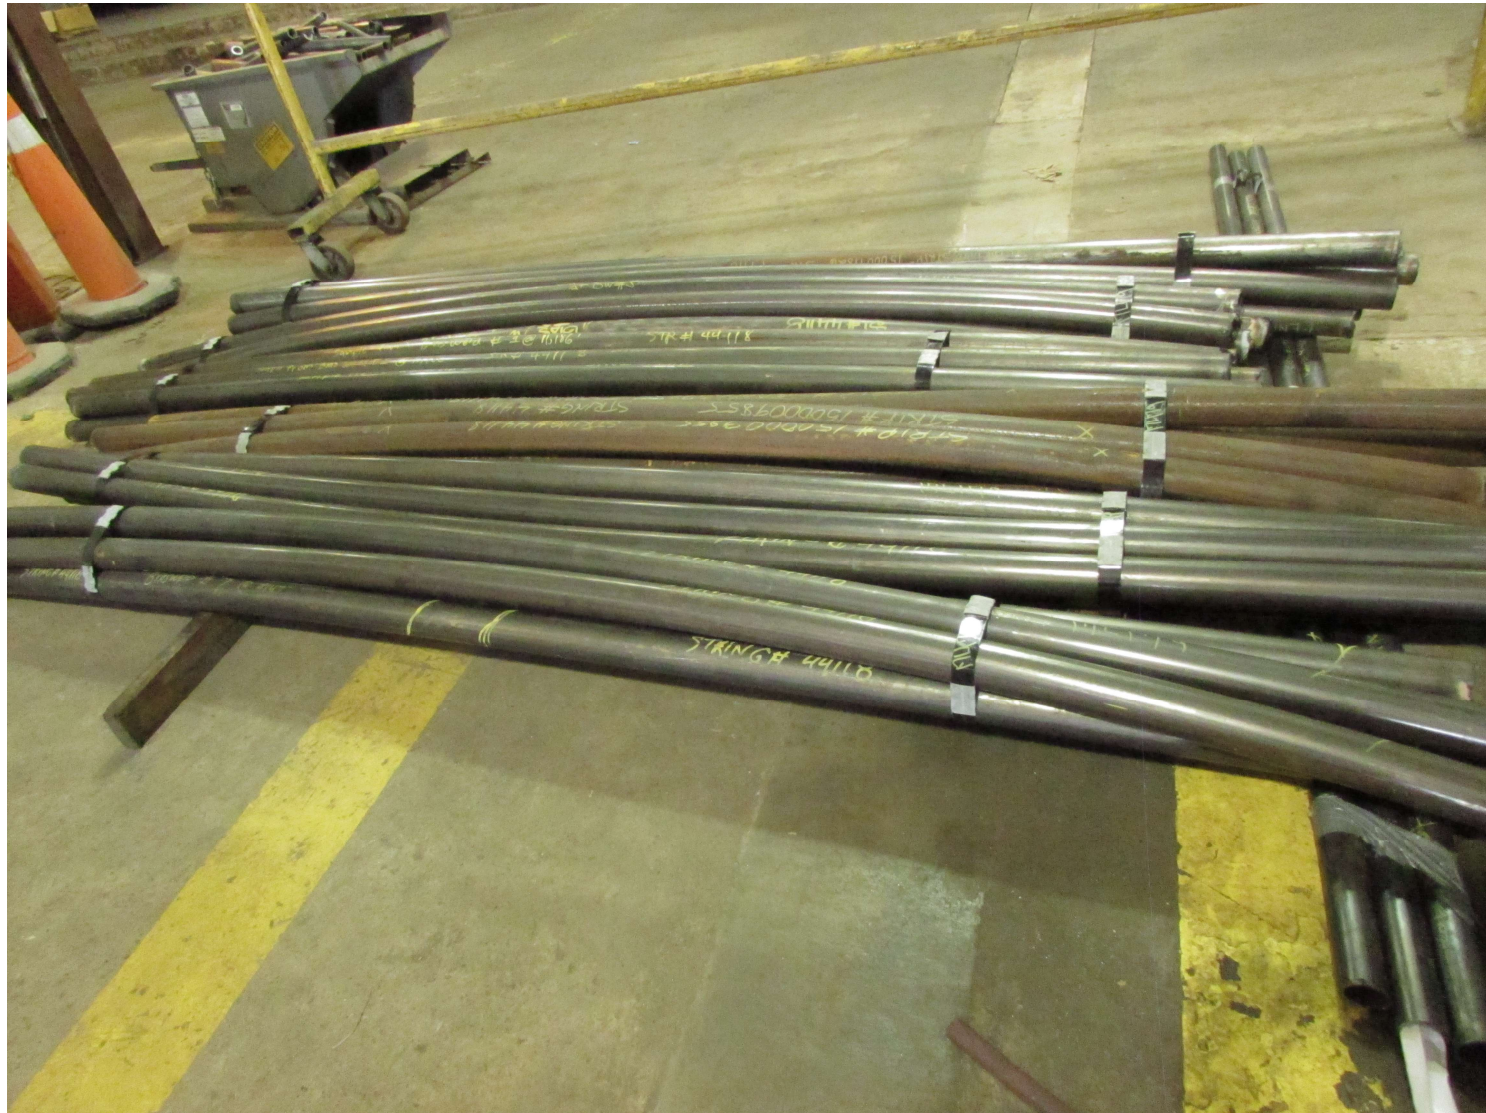
SN 441180000, Manufactured: 10/30/2015

# As-Received
