Coiled Tubing Bias Welds Recent Failures Trend

Tomas Padron, Coiled Tubing Research and Engineering (CTRE)

October 29th, 2014 ICoTA Roundtable, Calgary, Canada

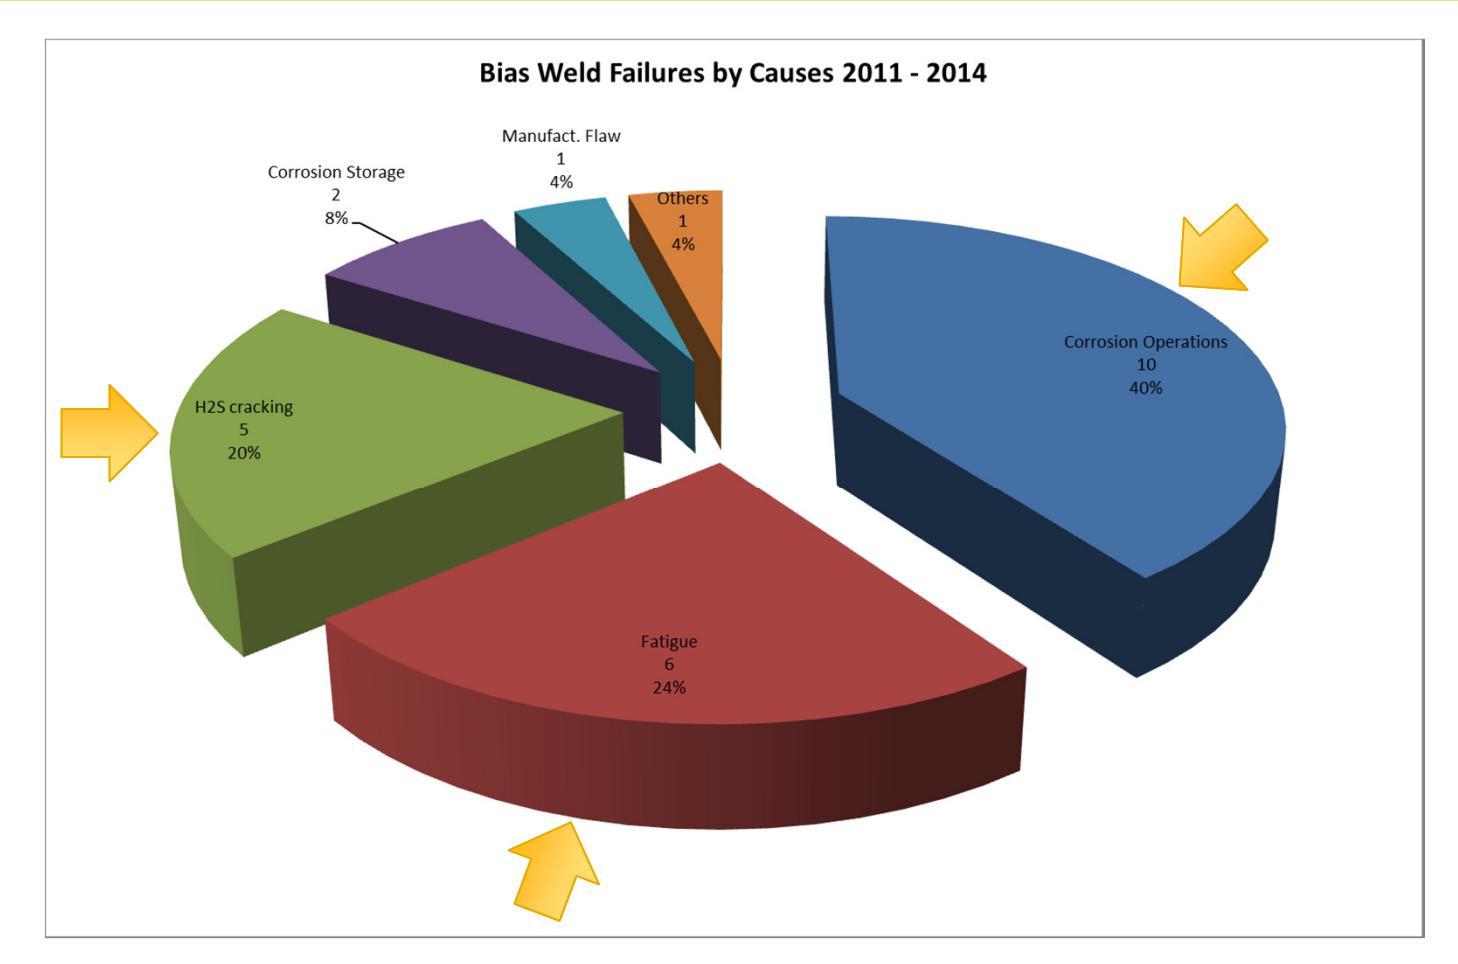
Corrosion Operations, Fatigue, and H2S Cracking represent 84% of the bias weld failures

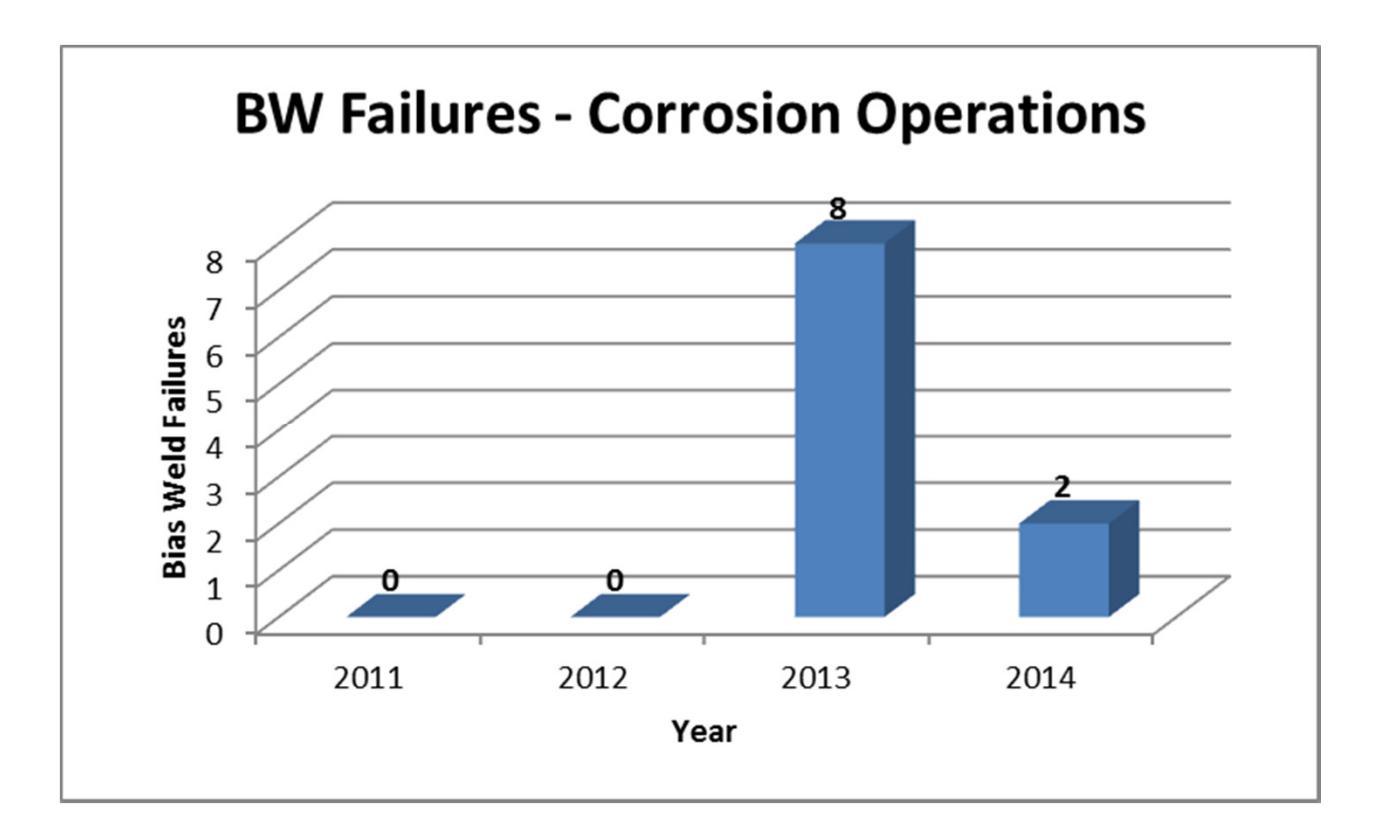
Corrosion Operations: failures associated with corrosion damage caused by fluids used during operations.

- Six (6) CT failures occurred while milling plugs in Alice – USA.
- String characteristics:
 - 2" OD x tapered
 - 90 Grade
 - Basically new strings
- All the failures occurred on bias welds.

- On 3 failures: internal pitting corrosion on the bias weld region.
- Fatigue cracks starting at these pits
- High pressure regime (around 7,000 psi).
- Fluid: recycled fluid "treated" with biocide.

- Sulfur (S) was found within the internal pits
- Recycled fluid analyses revealed:
 - Sulfur, pungent odors of rotten eggs, and sulfide in the form of black precipitates
 - 4.2 5.2 million bacteria per ml
 - APBs and SRBs

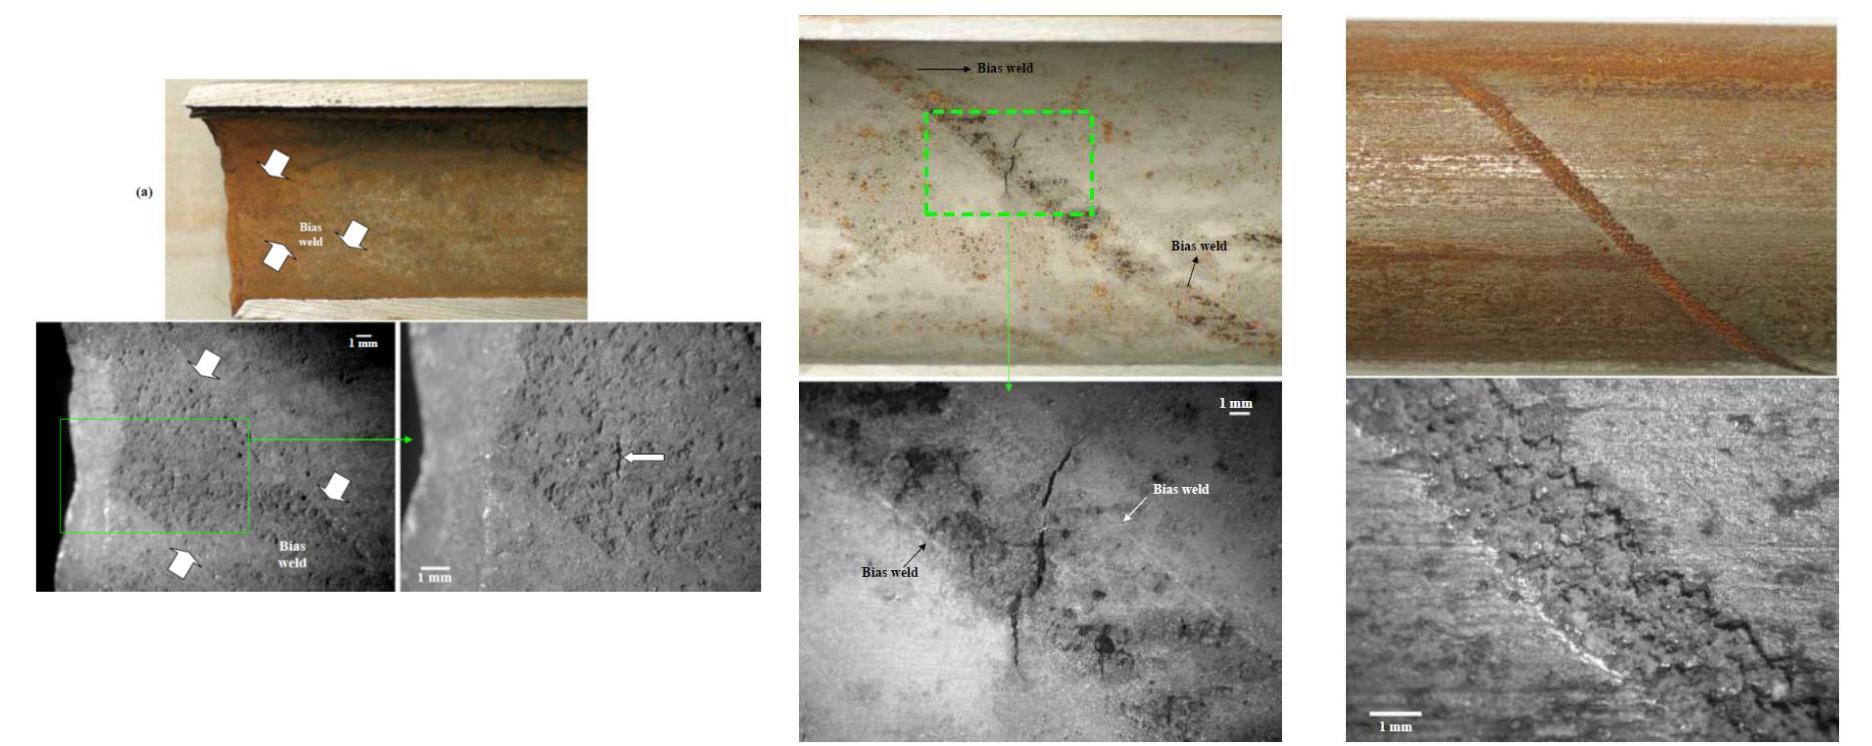
- Corrosion Operations:
 - The examples showed a greater susceptibility to corrosion damage on the bias weld region – this is considered as "expected" but....Could this be a topic for investigation and improvement?

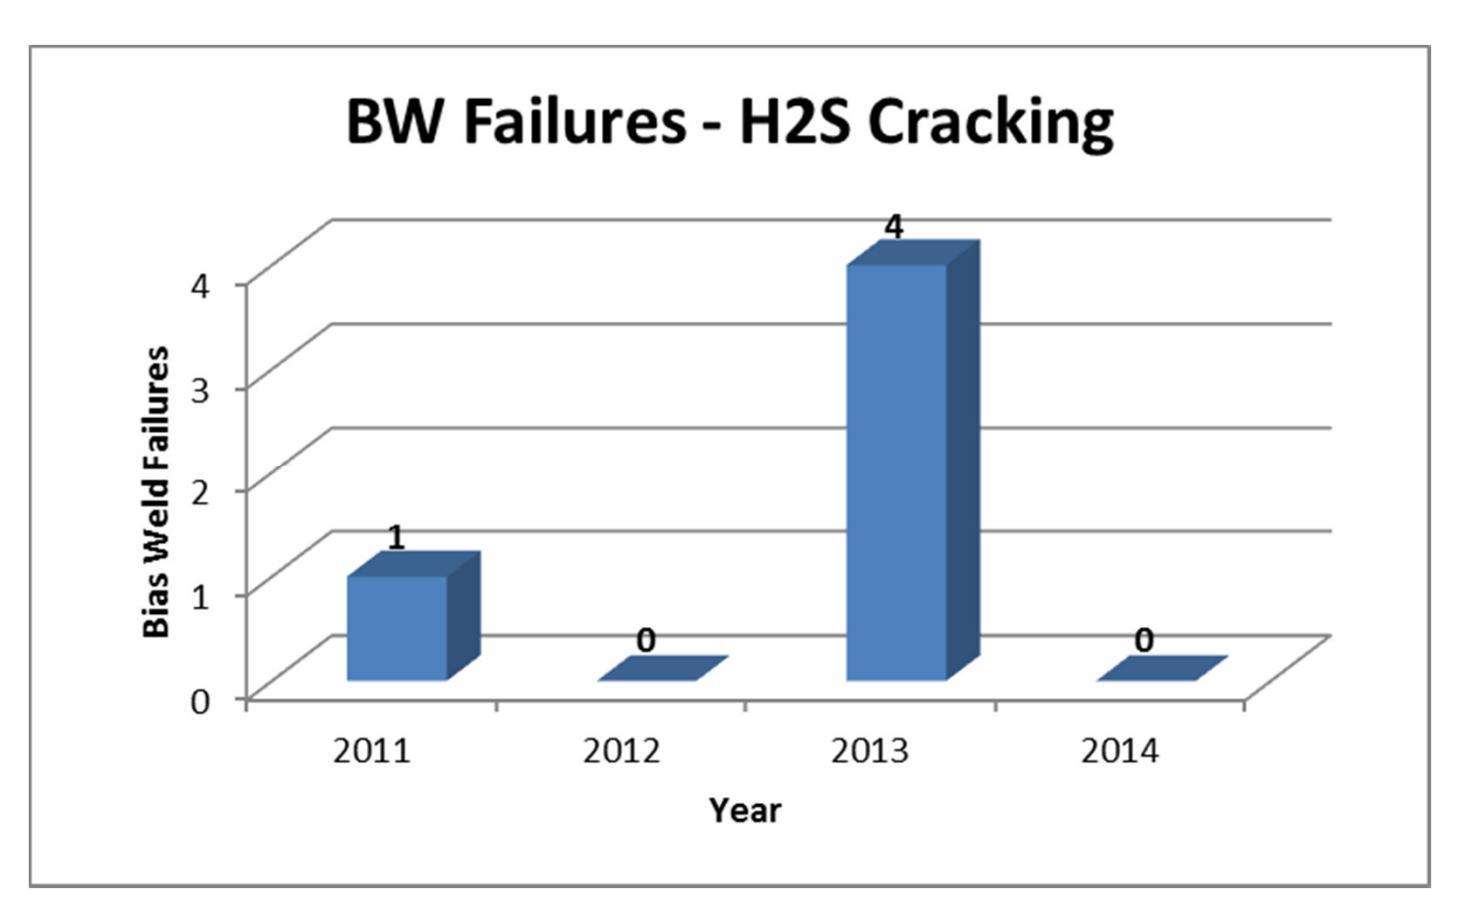
H2S cracking: failure by internal cracking due to the exposure to a sour environment. H2S sources could be different, i.e. well, contaminated fluid, etc.

- Three (3) CT failures occurred while milling plugs in Alice USA.
- String characteristics: 2" OD x tapered 90 Grade / Basically new strings
- Failures occurred as fractures at bias welds

- Internal corrosion damage very mild or absent no fatigue cracking associated with isolated pits
- Internal cracking on the bias welds "cleavage" features similar to cracking due to exposure to H2S

- Fluid: recycled fluid "treated" with biocide
- Sulfur was observed on some shallow pits
- Fluid analyses revealed the presence of SRBs
- "Localized sour environments" – Bias weld weakest point

- Corrective actions:
 - Treating for bacteria in the system (including tanks)
 - Treating circulating fluid
 - Treating stagnant fluid

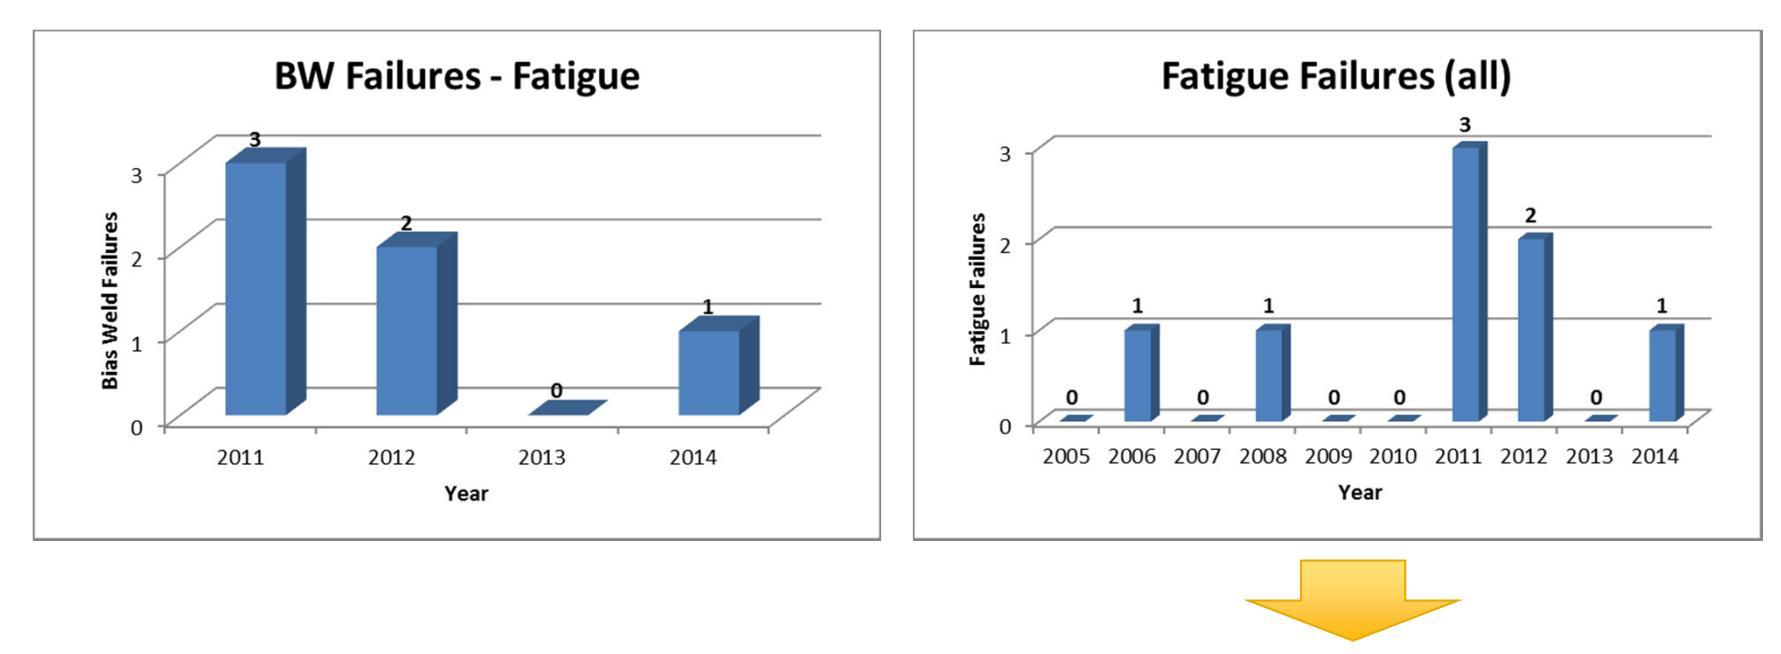
Not common to have "pure" fatigue failures

- Strings: 2" x tapered CT100+
- Operating Pressure: 6,000 7,000 psi
- Strains at bias weld locations: 1.8% 2.3%
- SFL used at bias weld locations: around 50%

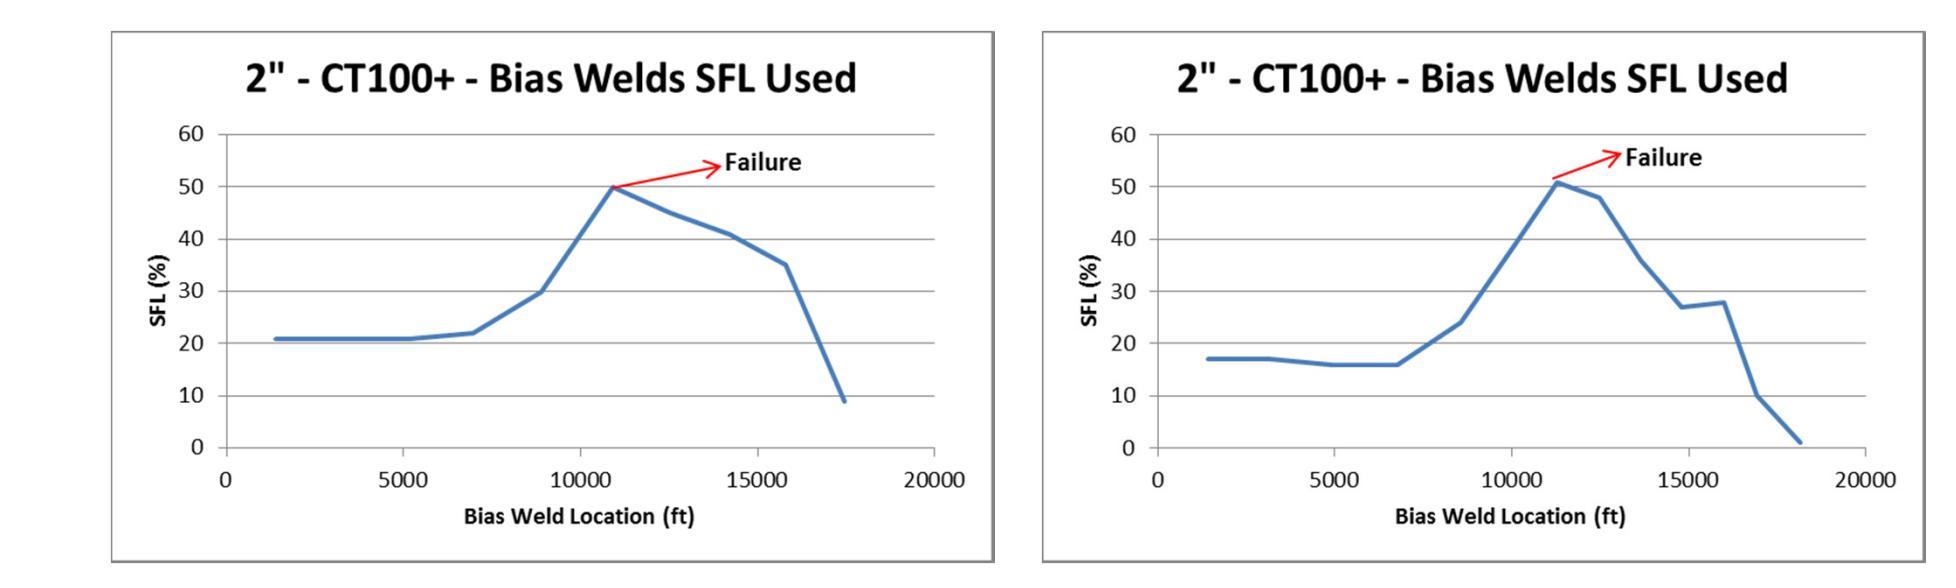
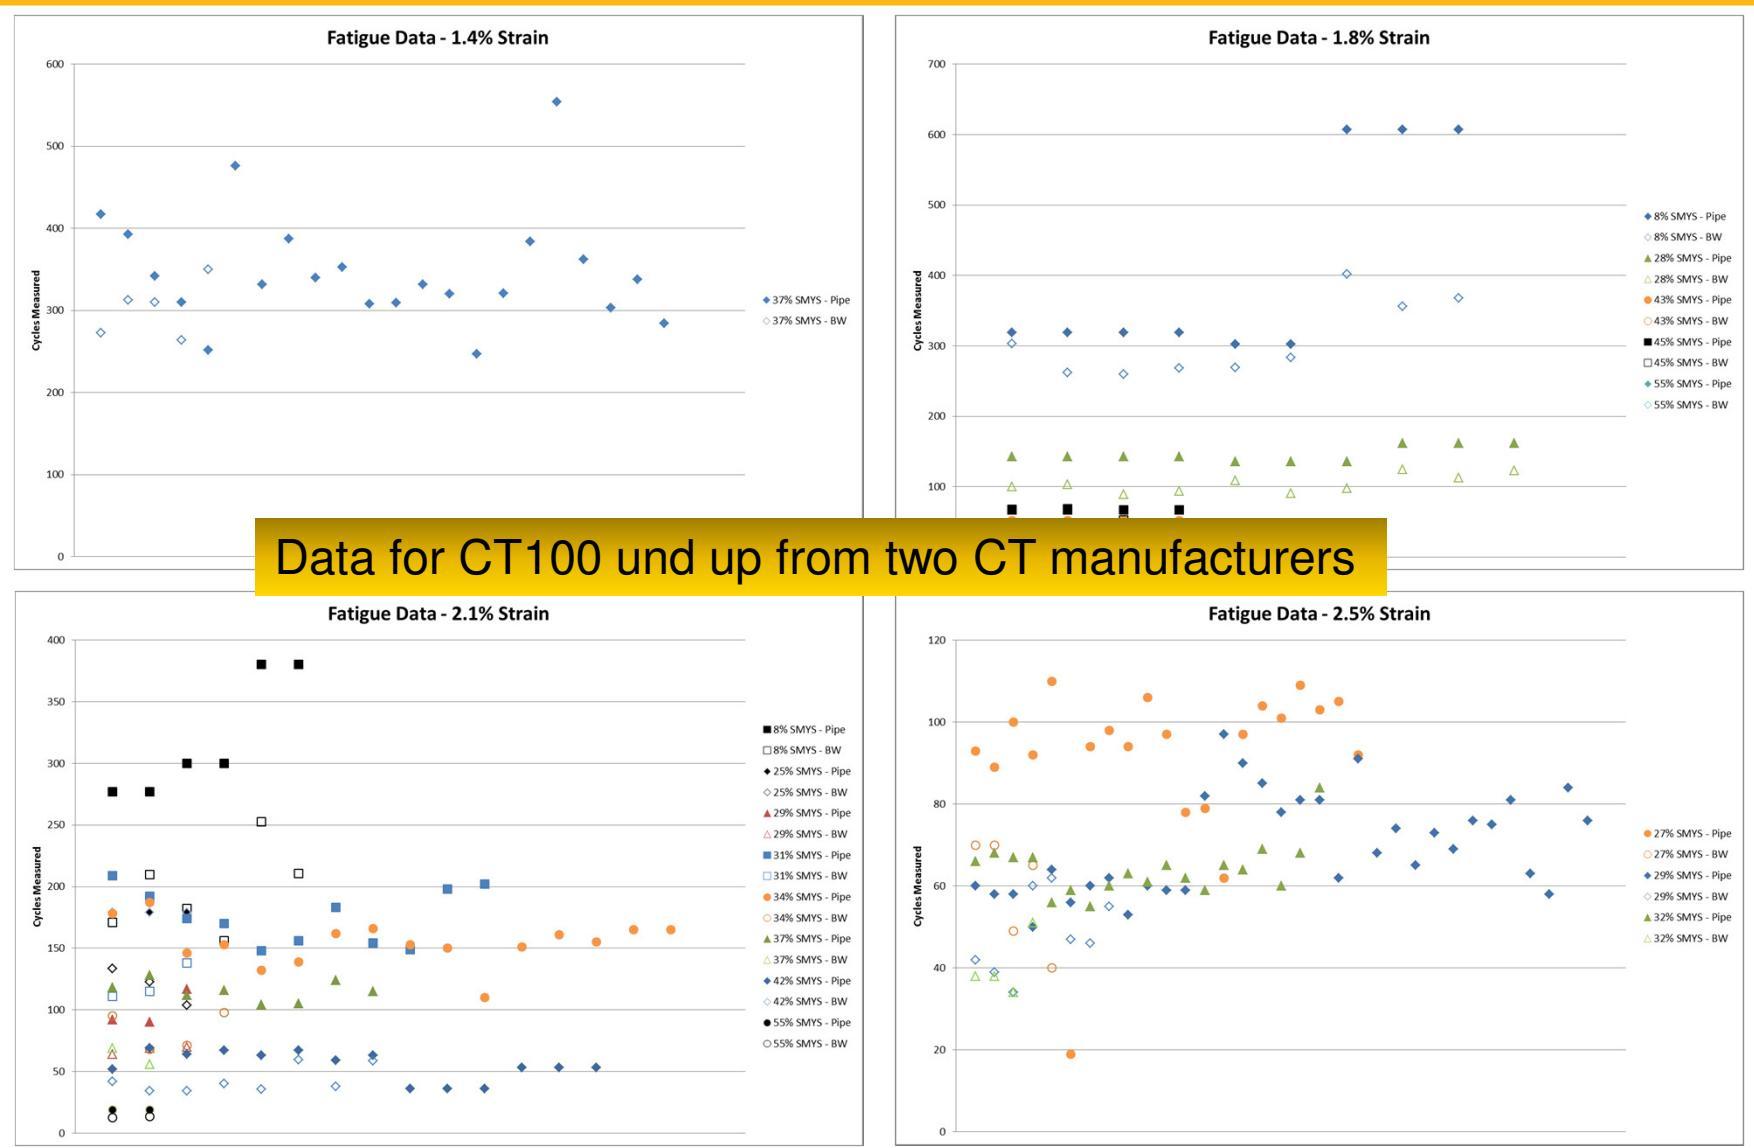
- Analysis of strings records showed:
 - Most of the retired strings without failures SFL at bias welds < 50%
 - Failures at bias welds SFL \ge 50%

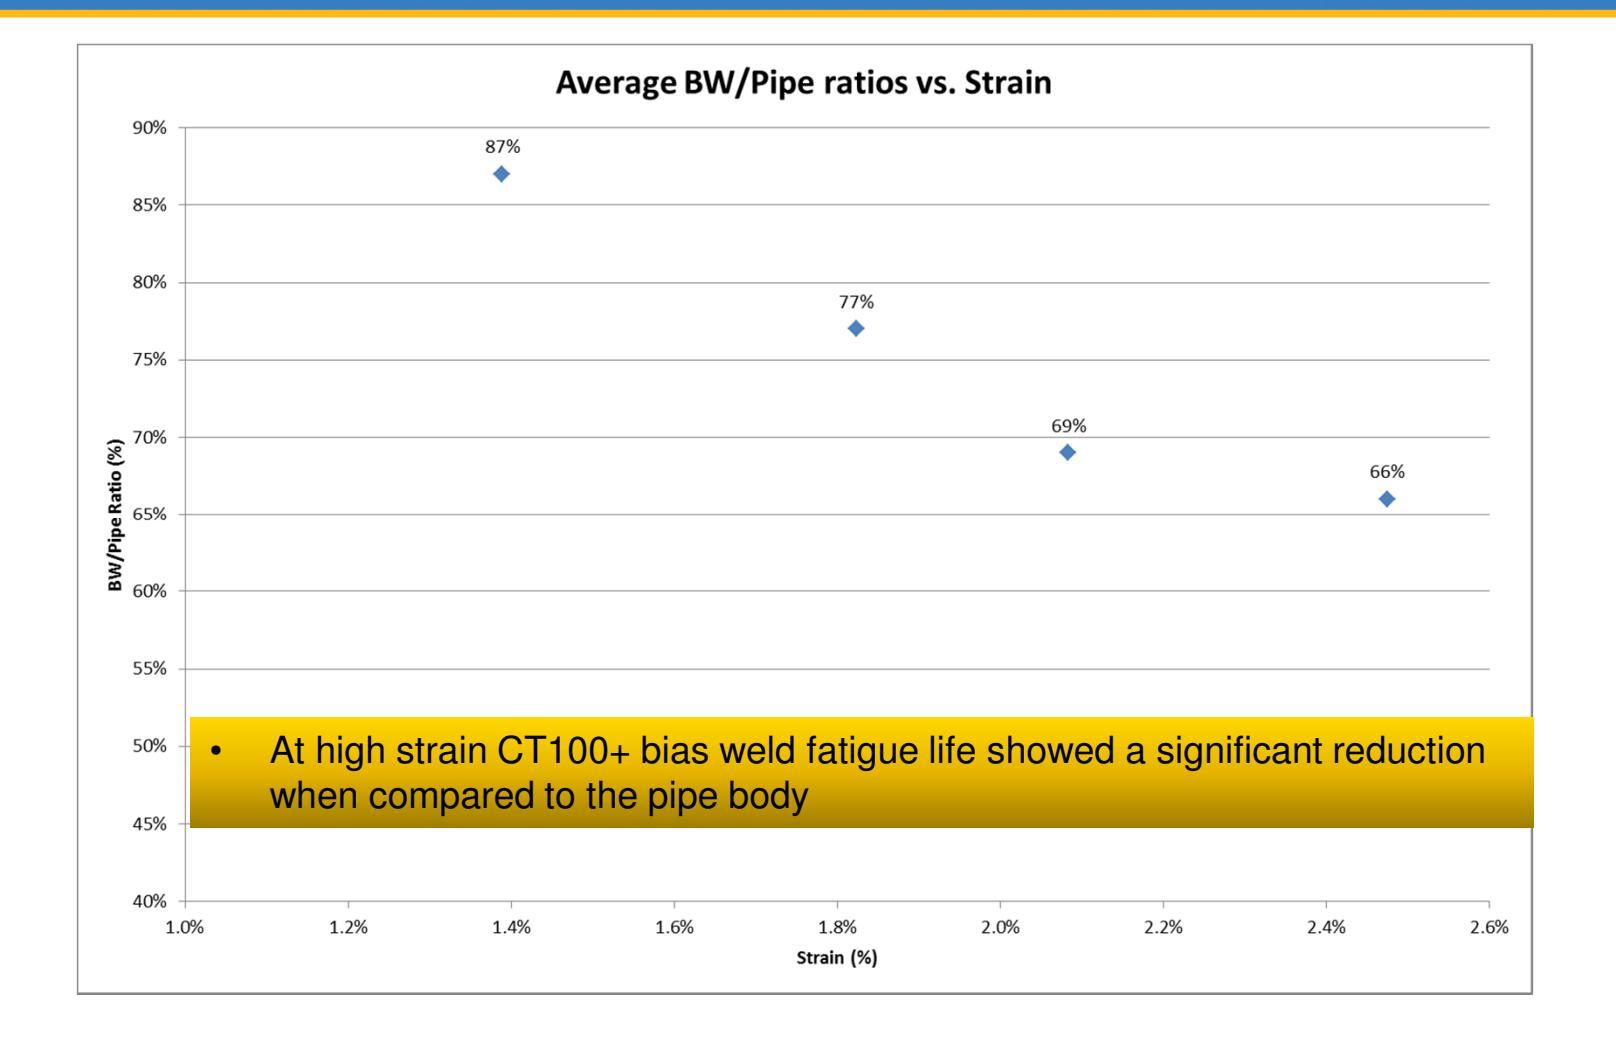
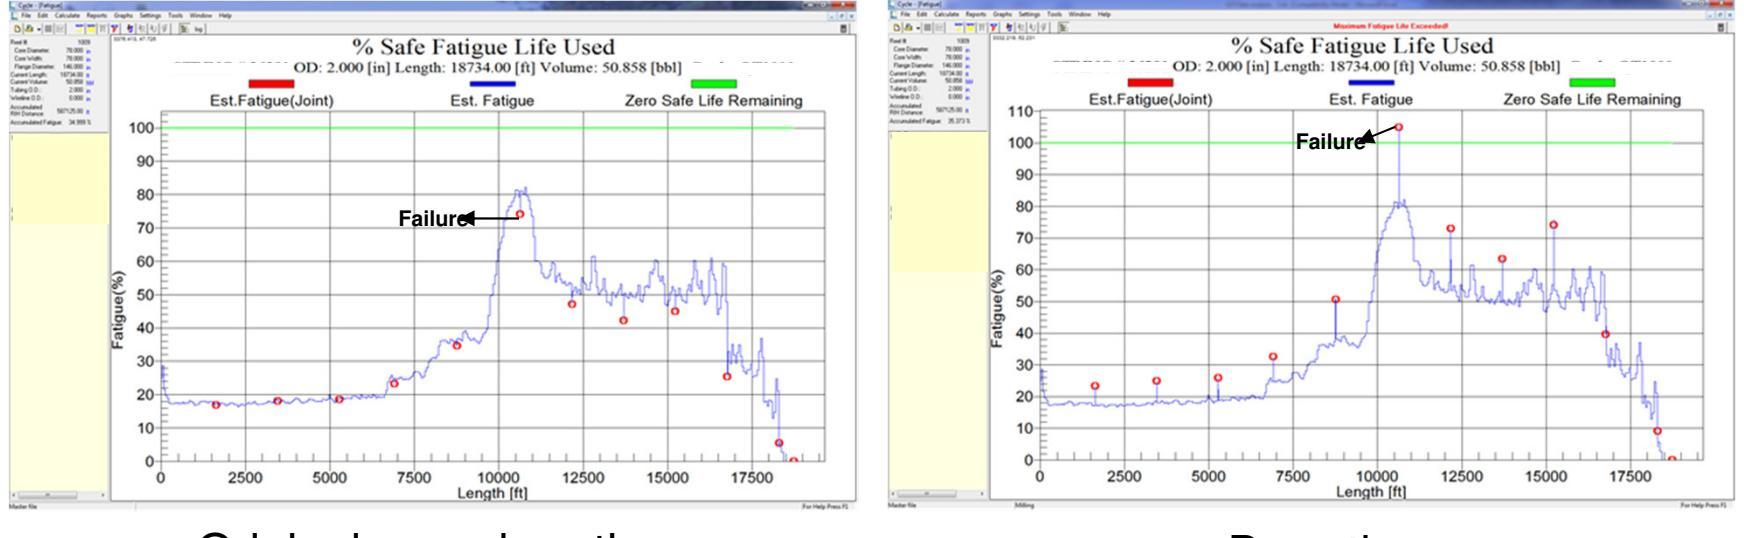
From the failures and the fatigue data it can be inferred that a bias weld derating is required for strings CT100 and up

De-rating should consider strain (reel and gooseneck):

Further fatigue testing on used bias welds (from strings retired from service) confirmed that the de-rating was required.

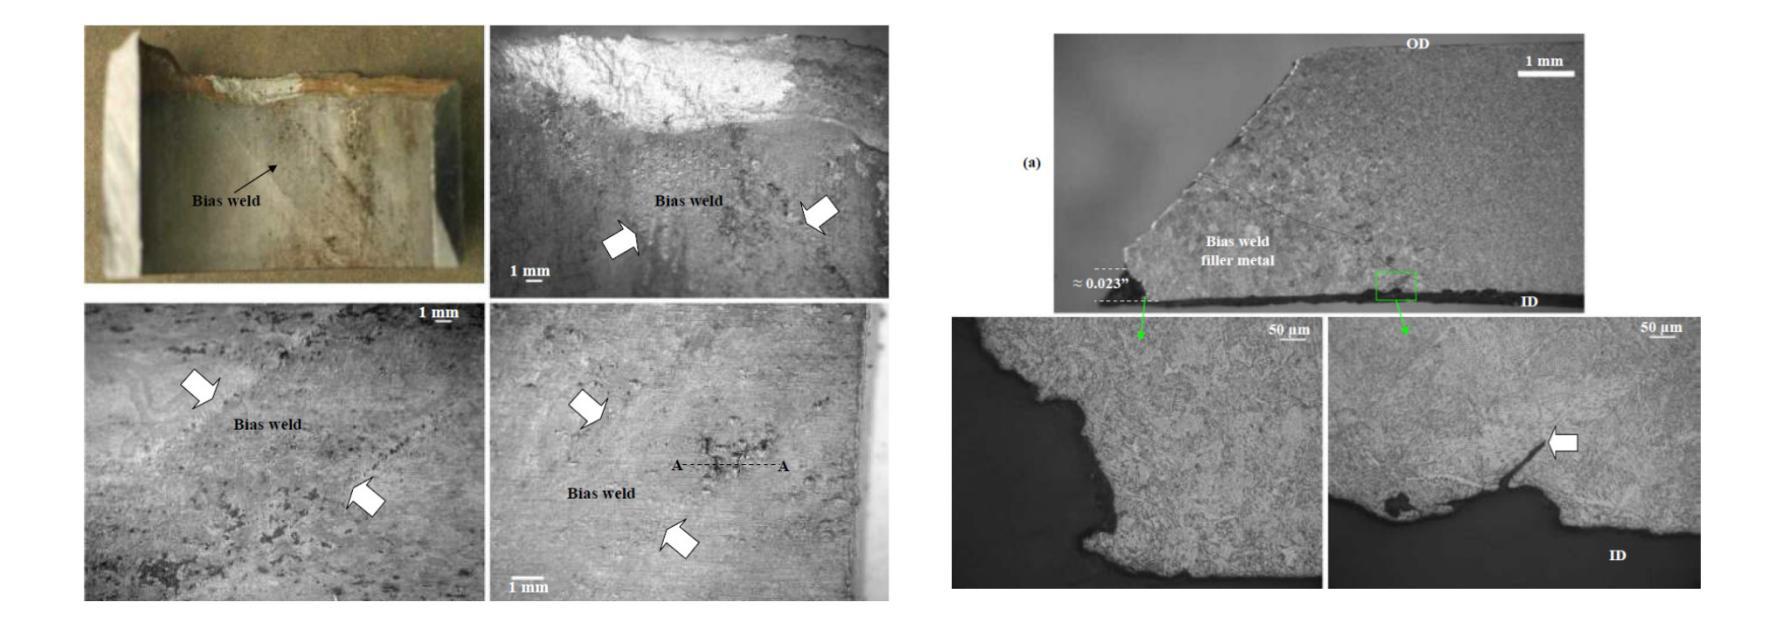
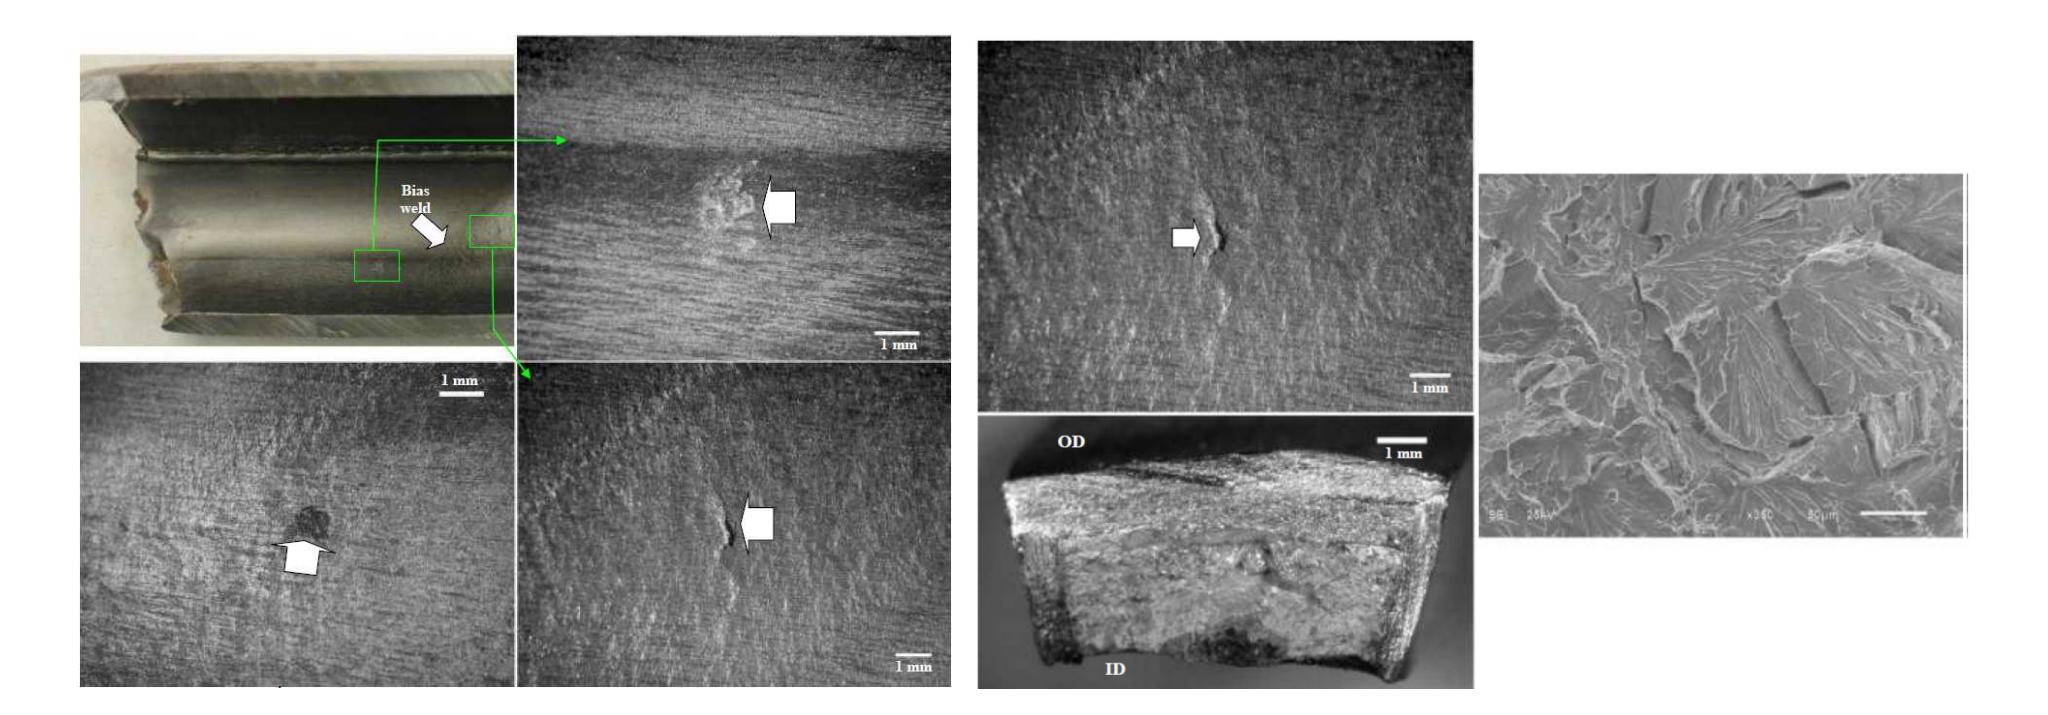
- Internal corrosion damage very mild or absent no fatigue cracking associated with isolated pits
- Internal cracking on the bias welds "cleavage" features similar to cracking due to exposure to H2S

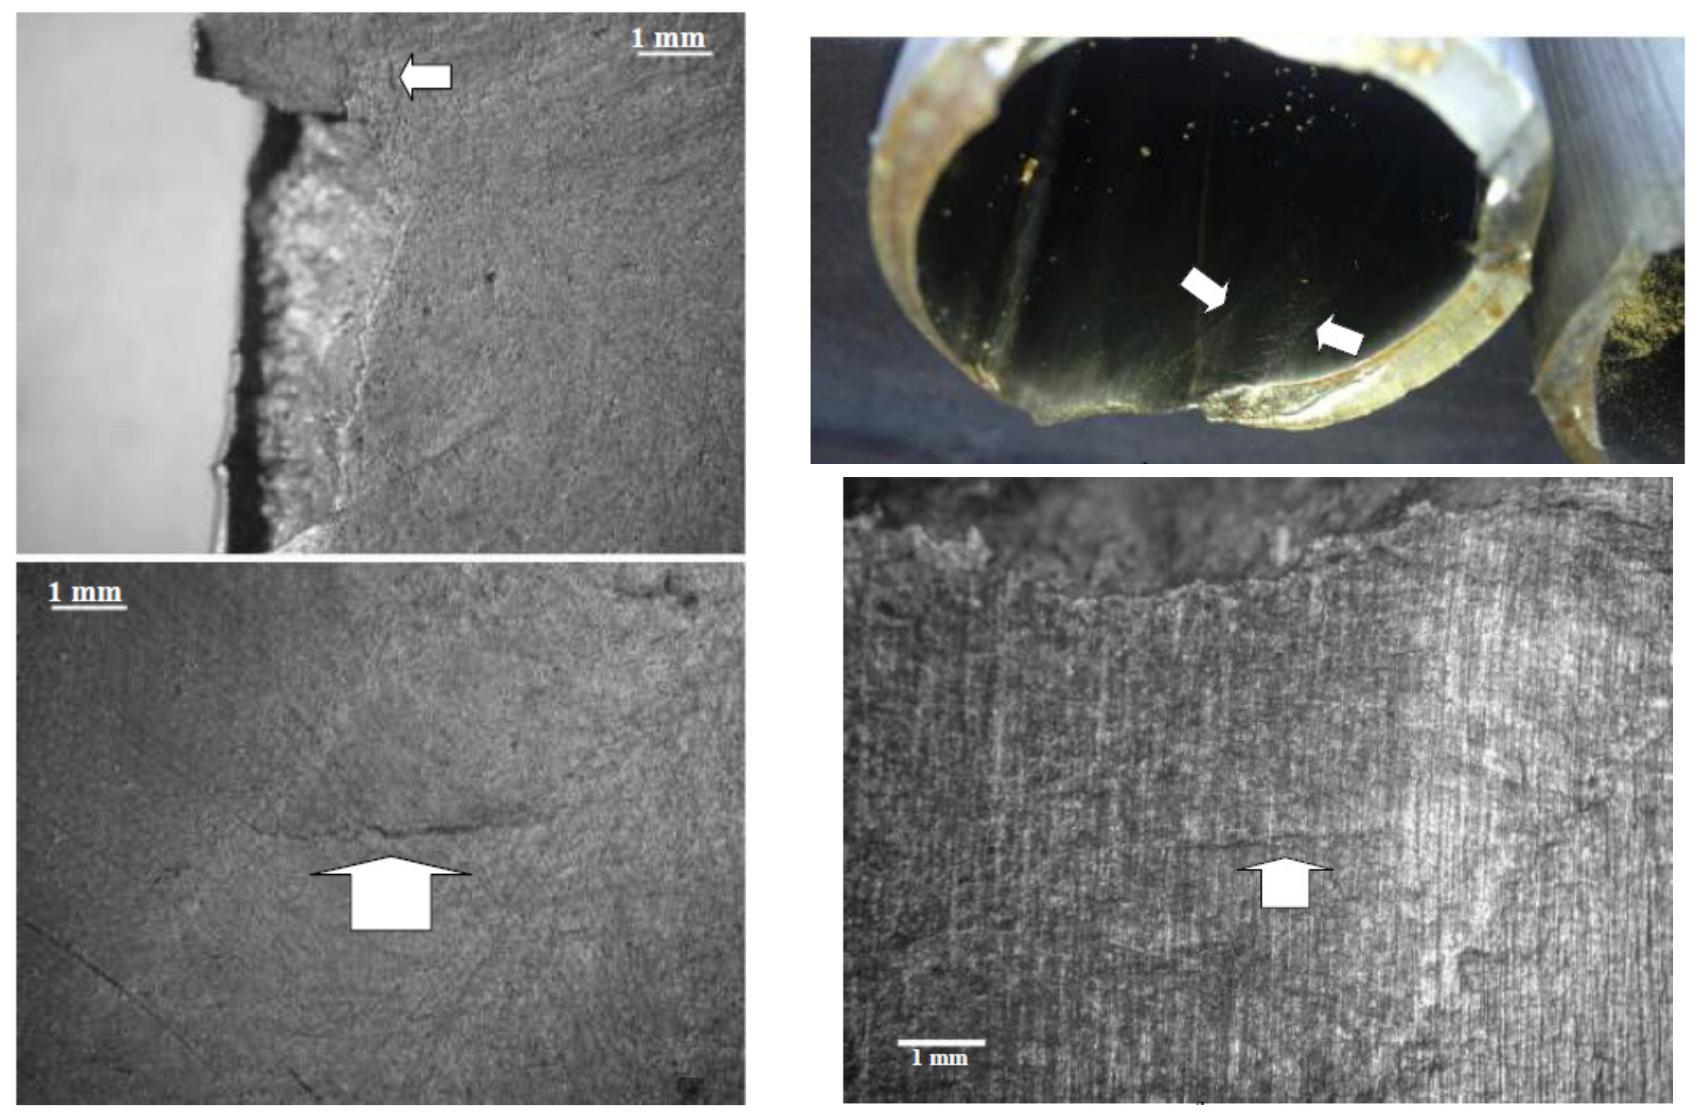
- Date: January 2013
- String: 1-3/4" x tapered CT80
- Failure: two cracks on bias welds
- Well: 37 psi H2S partial pressure
- Use of only H2S scavenger not anti-cracking inhibitor
- Cracking on bias welds due to Sulfide Stress Corrosion Cracking (SSCC).
