# Field Performance of BlueCoil Including Performance of Mechanically Damaged CT

Radovan Rolovic & Bruce Reichert  
Tenaris Coiled Tubes

ICoTA Roundtable, Calgary, Canada  
October 25, 2017

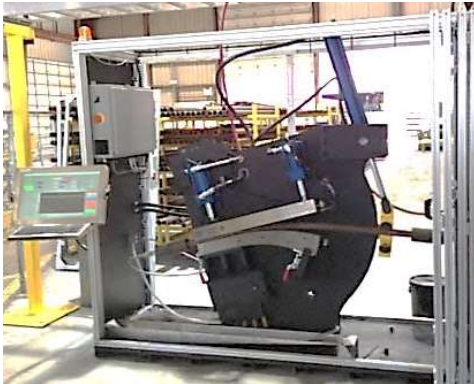
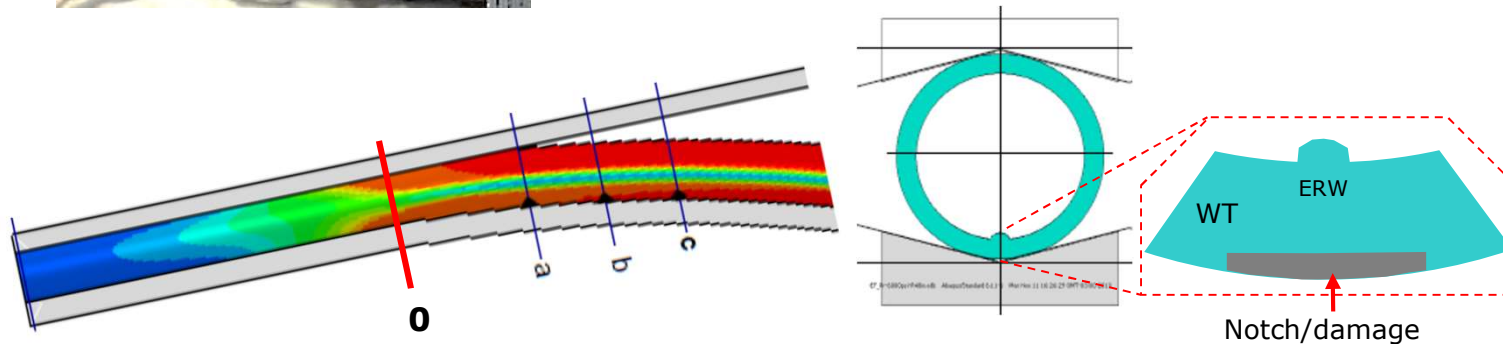
- ❑ 3 same transverse EDM notches on OD intrados along ERW at  $\sim 2.3''$  apart, starting at  $4''$  into the gage section (this is where undamaged CT normally fails)
- ❑ New  $2.0'' \times 0.204''$  CT
- ❑ 5%, 10%, and 15% WT notch depth,  $0.012''$  wide (longitudinally), 7x transverse length to depth ratio, sharp corners
- ❑ HT-125, HT-110, HS-110
- ❑ 500 psi and 6100 psi fatigue tests
- ❑ 3 repeated fatigue tests for each grade and condition

**Removing/grinding out these notches (up to ~15% deep) to a smooth surface restores the fatigue life close to 100%**
