Coiled Tubing String Failures – Past and Present

ICoTA Canada Breakfast Technical Session

May 30th 2018

Tomas Padron – Coiled Tubing Research & Engineering

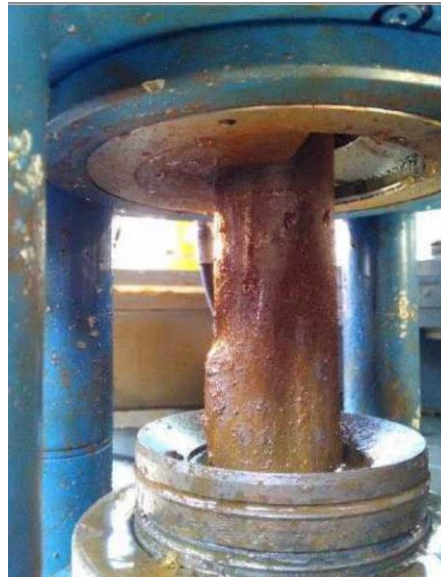
2-3/8" OD – CT100

Collapse

RIH Cleanout

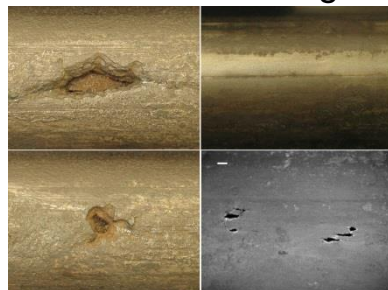
1-3/4" – CT1300

Pressure testing

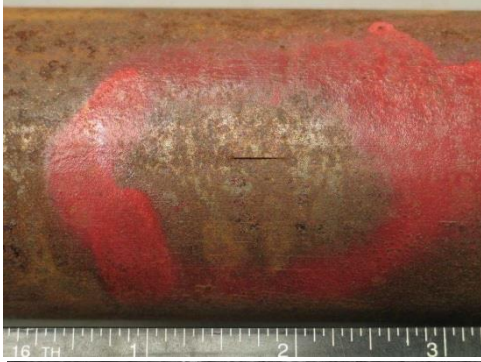
Optiport
2" – CT90

Small longitudinal splits

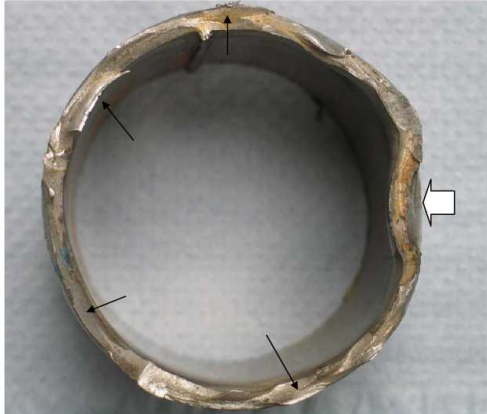
Frac – 2-7/8” – CT70

Fracture origin

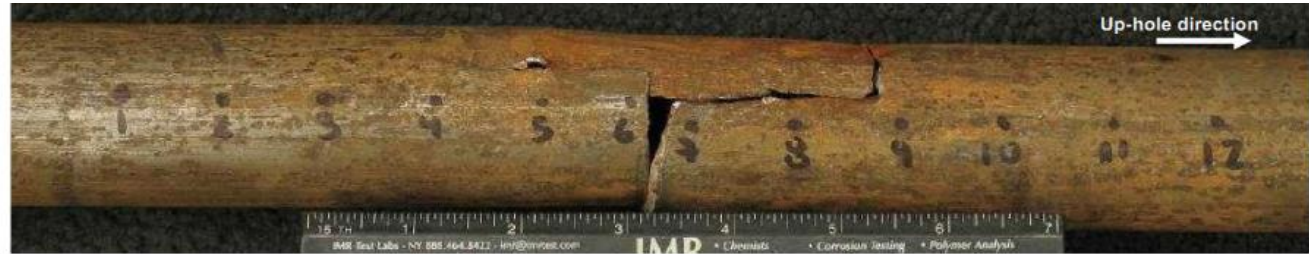
Acid corrosion

External abrasion

Location	Down-hole end (1)	1	2	3	4	5	6	7	8	9	10	11	12	Up-hole end (1)
Thickness measured (in.)	0.121"	0.111	0.107	0.101	0.083	0.068	0.056	0.056	0.082	0.087	0.105	0.120	0.120	0.133

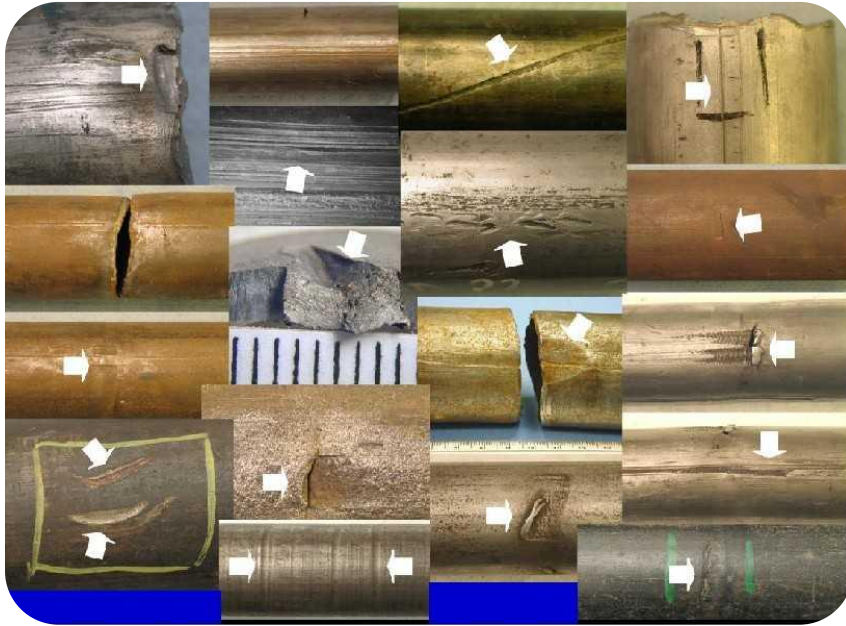
- Normally caused by the action of the surface equipment.
- Can be very diverse.
- Stress/strain concentration point

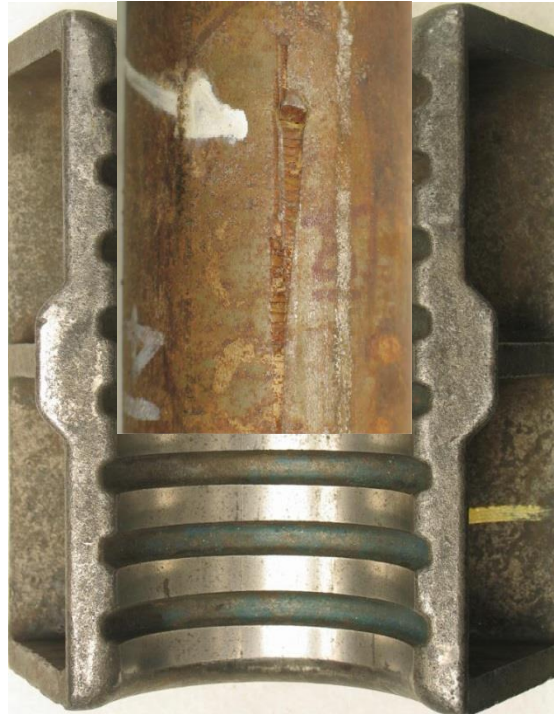
Main Failures Causes Review: Longitudinal Plowing Marks (LPM)

Frequently associated with worn gripper blocks

- Replacing “smooth” gripper blocks based on OEM recommendations
- Coating gripper blocks with tungsten carbide
- Inspect gripper blocks prior mobilization for the presence of debris in the grooved gripper blocks
